**New York State Department of Transportation  
Red Flag 3B190TW044**

*BIN:* 3209800

*Feature Carried:* FREESE ROAD

Subject: Cracked, Crippled, and Buckled Stringer Webs in Span 1

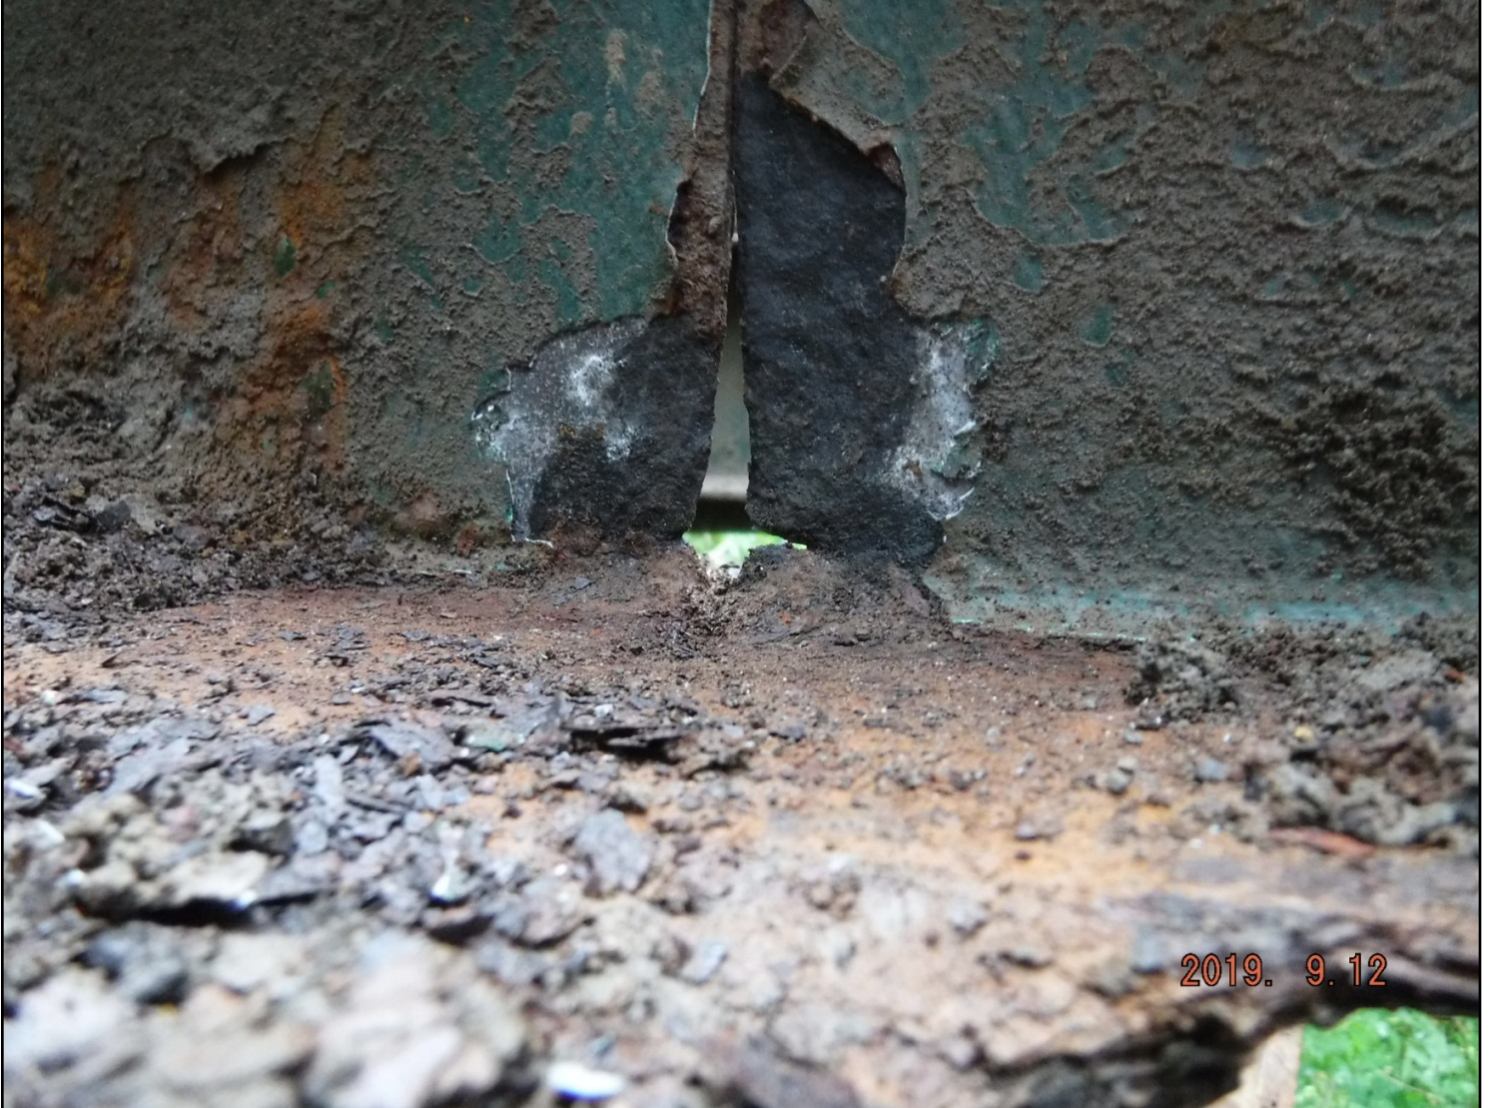
Photo Number: 2

-Stringer 2, Panel 1 at Floorbeam 1: 3/8" long crack to the lower web and it appears that the web has slightly crippled at the base. (photo 2)

-Stringer 2, Panel 2 at Floorbeam 1: 1/8" long crack to the lower web and it appears that the web has slightly crippled at the base. (photo 2)

***Attachment Description: Stringer 2 Lower Webs at Floorbeam 1 (Panels 1 and 2), Looking Right***

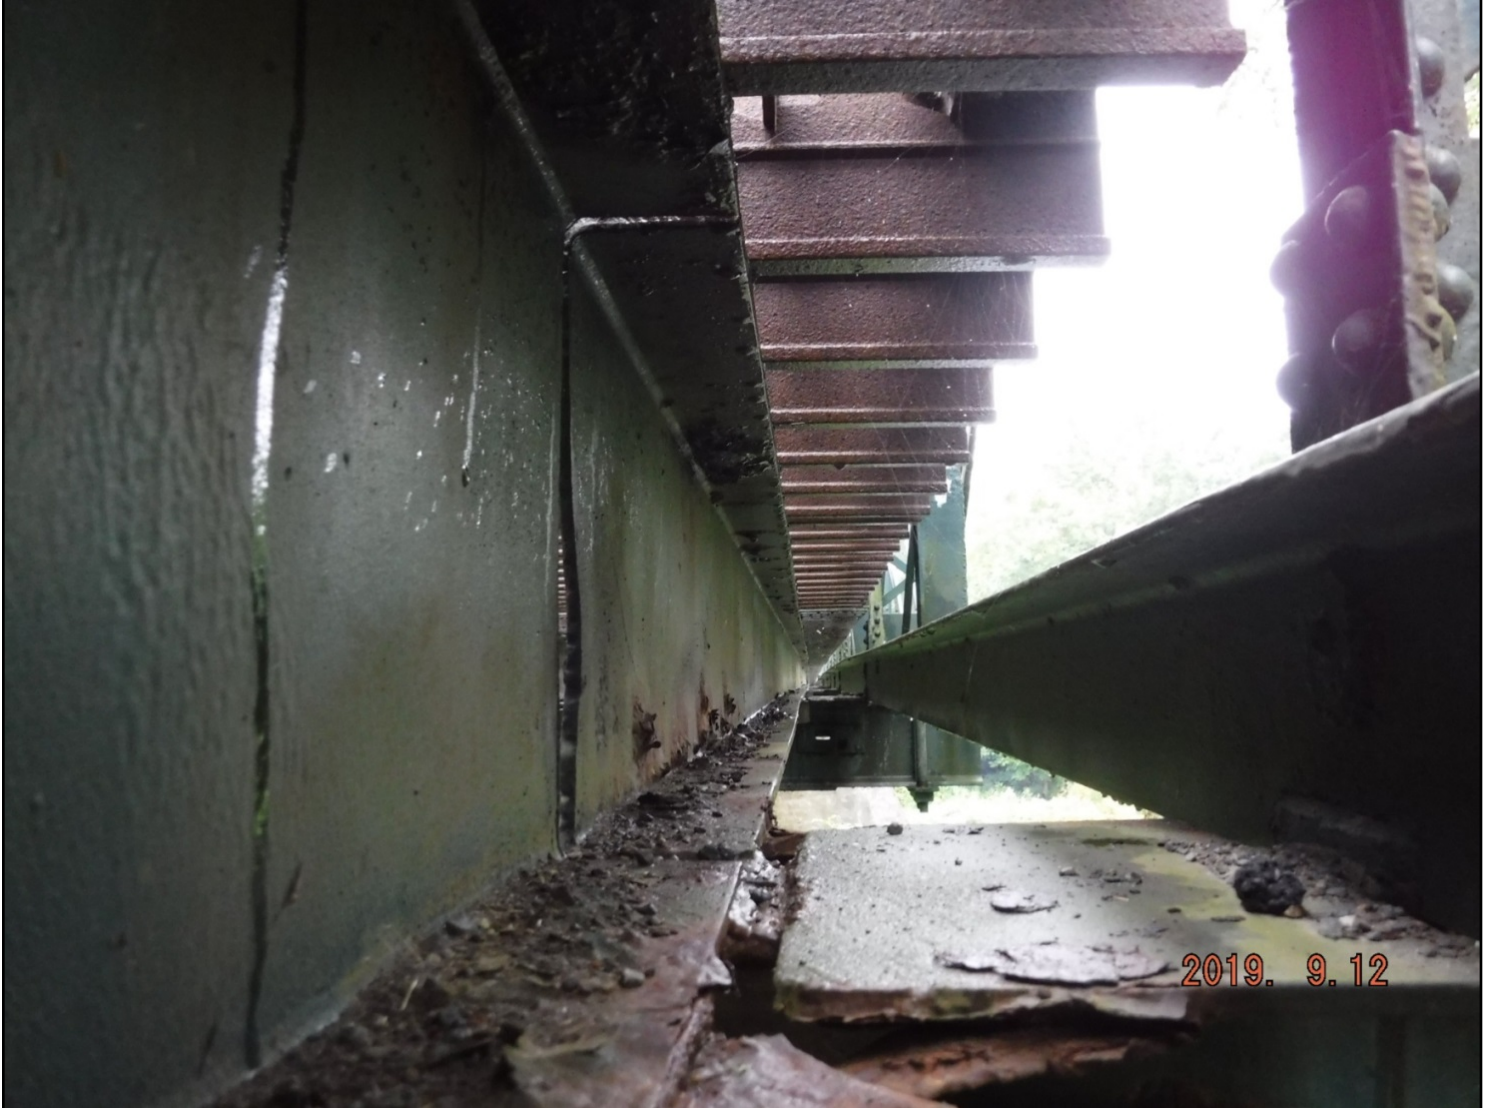
Photo Number: 3

-Stringer 4, Panel 2 at Floorbeam 1 is buckled 5/16" to the Right at approx. mid-height. There is no section loss to the web. (photo 3)

***Attachment Description: Stringer 4, Panel 2 at Floorbeam 1, Looking Ahead***

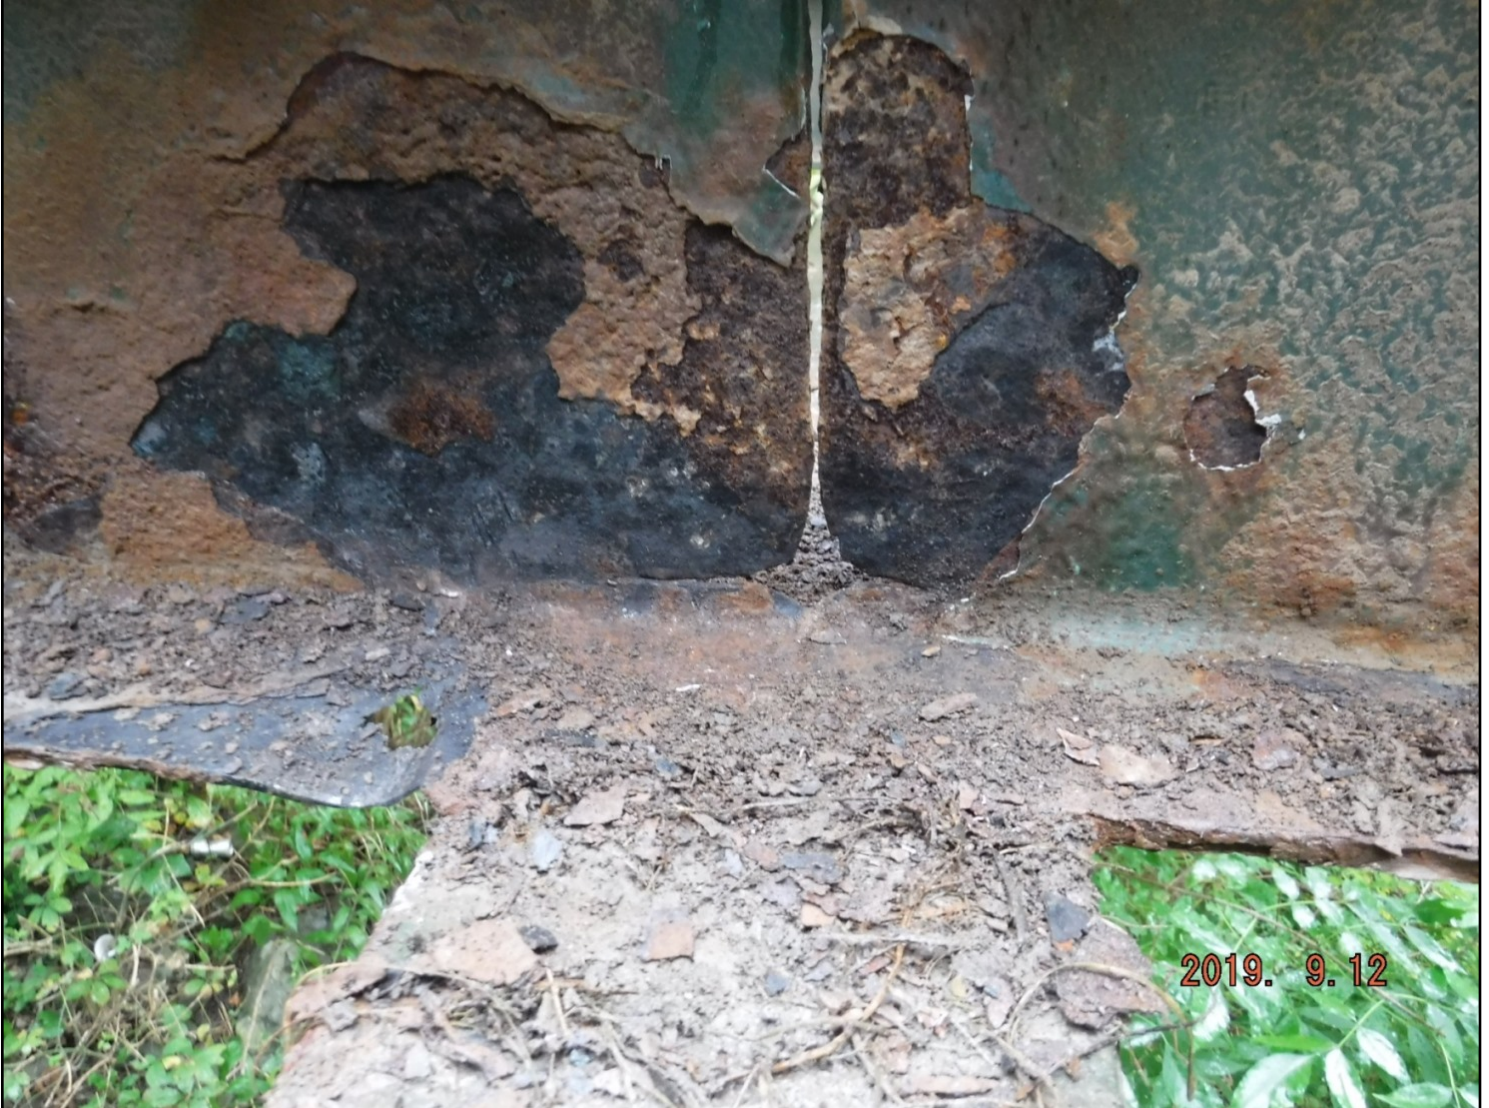
Photo Number: 4

-Stringer 2, Panel 2 at Floorbeam 2: 2" long crack surrounded by approx. 50% section loss to the lower web. There is also a hole to the Right side bottom flange at the floorbeam. Overall bottom flange section loss is approx. 50%. (photo 4)

-Stringer 2, Panel 3 at Floorbeam 2: 1" long crack surrounded by approx. 50% section loss to the lower web. (photo 4)

**Attachment Description: Stringer 2 Lower Webs and Bottom Flanges at Floorbeam 2 (Panels 2 and 3), Looking Left**

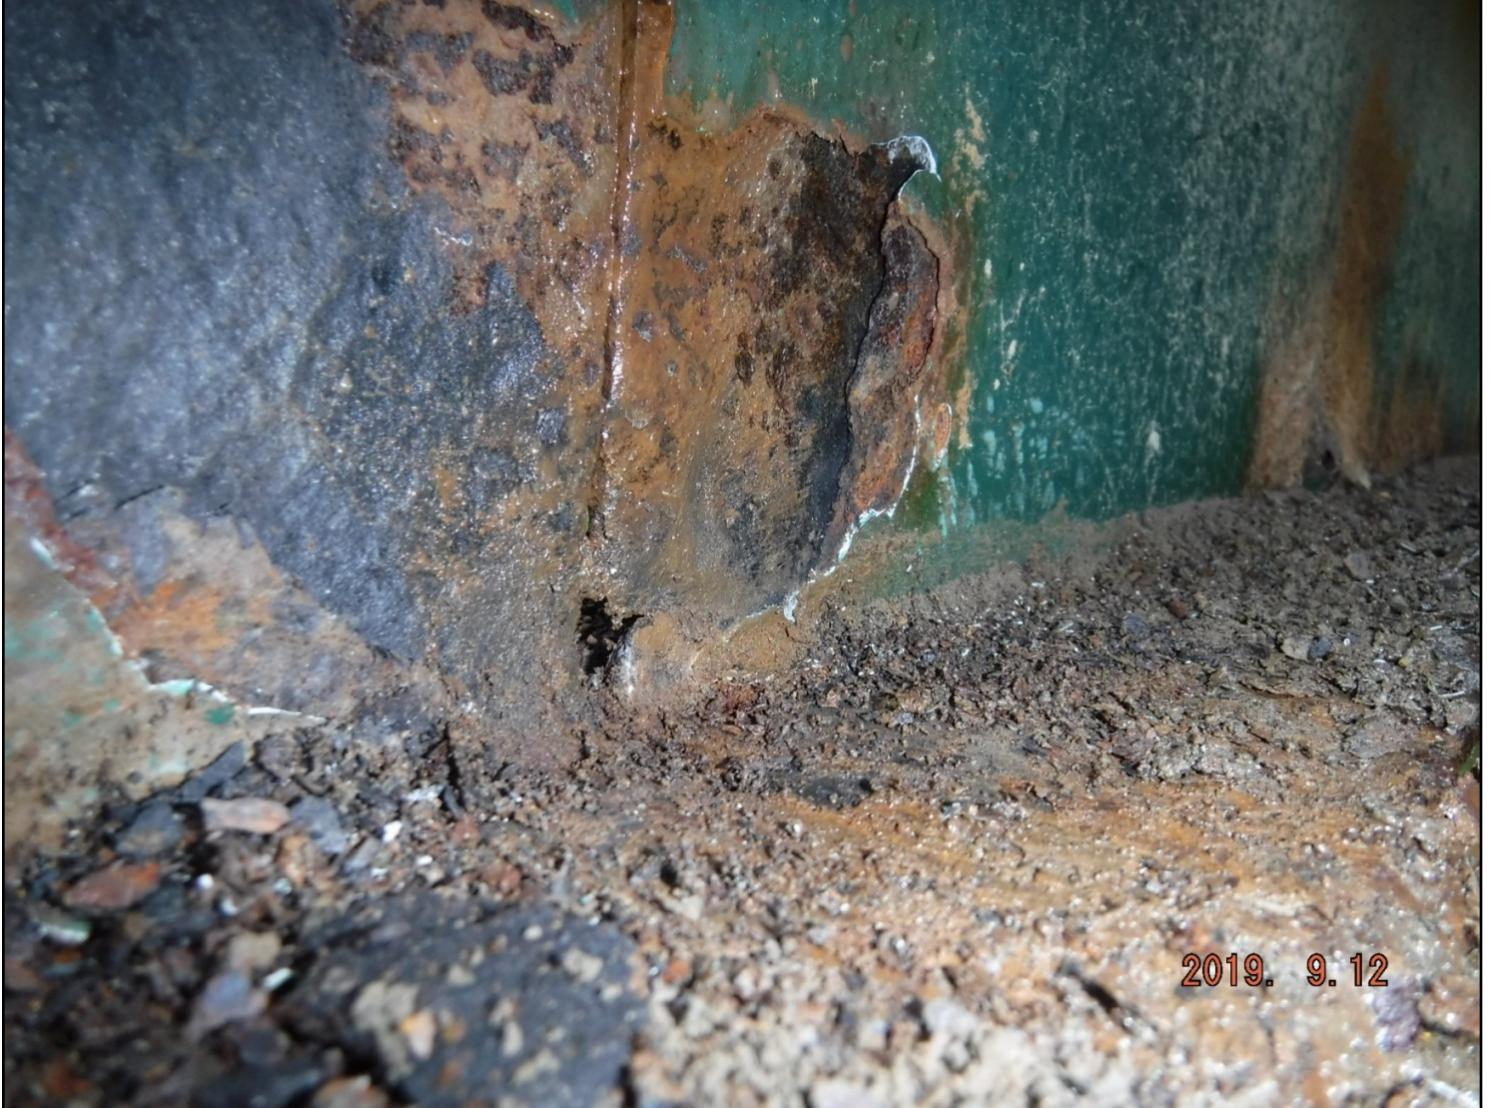
Photo Number: 5

-Stringer 2, Panel 4 at Floorbeam 3: 1/2" long crack surrounded by approx. 50% section loss to the lower web. (photo 5)

**Attachment Description: Stringer 2 Lower Web at Floorbeam 3 (Panel 4), Looking Left and Ahead**
