**New York State Department of Transportation
Red Flag 3B190TW049**

BIN: 3209800

Feature Carried: FREESE ROAD

Feature Crossed: FALL CREEK

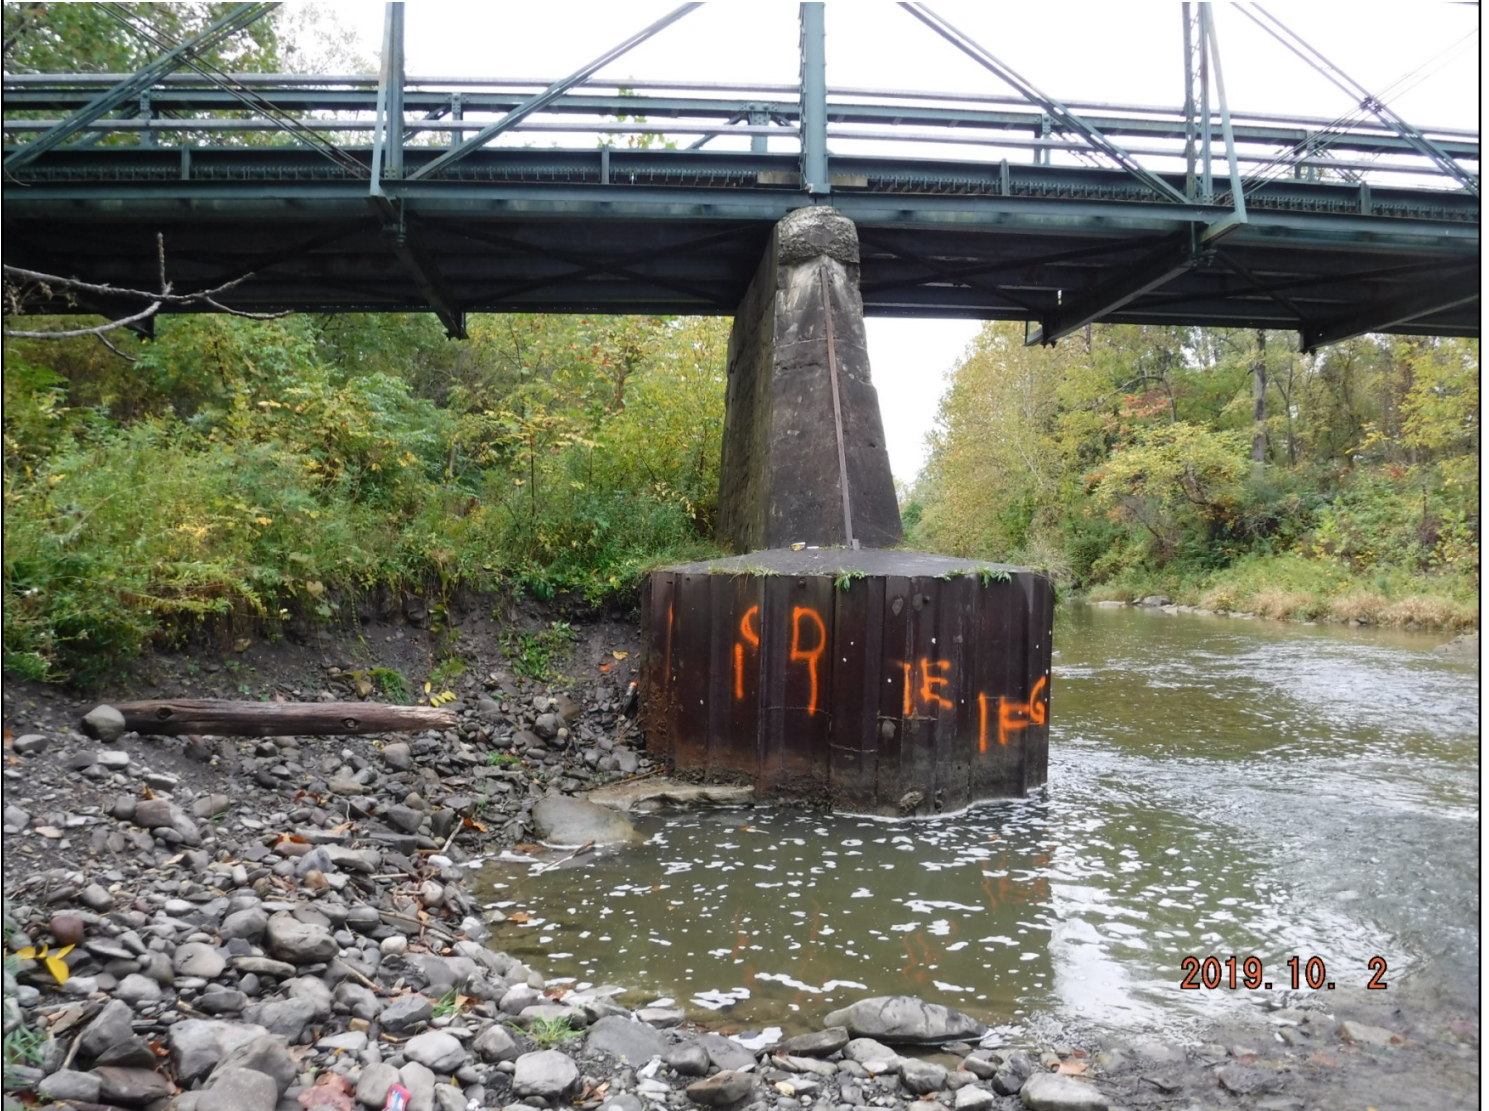
Photo Number: 1

The upstream side (Right side) and the End Right portion of the pier footing is undermined more than 5 ft at one location (other readings ranged from 2 ft+/- to 4 ft+/-). The undermining extends over a length of 15 ft. The water was approx. 4.5 ft at the pier and accurate readings were not possible. Based on the limited reach from the scour rod, due to depth of water, it appears that the footing is undermined at least up to the edge of the pier wall at some locations. There was no undermining previously noted although the sheeting appeared to be mostly exposed based on photos from past inspections. It should also be noted that the Fall Creek was flowing well above normal during the Fall of 2018.

Attachment Description: Pier, Right Side (Upstream Side), Looking Left

A diving inspection is recommended to obtain more accurate undermining readings. There was no previous diving inspection for this bridge.

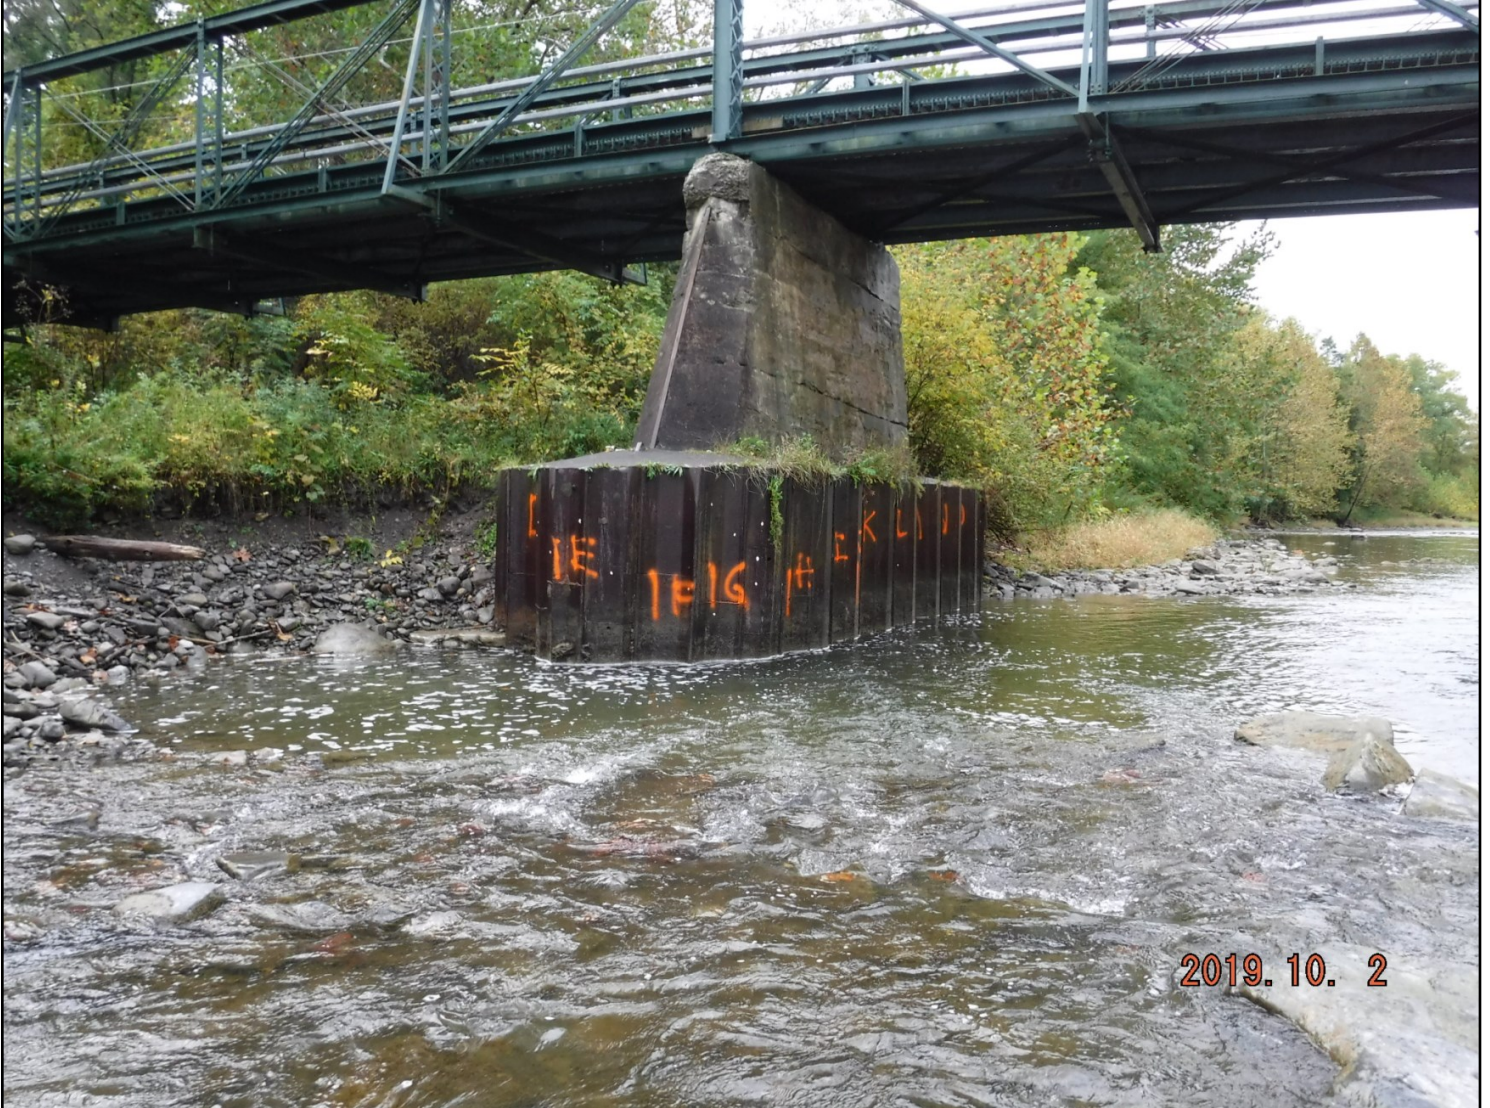
Photo Number: 2

Attachment Description: Pier, Right and End Sides (Upstream Side), Looking Left

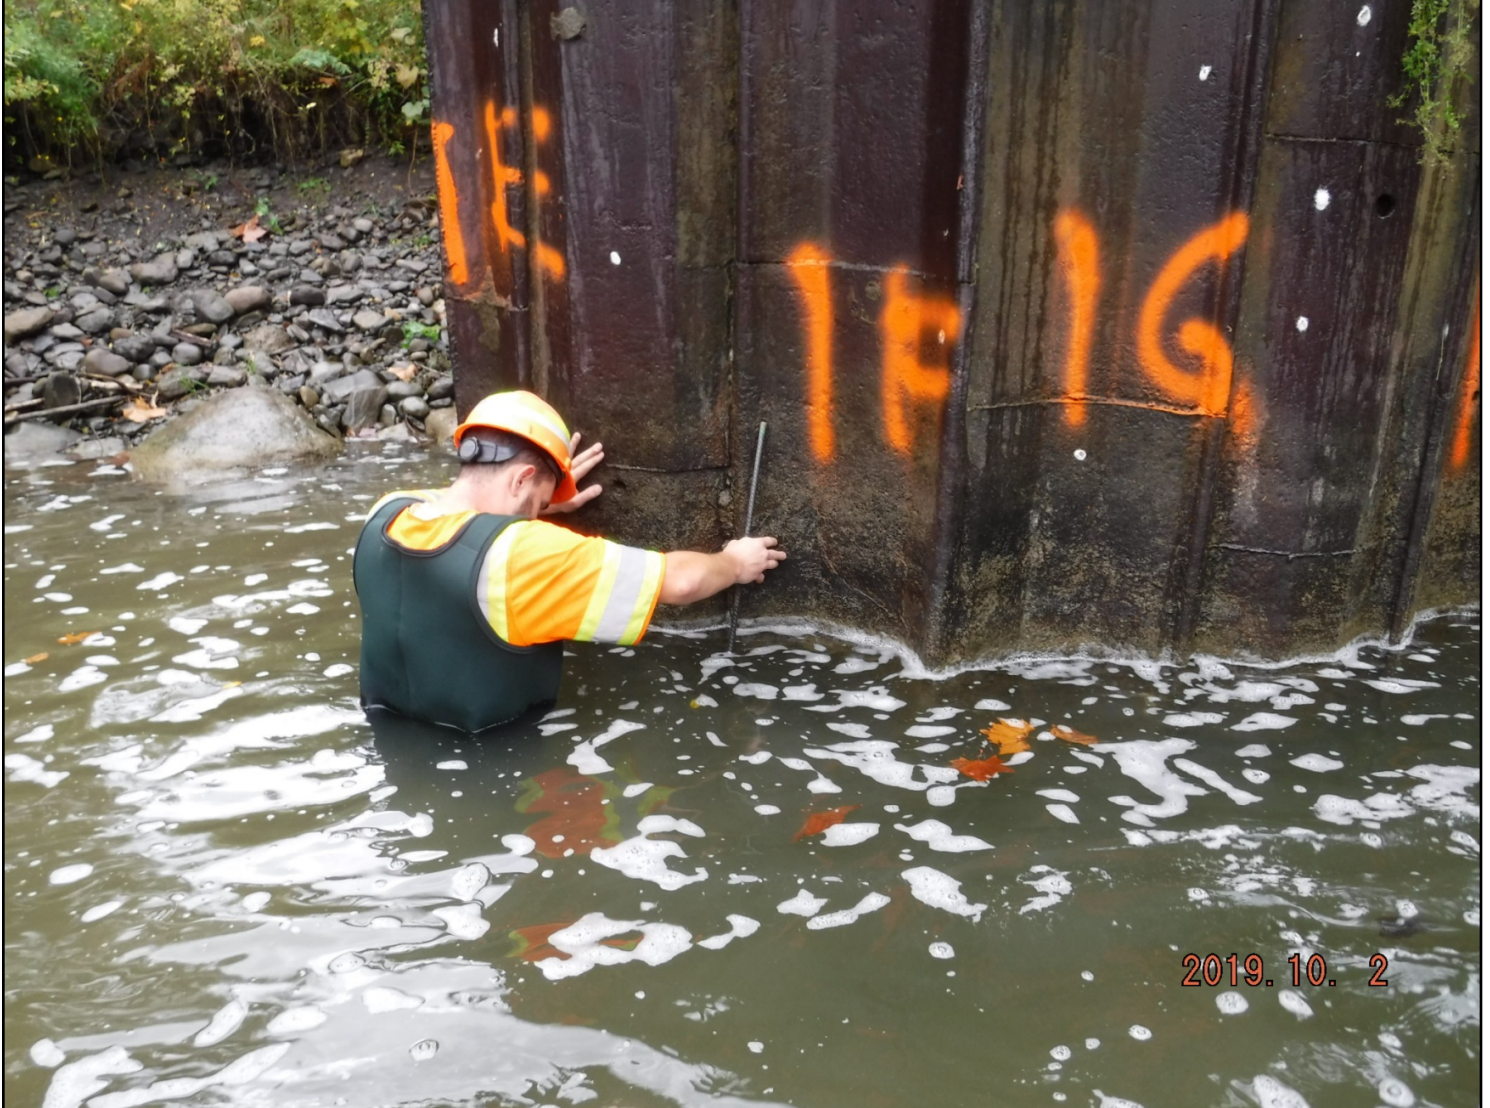
Photo Number: 3

Attachment Description: Pier, Right Side (Upstream Side), Looking Back (scour readings)

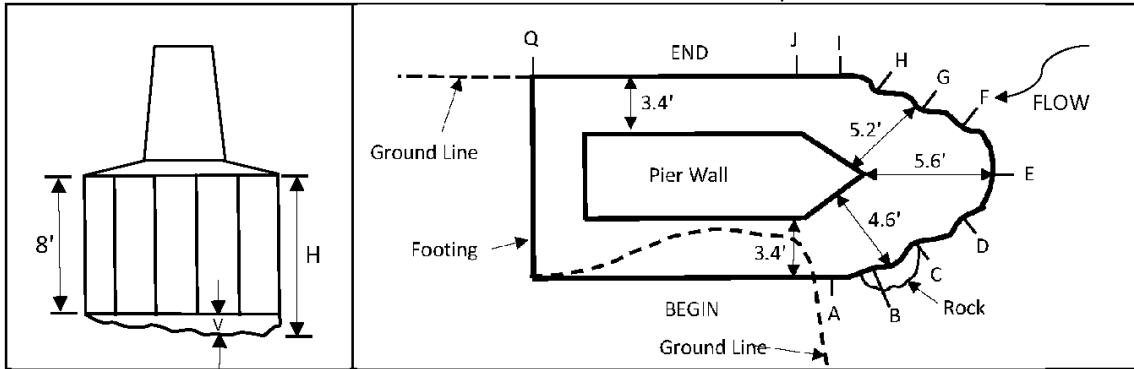
Photo Number: 4

UNDERMINING DOCUMENTATION ALONG PIER

| 2019 | New undermining and Pier profile readings taken. The footing is undermined by 5 ft. + at station E. Water is 4.5 ft. +/- deep along the pier which makes accurate undermining readings very difficult. |
