**New York State Department of Transportation
Yellow Flag 3B190TW046**

BIN: 3209800
Feature Carried: FREESE ROAD
Feature Crossed: FALL CREEK
Orientation: 8 - NORTHWEST
Region: 03 - SYRACUSE
County: TOMPKINS
Political Unit: Town of DRYDEN
Approximate Year Built: 1920
Posted Load Matches Inventory : Yes
Bridge Load Posting (Tons) : 15
Primary Owner: 30 - County
Primary Maintenance Responsibility: 30 - County
Typical or Main Span Type: 3 - Steel, 10 - Truss - Thru
This Bridge is not a Ramp
Number of Spans: 2

Subject: Heavy Section Loss to the Stringer Flanges

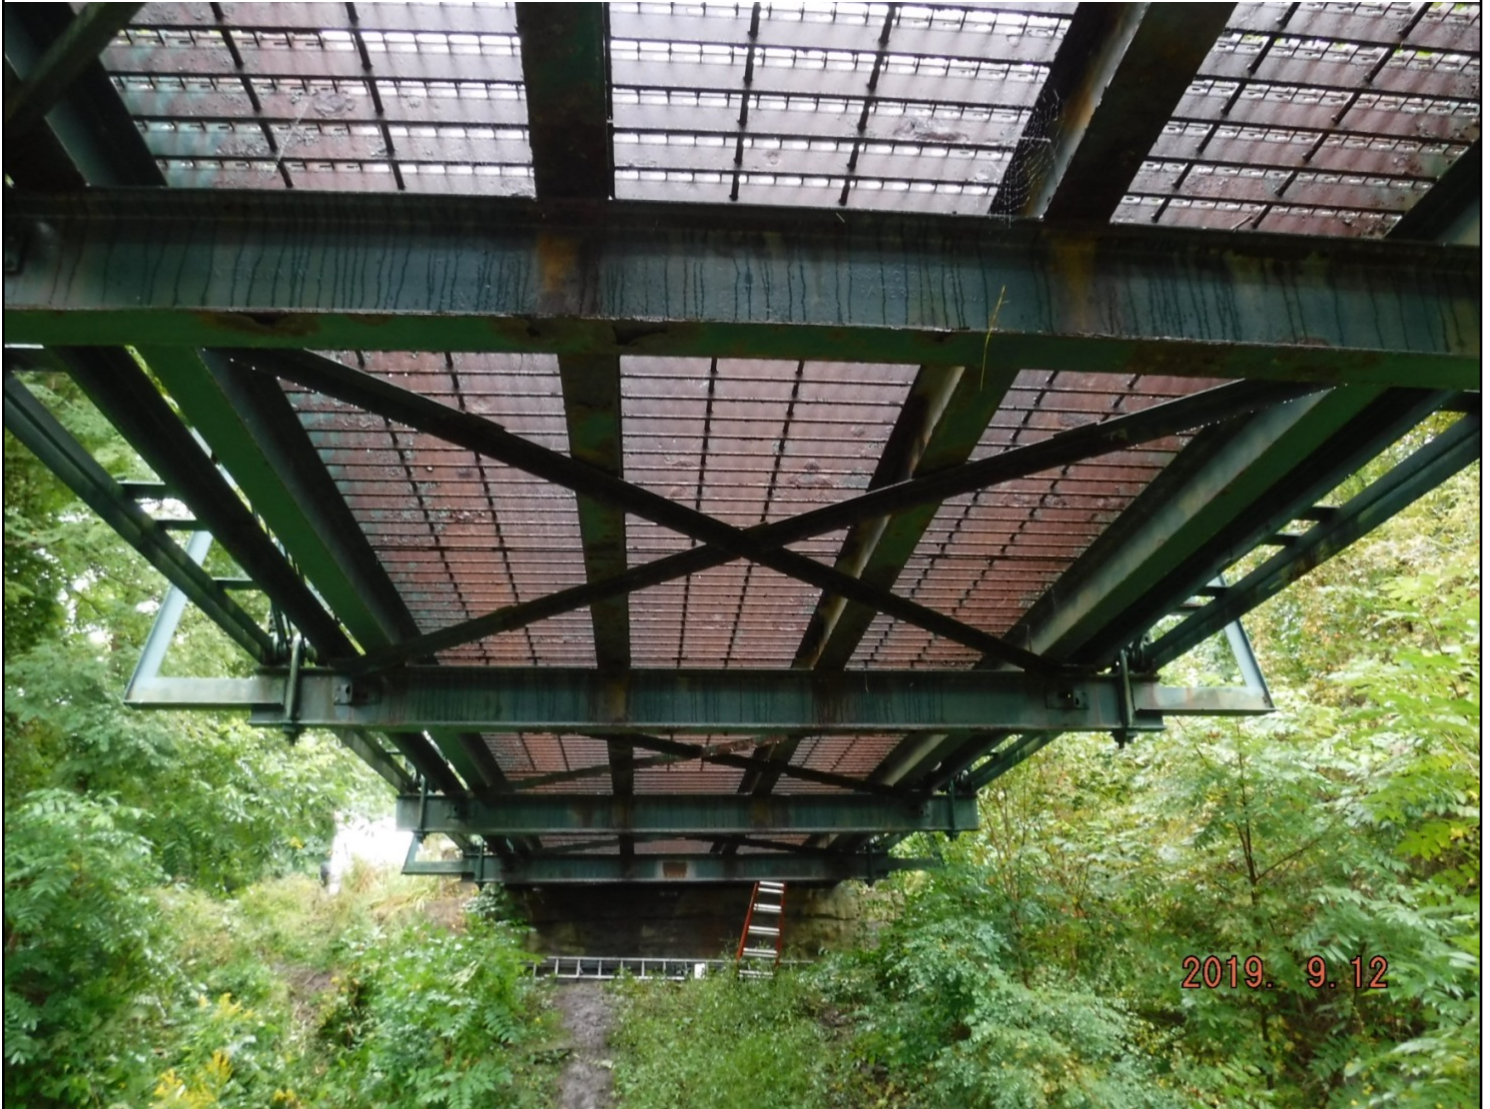
Photo Number: 1

This structure is a two span continuous pony truss with a floorbeam and stringer floor system supporting an open steel grate deck (photo 1). The stringers are noted to be 12"27#WF in the plans in the BIN folder (tw=0.24" and tf=0.4").

Attachment Description: General View of Underside of Span 1, Looking Back

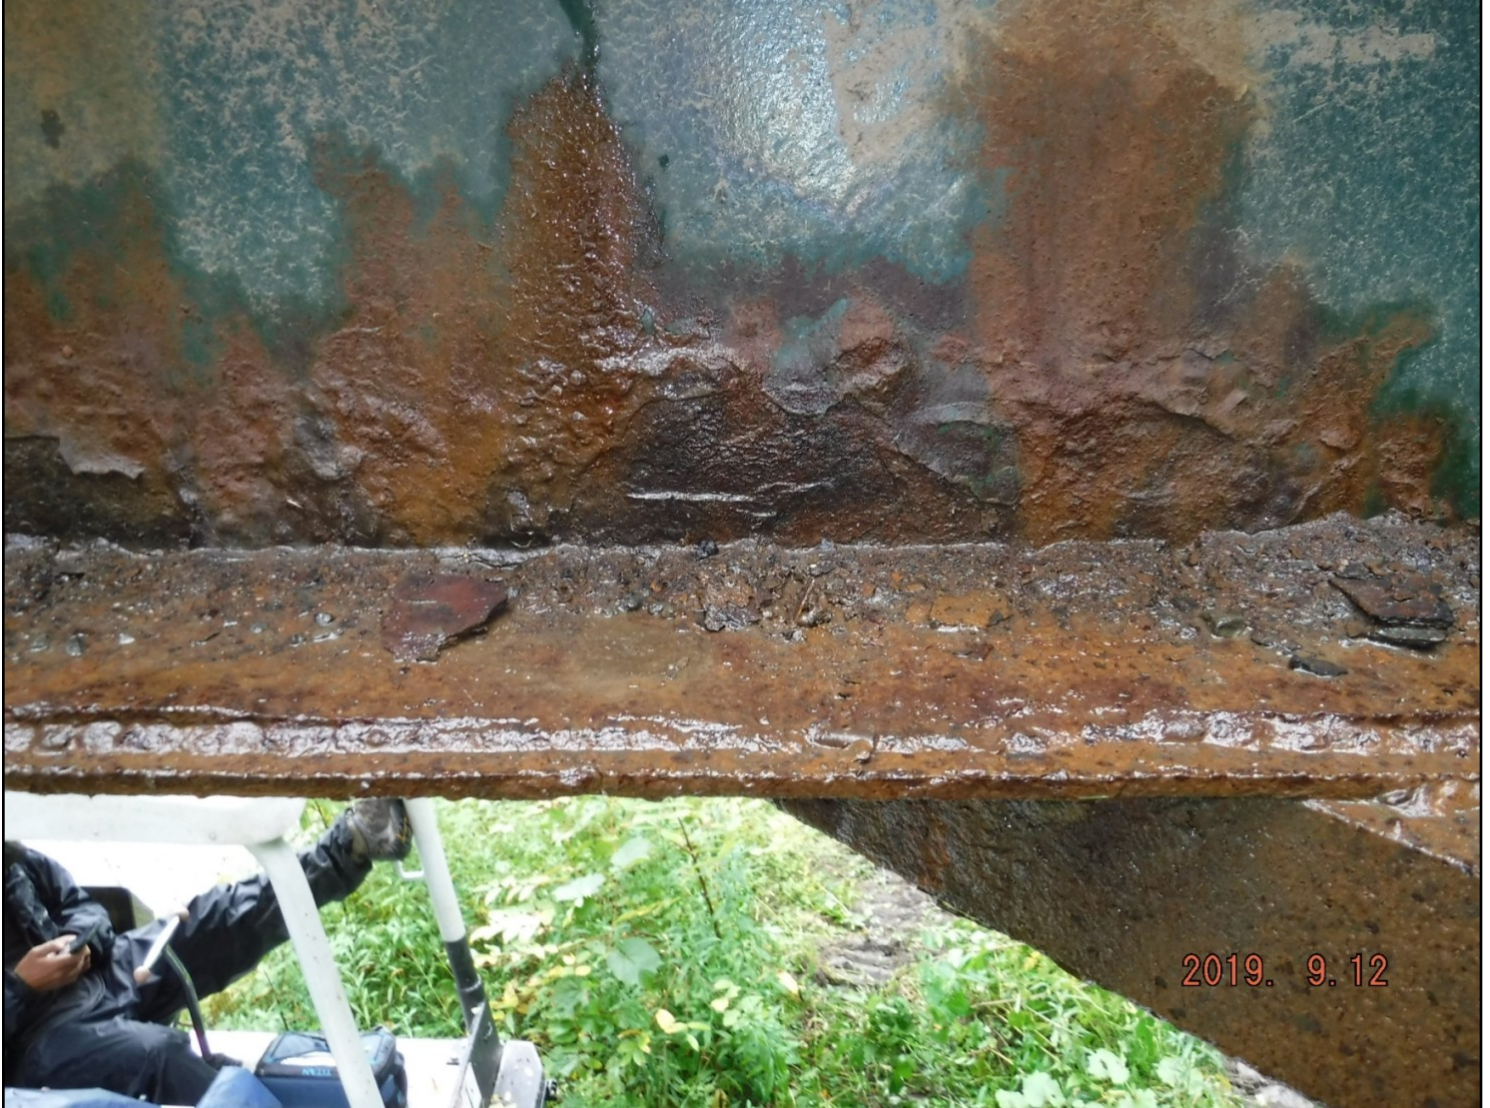
Photo Number: 2

Stringer 2 in Panel 5: This stringer was reported to have 43% section loss to the bottom flange approx. 6 ft+/- from floorbeam 4 in 2016. Prior to 2017, a 1/4" thick steel plate was welded to the bottom flange. The plate is approx. 18" long. In 2017 and 2018 the section loss was noted to be 44% to the bottom flange and the plate was not mentioned. There are no plans or calculations for this plate in the BIN folder and it is unknown if it was designed. Therefore, this stringer is still included in this flag. Section loss to the bottom flange neglecting the plate is 32%. The average thickness to the bottom flange including the plate is 0.523" (original flange thickness is 0.4"). Top flange loss is approx. 5% (was 5%) (photos 2 and 3)

Attachment Description: Span 1, Stringer 2 in Panel 5 near Midspan, Looking Right at Bottom Flange – 1

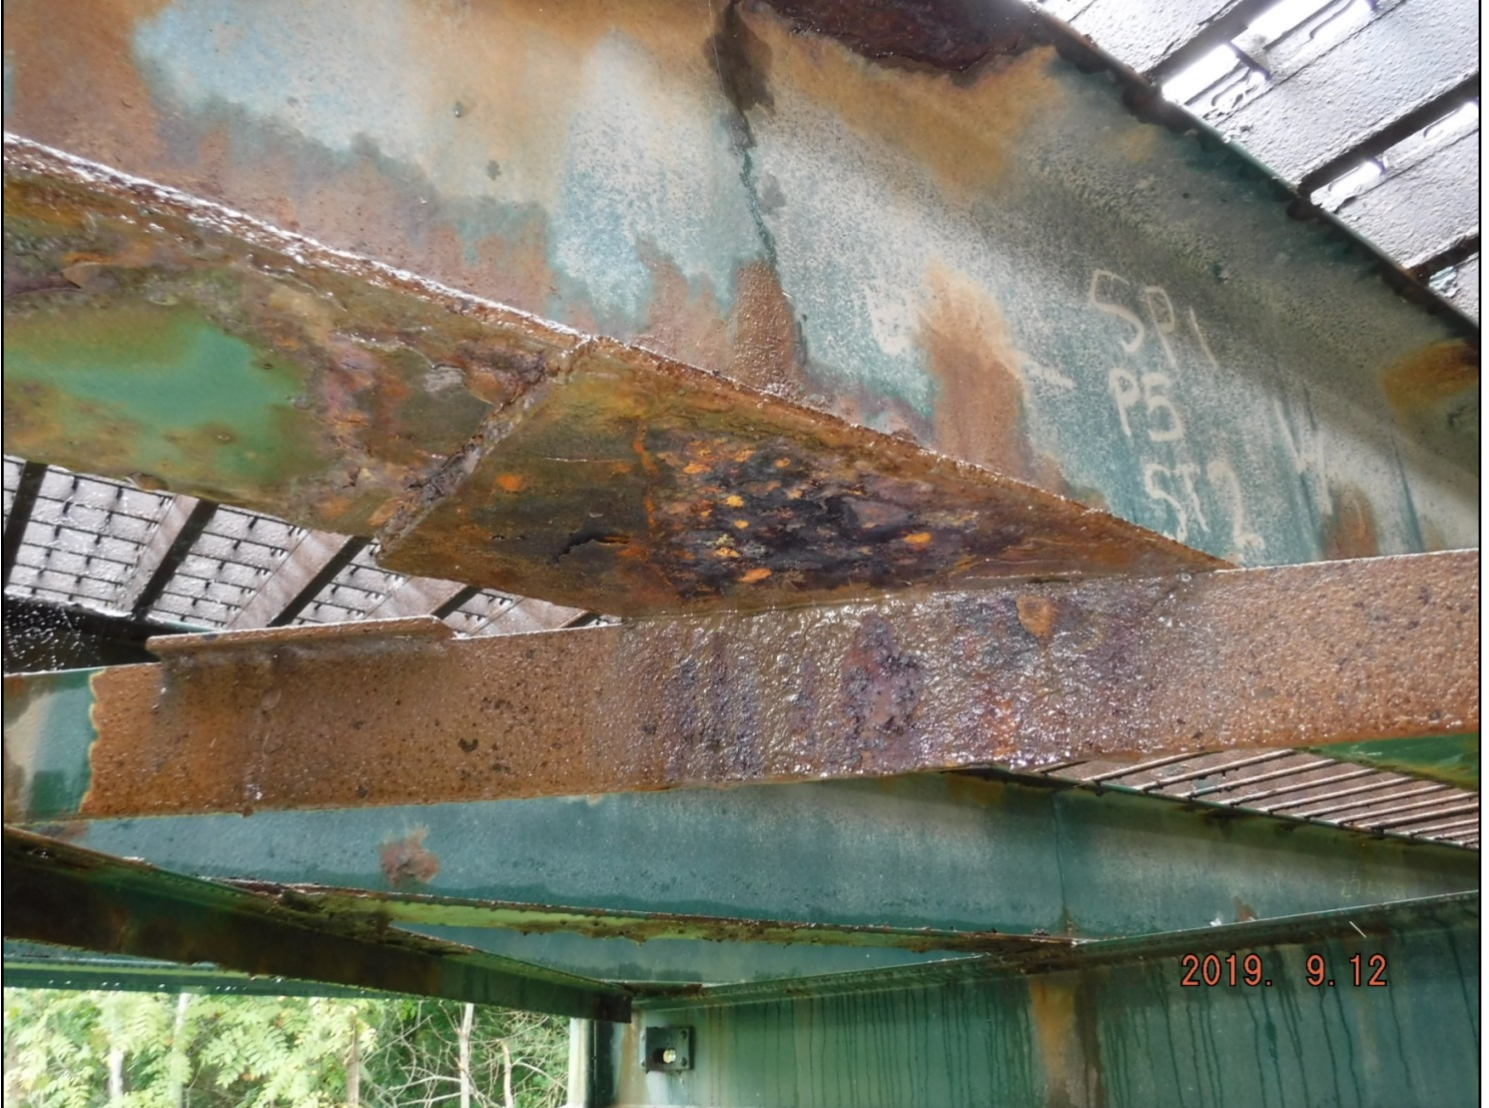
Photo Number: 3

Attachment Description: Span 1, Stringer 2 in Panel 5 near Midspan, Looking Right at Bottom Flange – 2

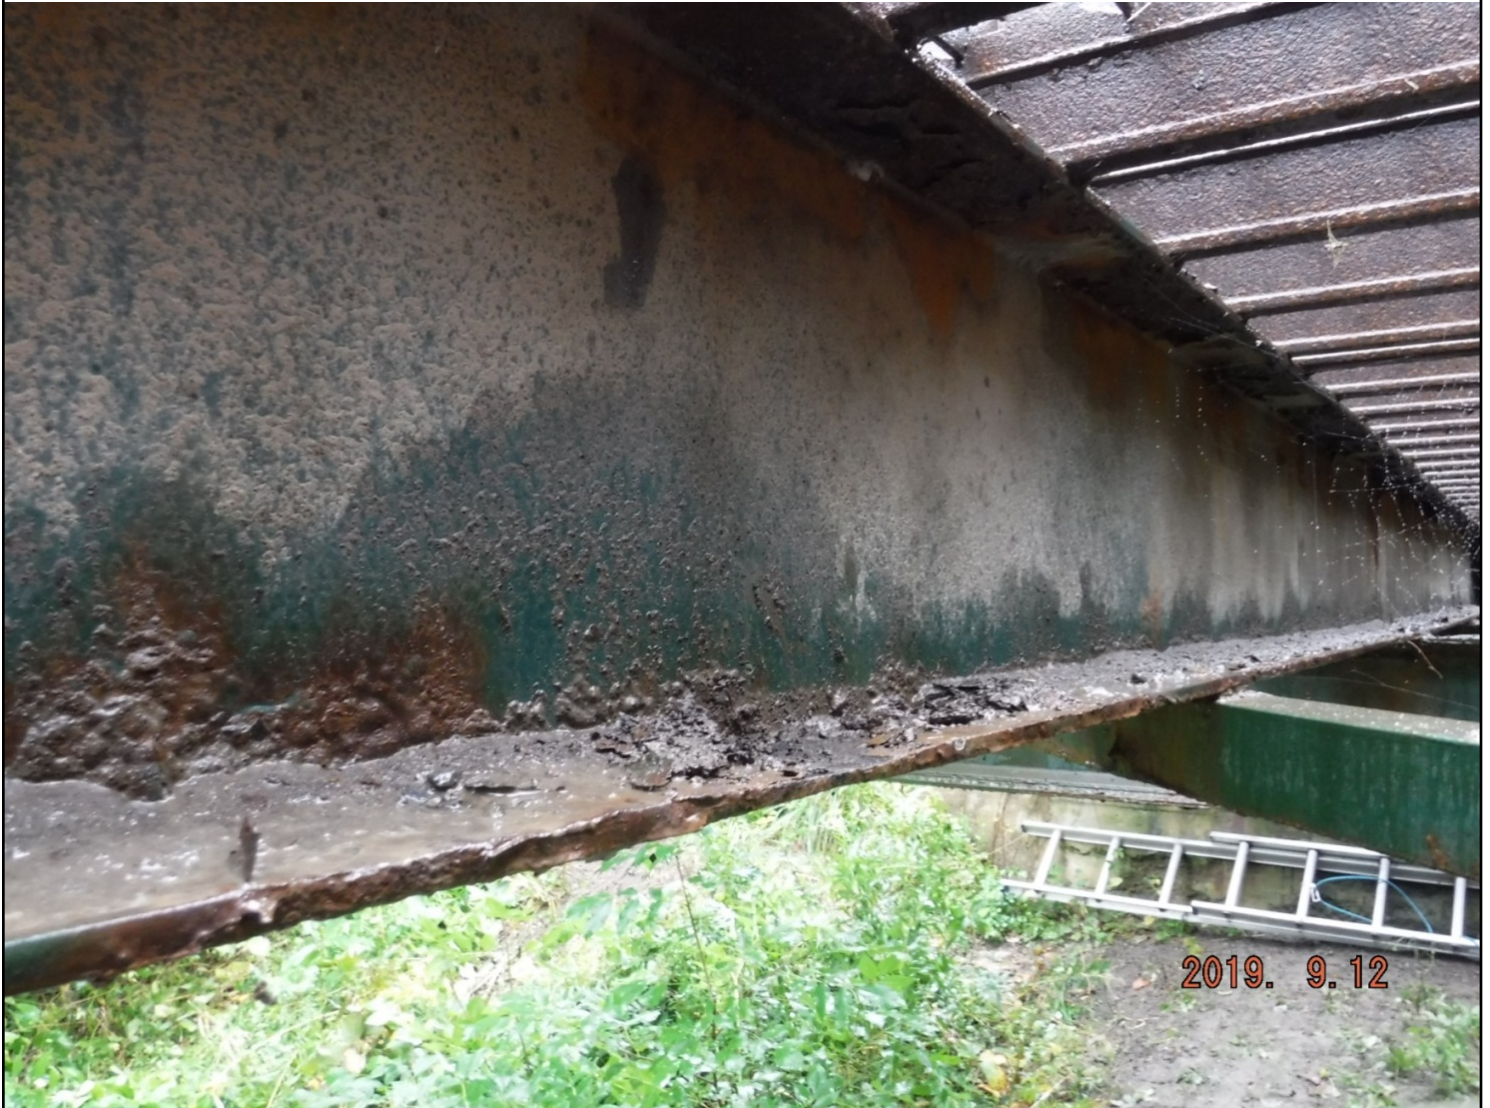
Photo Number: 4

Stringer 3 in Panel 2 at midspan: Top flange loss is 5% and bottom flange loss is 55% (there were no previous losses) (photo 4). The stringer 2 losses in panel 2 are included for information purposes (see attached sketch).

Attachment Description: Span 1, Stringer 3 in Panel 2 at Midspan, Looking Back

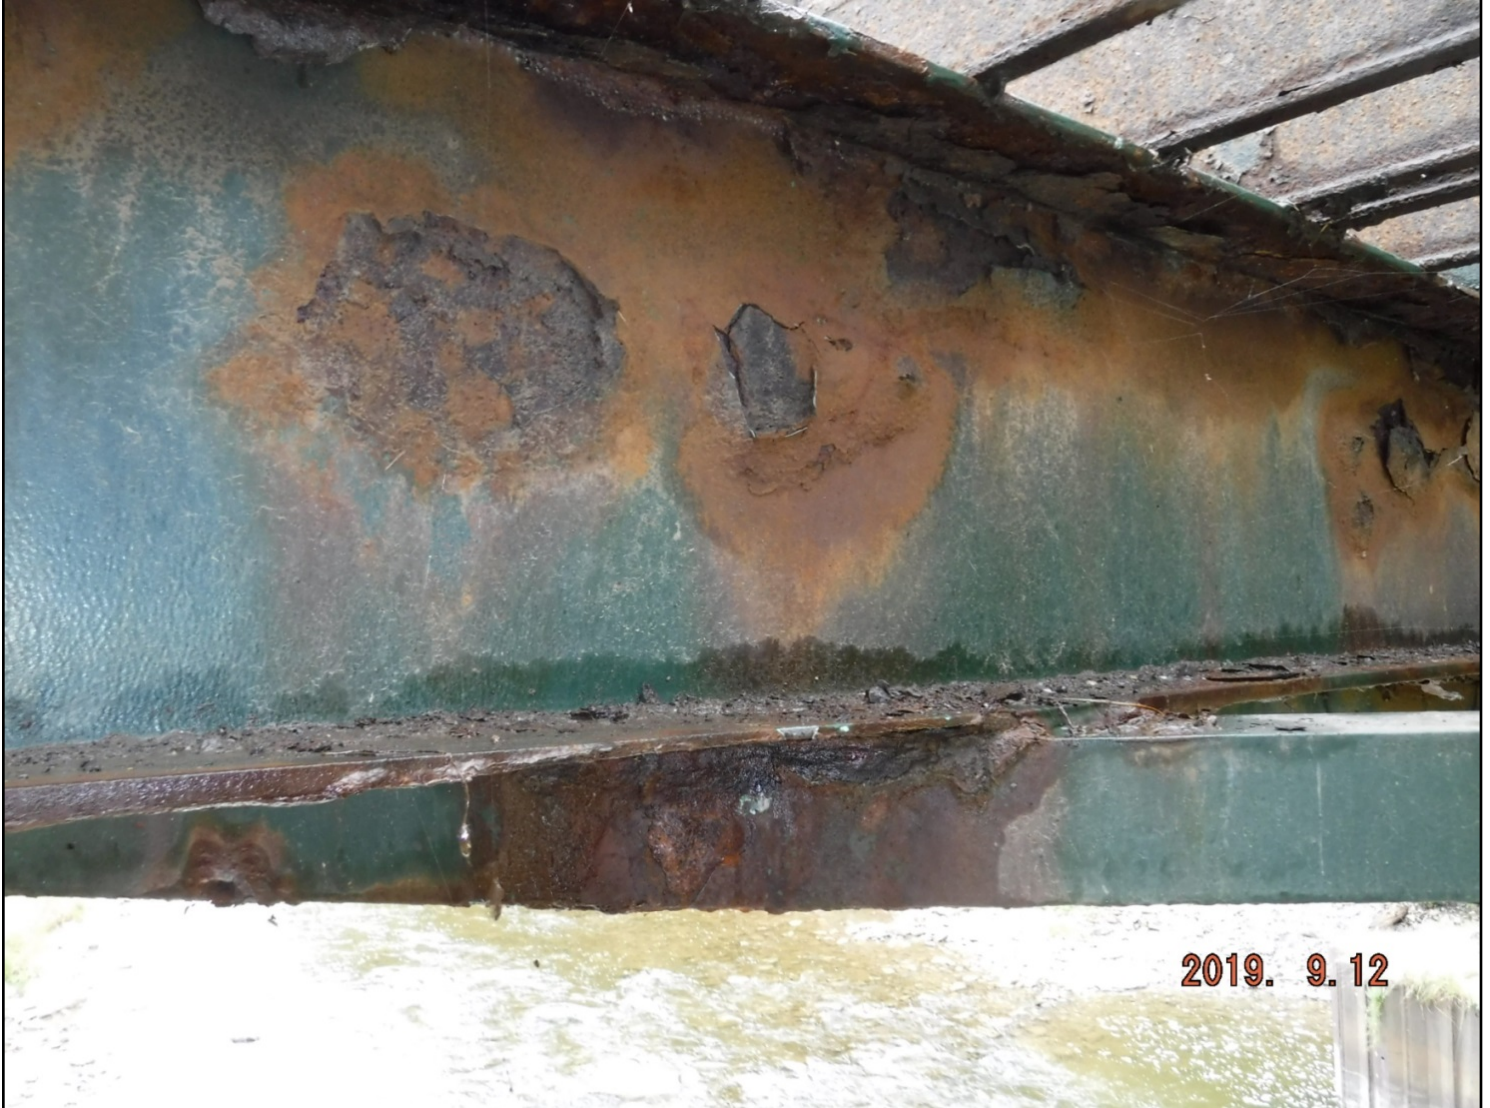
Photo Number: 5

Stringer 2 in Panel 4 at 5-6 ft from floorbeam 4: Top flange loss is 24% (was 37%) and bottom flange loss is 39% (was 48%). (photo 5)

Attachment Description: Span 2, Stringer 2 in Panel 4 near Midspan, Looking Right and Back
