**AQUATIC RESOURCES REPORT**  
**Ellis Tracts Project**  
Town of Dryden, Tompkins County, NY

**APRIL 2017**

## **Aquatic Resources Report Ellis Tracts Tompkins County, New York**

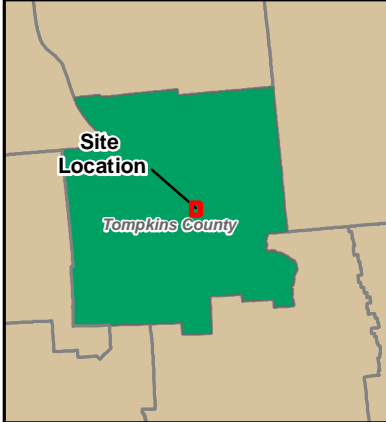
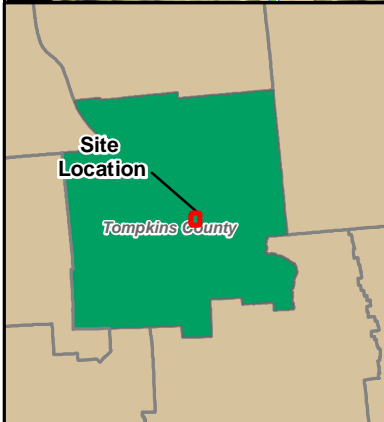
A review of published and publicly available soils data for the survey area indicates that twenty (20) soils series are mapped within the survey boundary (Attachment A, Figure 1). Mapped soil series are summarized in Table 1 below.

Source:  
Orthoimagery basemap from ArcGIS Online Services, available at: <http://services.arcgisonline.com/arcgis/services>. Soils from USDA Web Soil Survey and USFWS NWI from USFWS; downloaded April 2017.

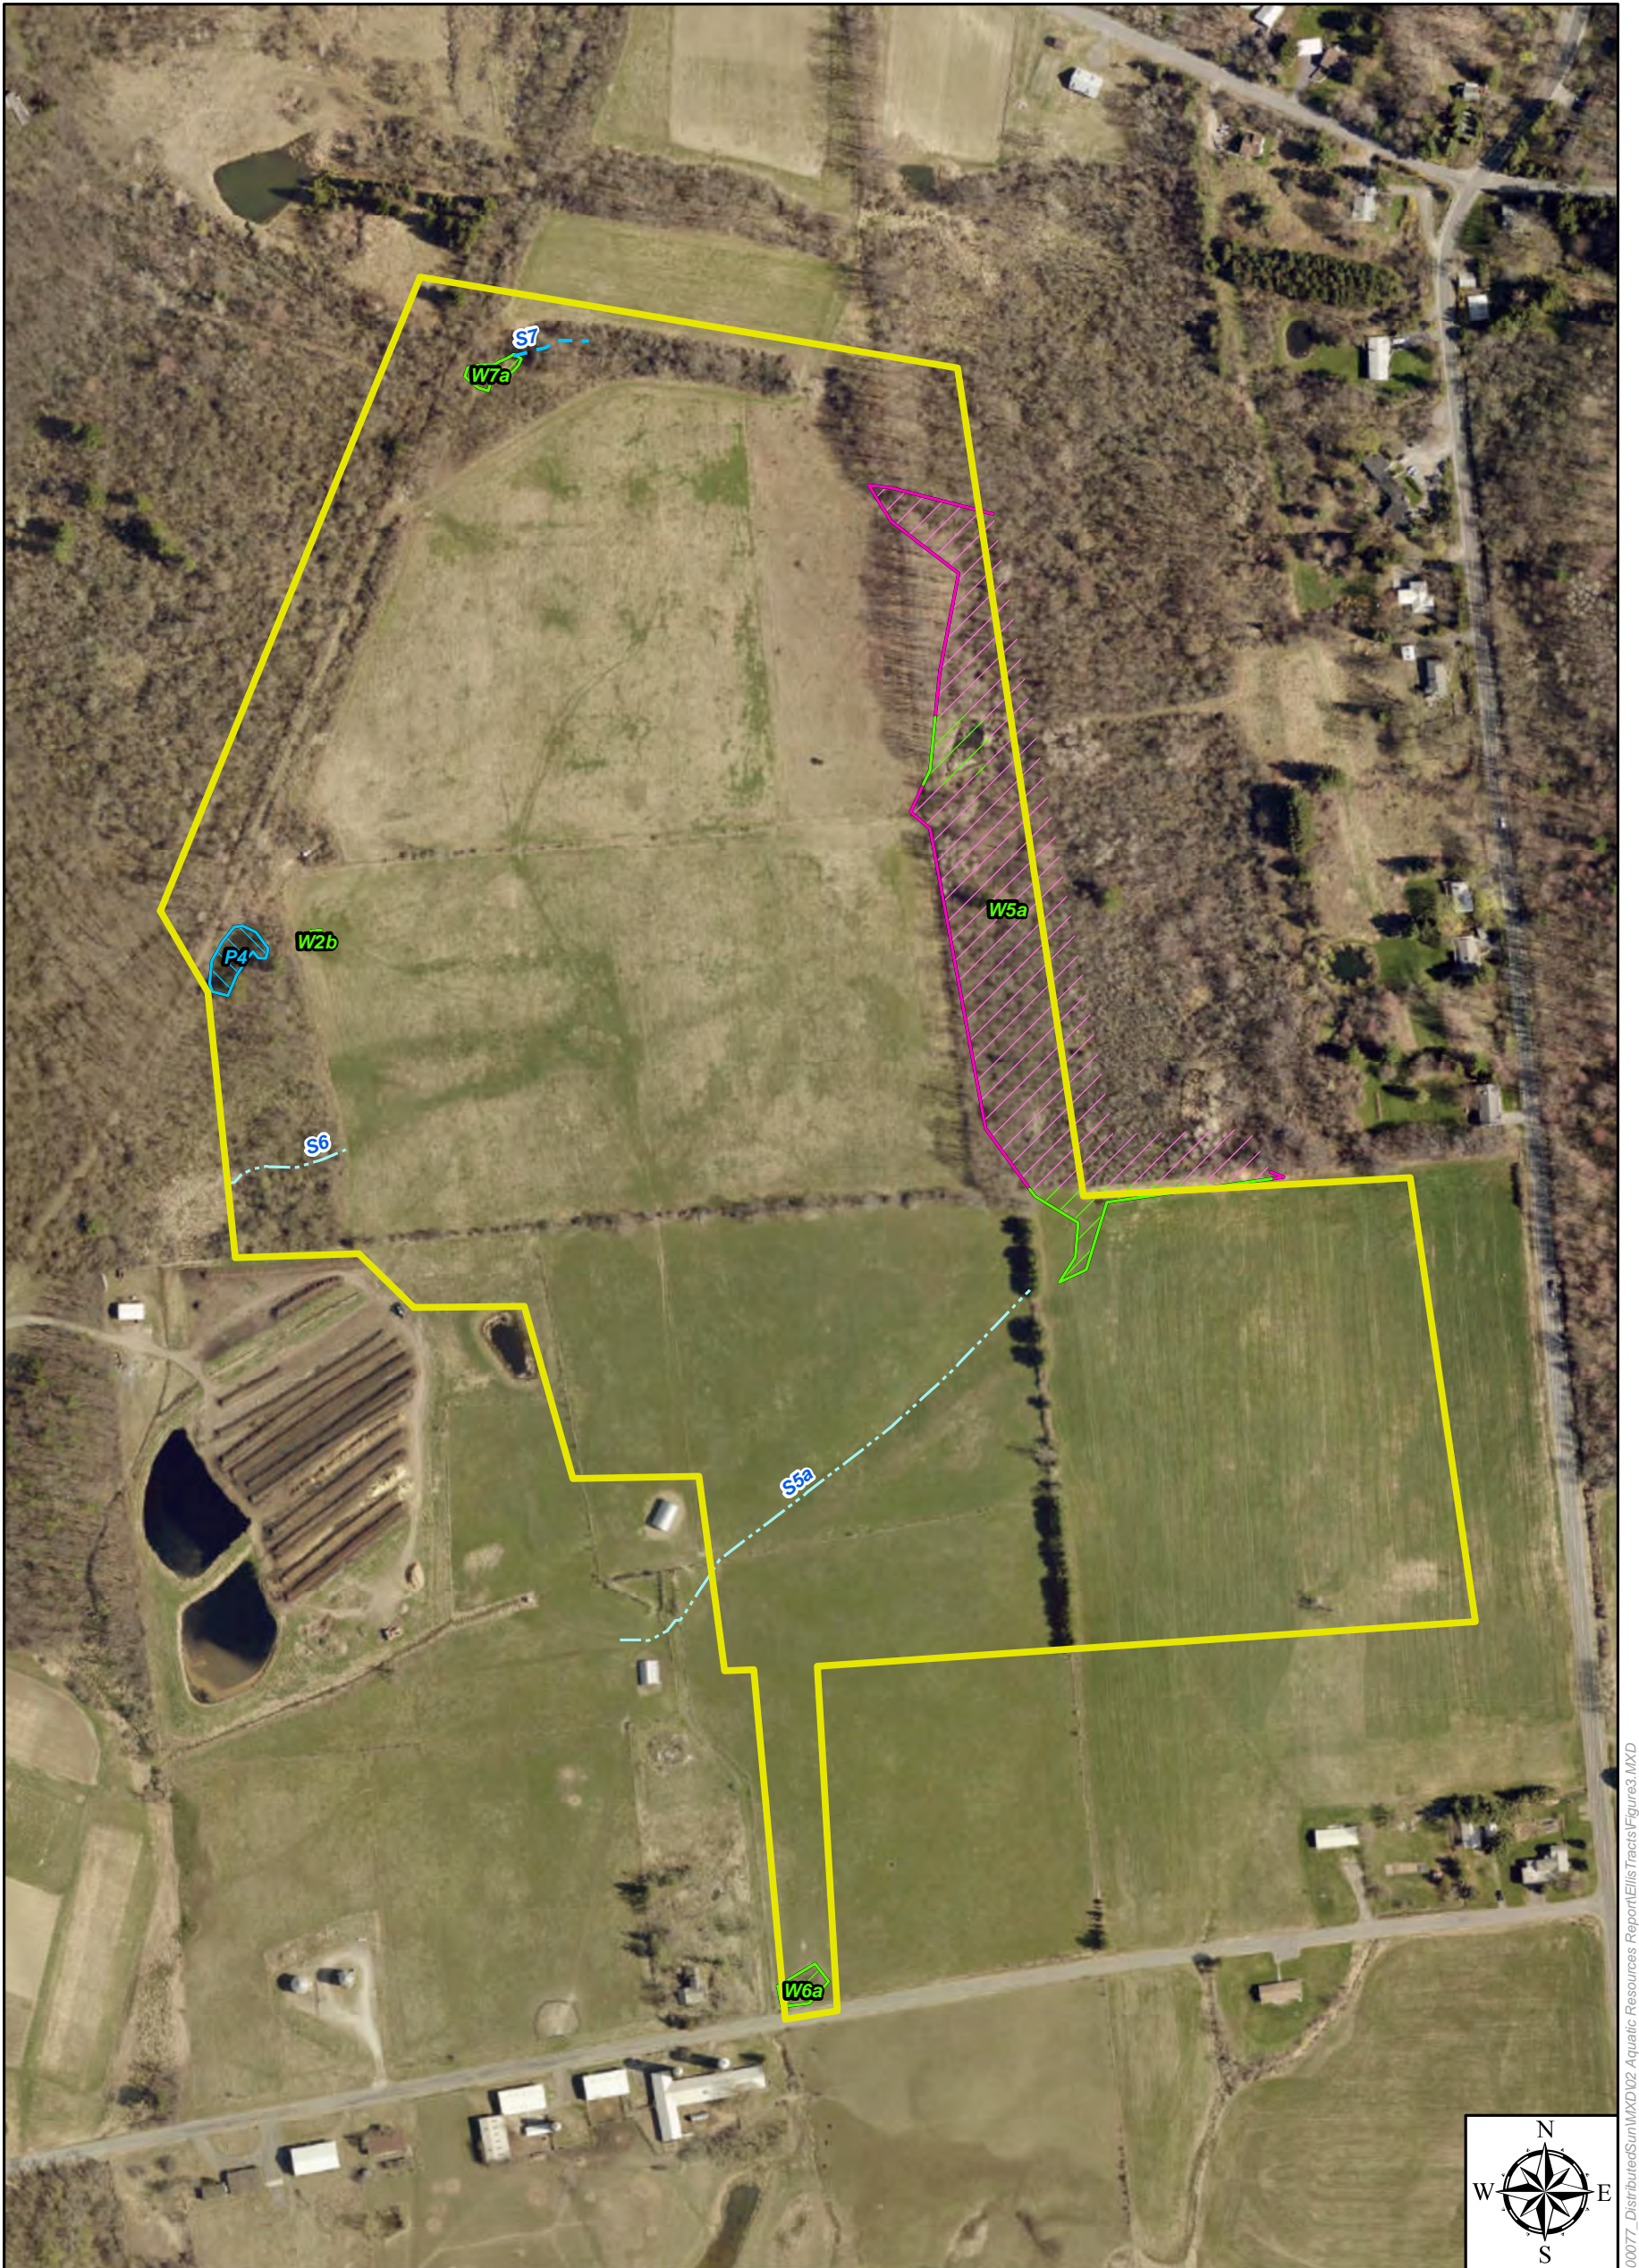
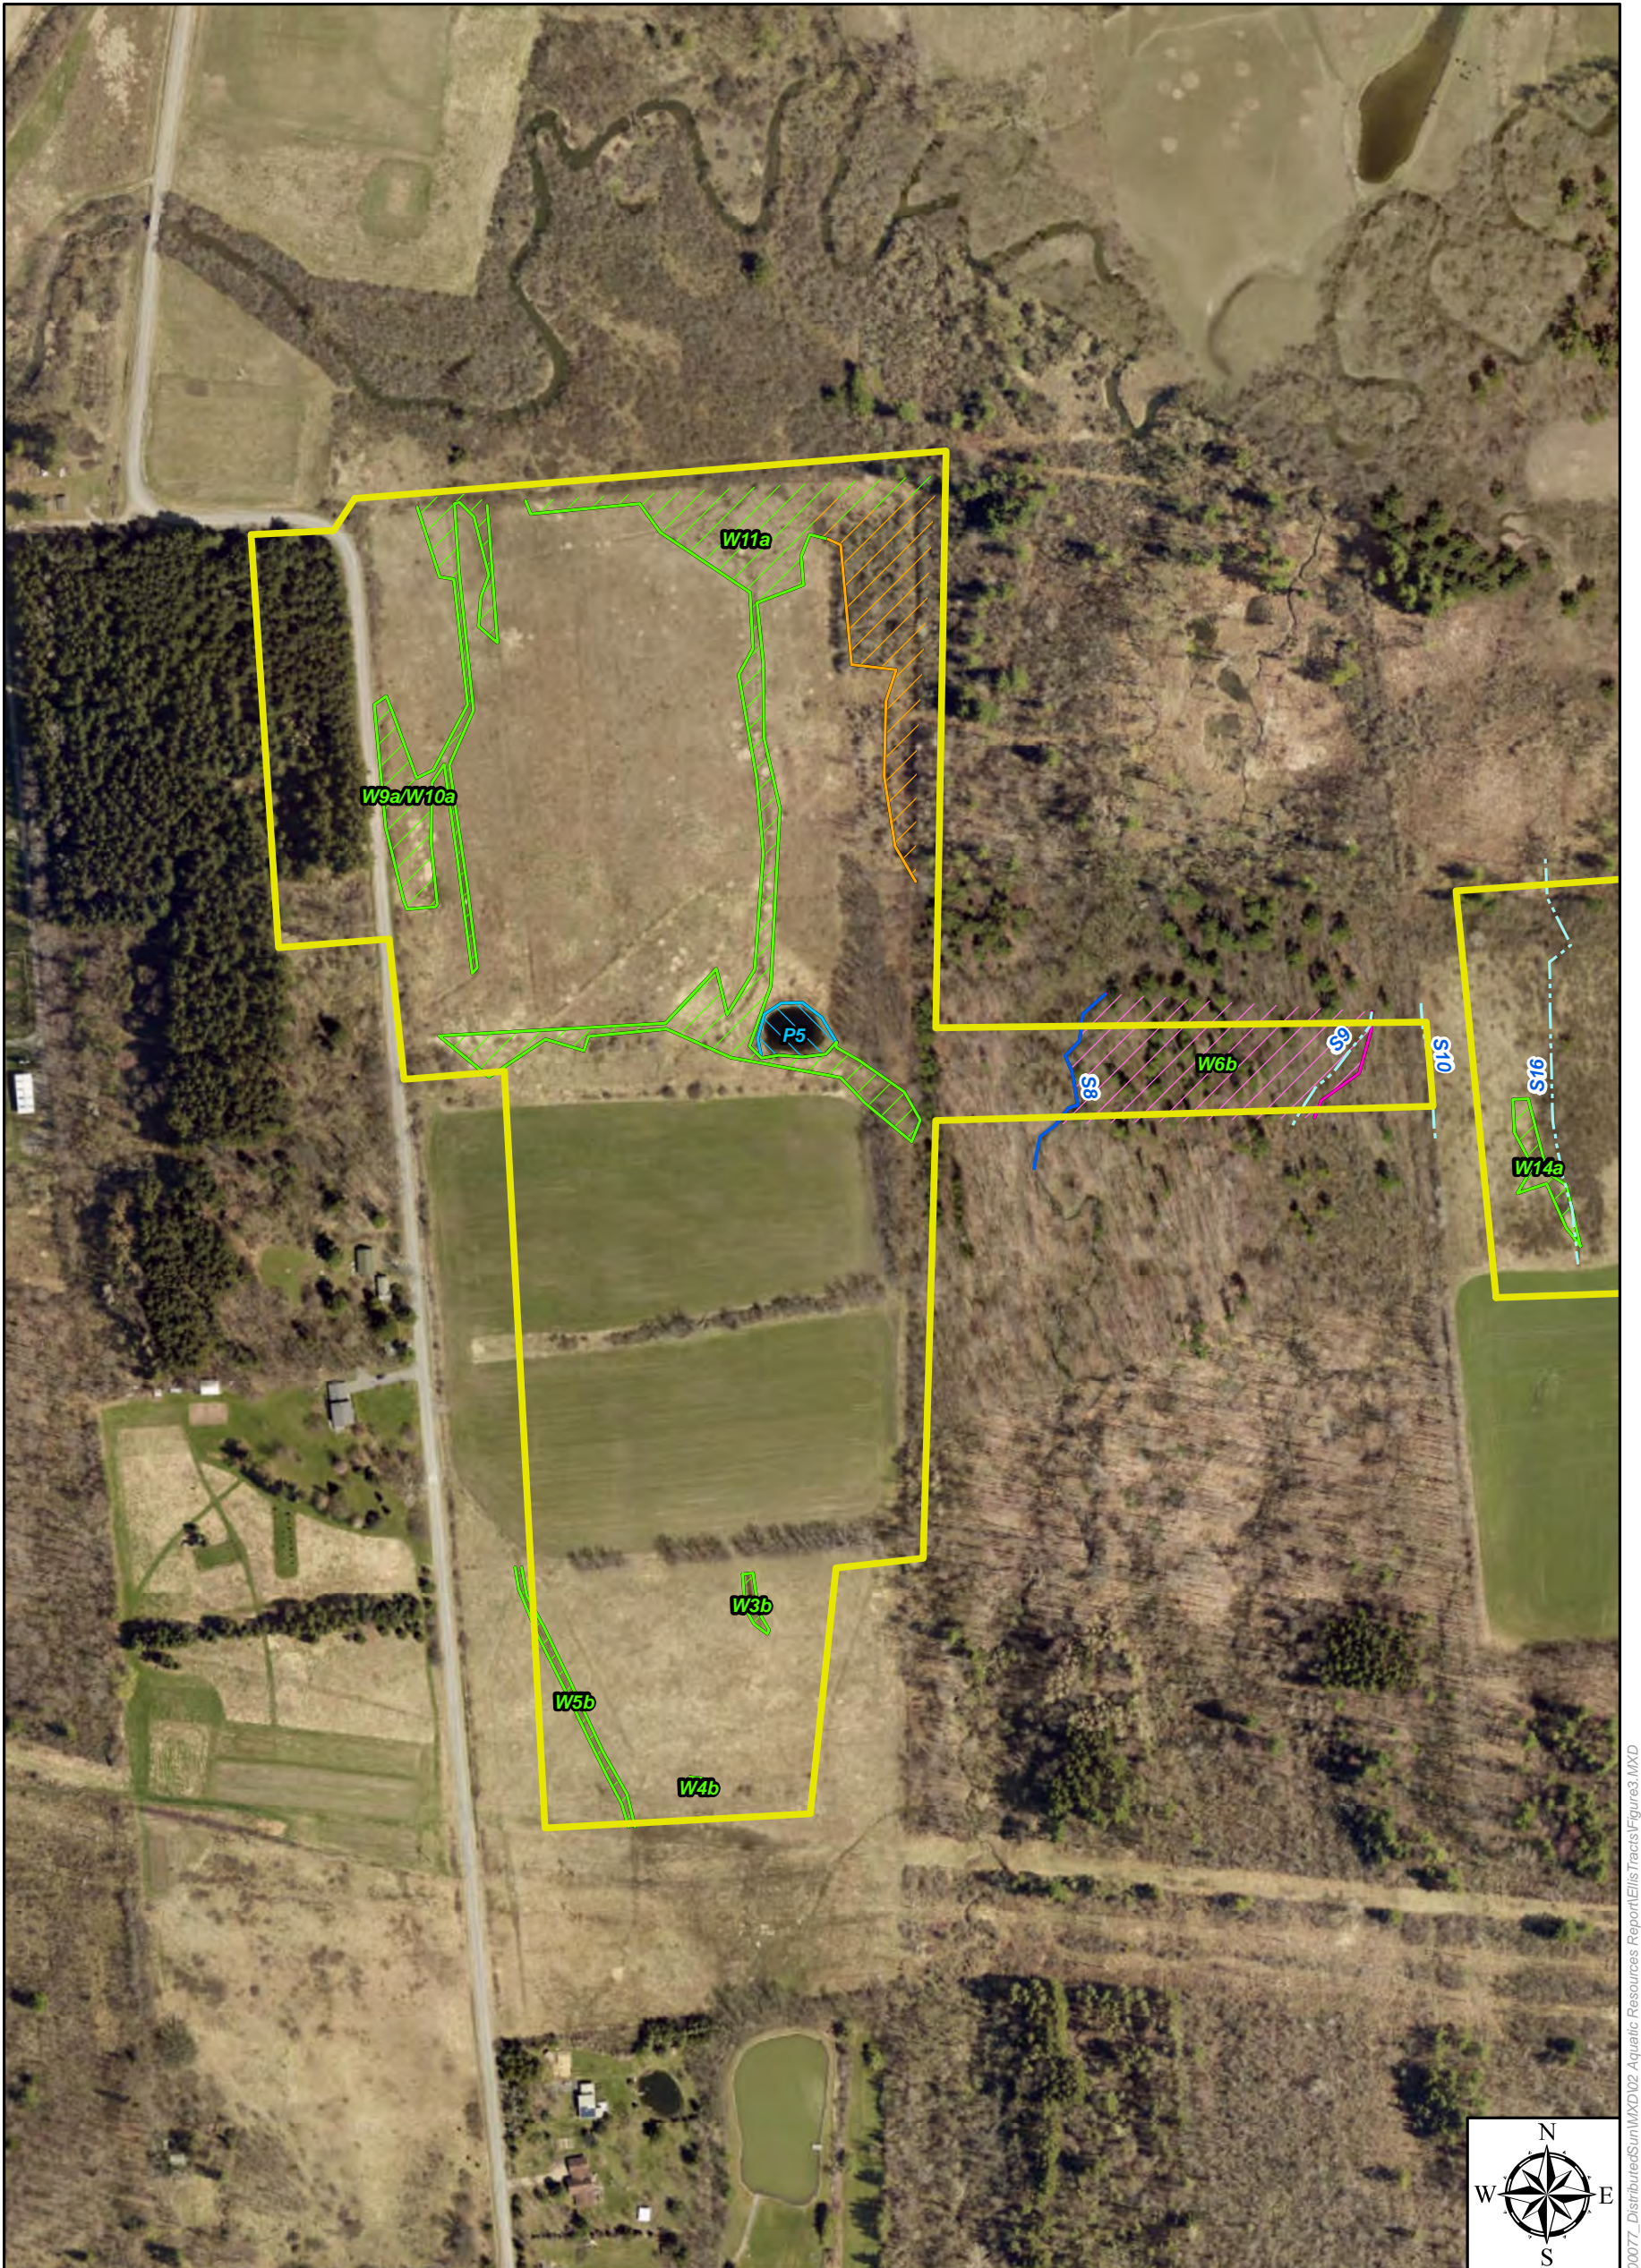
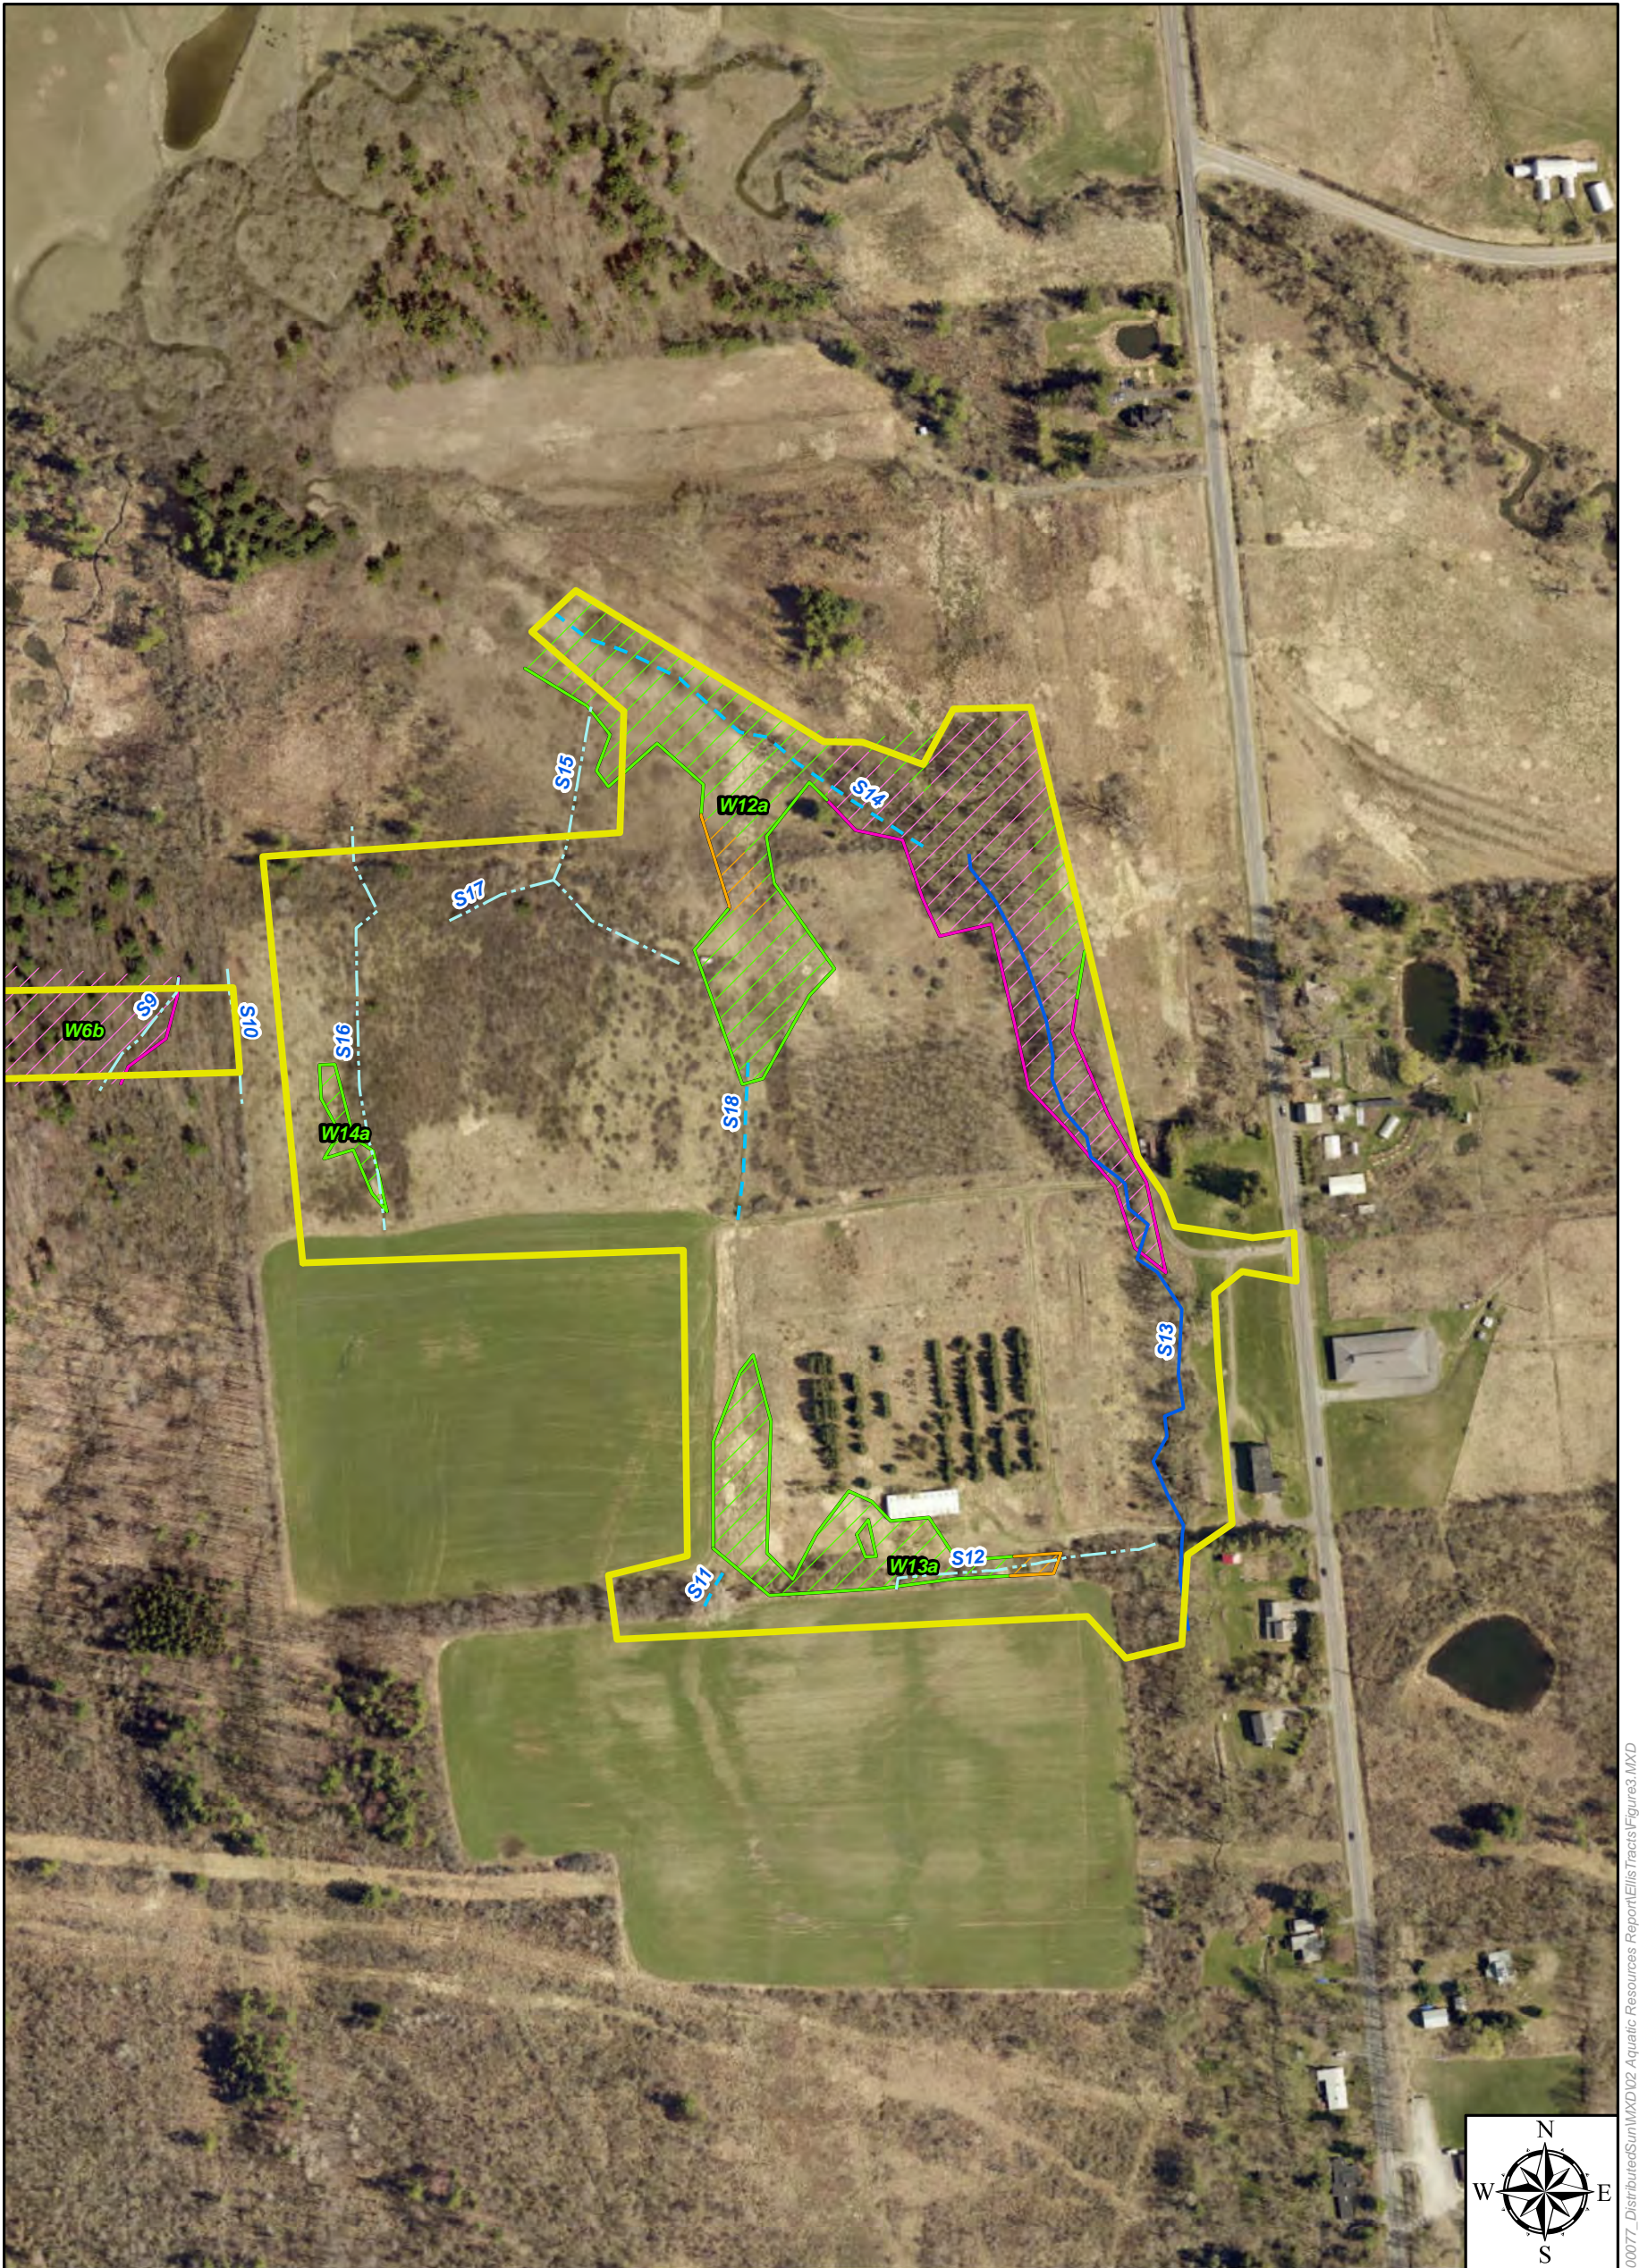
**Figure 3. Delineated Aquatic Resources on the Ellis Tracts Project. Town of Dryden, Tompkins County, NY.**

Thirteen (13) wetlands meeting USACE identification criteria were identified in the survey. Three (3) of the identified wetlands contain multiple cover classes (PFO, PSS, and/or PEM) as defined by Cowardin classification. Table 2 below summarizes these wetlands and their current conditions. Geometry and alignments of these wetlands are provided in Attachment A, Figure 2, and photos of these wetlands can be found in Attachment B.

Fourteen (14) streams were identified during the survey, all unnamed tributaries (UNT) to Cascadilla Creek immediately north of the Site. Table 3 below summarizes the streams identified on-site. Geometry and alignments of these streams are provided in Attachment A, Figure 2, and photos of these streams can be found in Attachment B.

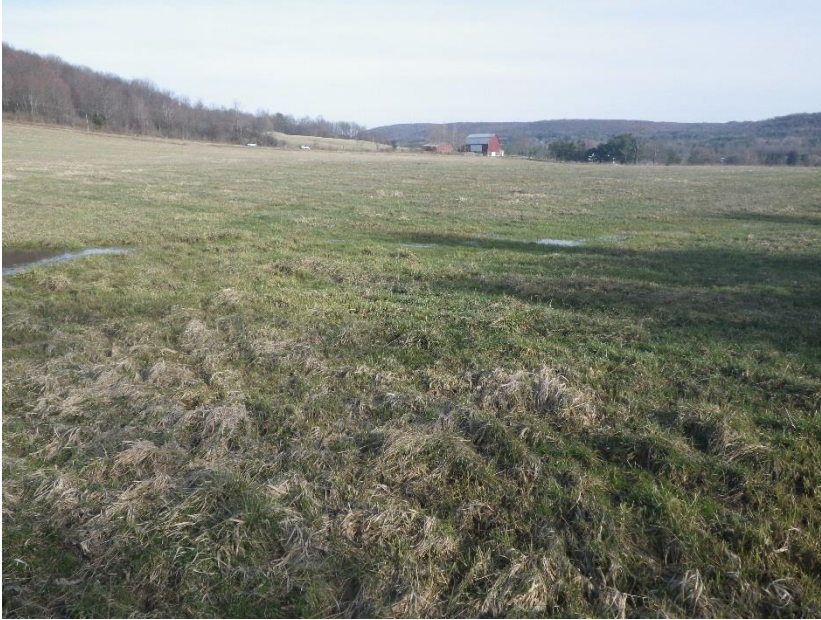
**Photographer:** M. Guinan  
**Date:** 04/05/2017  
**Photo No.:** 1  
**Direction:** SE

**Comments:** Wetland W5a PEM portion characterized by tussocks, drainage patterns and standing water.

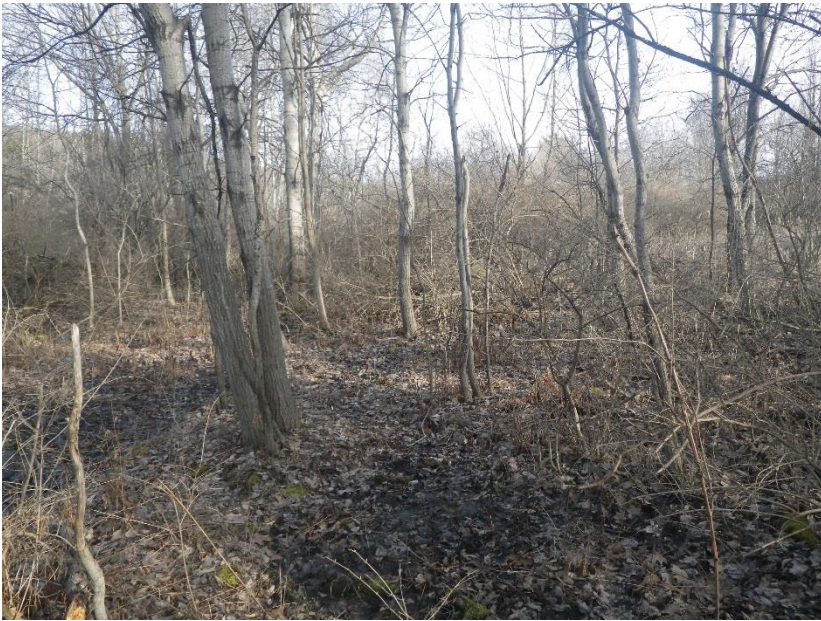
**Photographer:** M. Guinan  
**Date:** 04/05/2017  
**Photo No.:** 2  
**Direction:** E

**Comments:** Wetland W5a PFO section characterized by living trees, redox depressions, moss trim lines, buttressing of individual features.

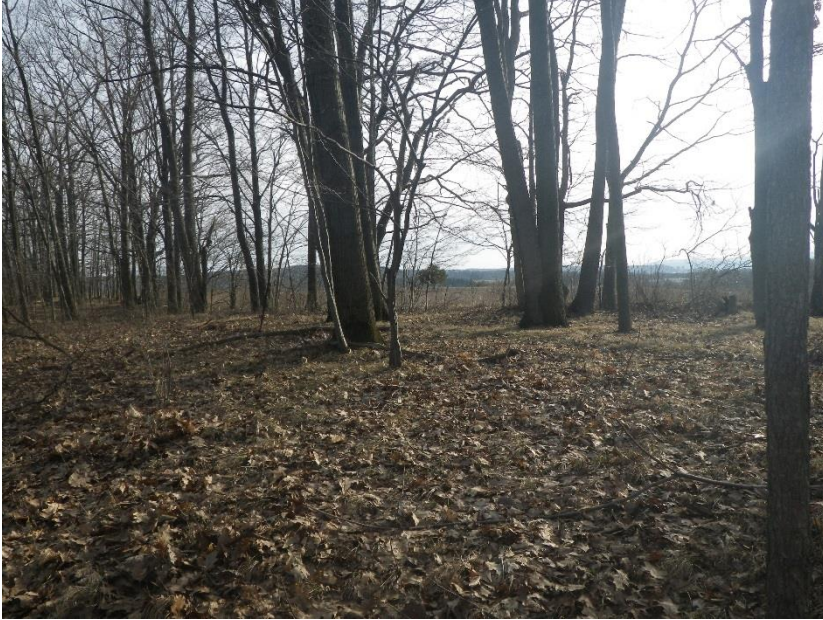
**Photographer:** M. Guinan  
**Date:** 04/05/2017  
**Photo No.:** 3  
**Direction:** S

**Comments:** Upland area adjacent to wetland W5a. No signs of hydrophyte growth or hydrology are present and soil indicators are lacking.

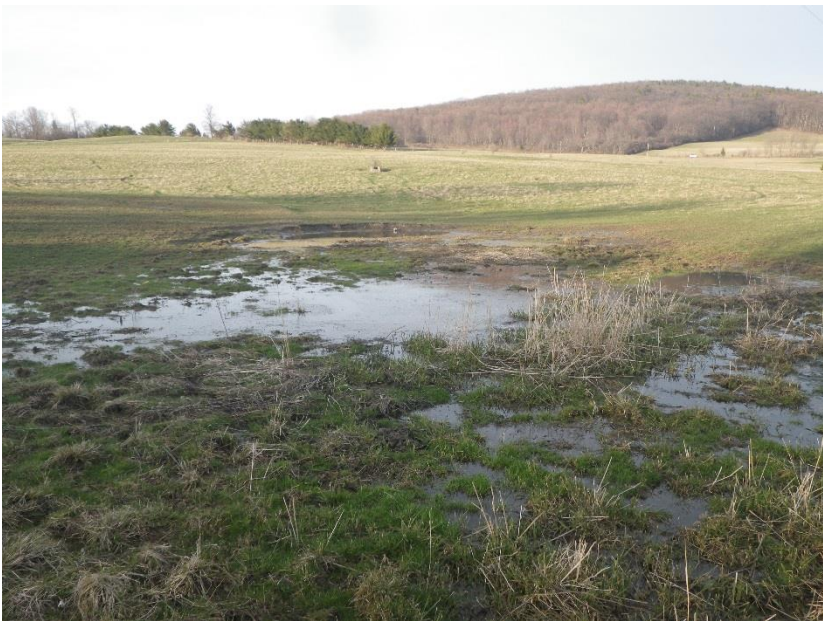
**Photographer:** M. Guinan  
**Date:** 04/05/2017  
**Photo No.:** 4  
**Direction:** NE

**Comments:** Wetland W6a PEM characterized by tussocks, drainage patterns, stressed vegetation growth and standing water

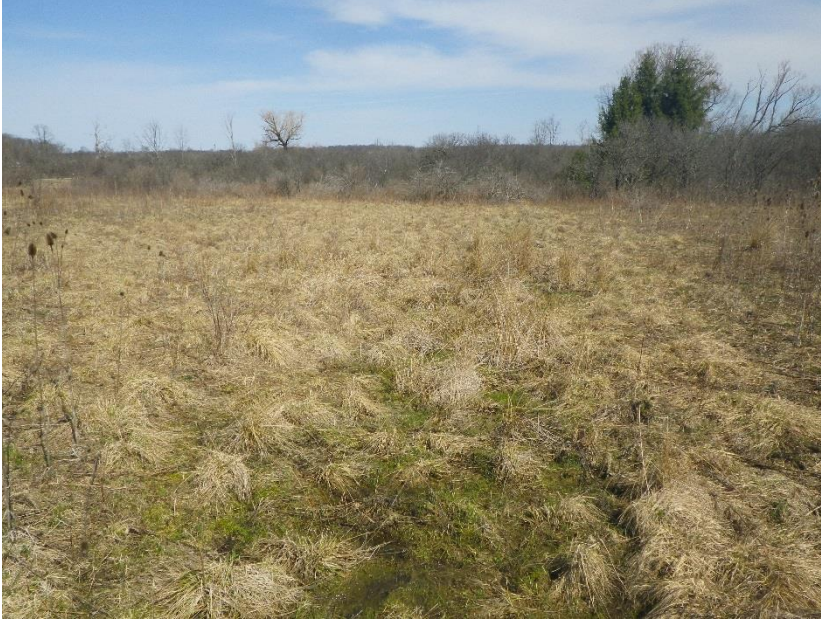
**Photographer:** M. Guinan  
**Date:** 04/10/2017  
**Photo No.:** 5  
**Direction:** N

**Comments:** Wetland W9a/W10a characterized by tussocks, drainage patterns and hydrophyte growth. Wetland is formed in an open meadow between swales and drains to a larger scrub/shrub wetland located outside of survey boundaries.

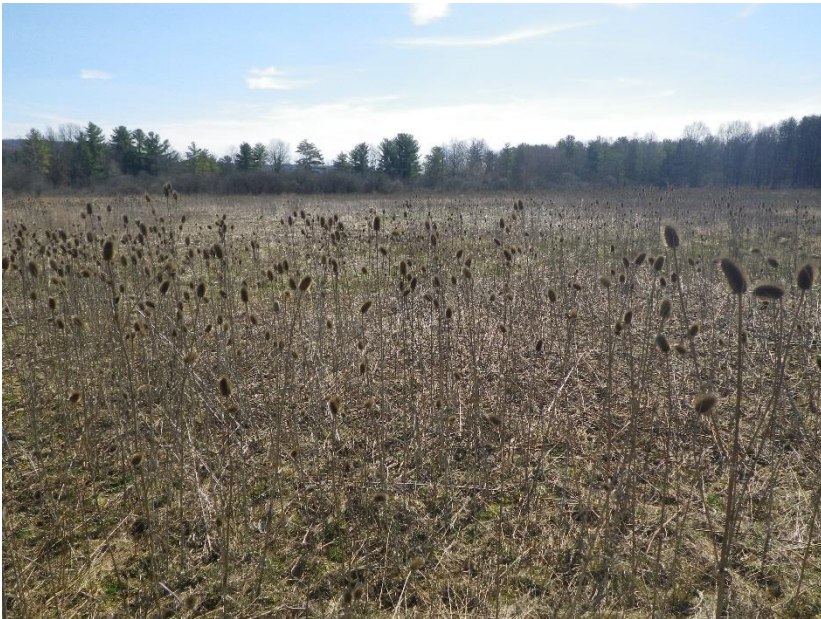
**Photographer:** M. Guinan  
**Date:** 04/10/2017  
**Photo No.:** 6  
**Direction:** E

**Comments:** Upland area adjacent to wetland W9a/W10a. No signs of hydrology are present and vegetation community changes are obvious.

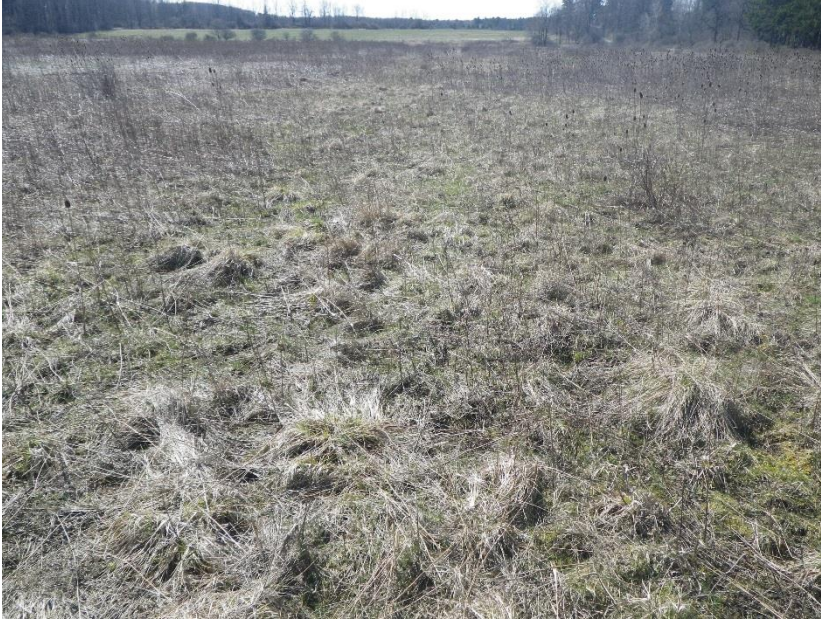
**Photographer:** M. Guinan  
**Date:** 04/10/2017  
**Photo No.:** 7  
**Direction:** N

**Comments:** Wetland W9a/W10a PEM section characterized by tussocks, drainage patterns, and hydrophyte growth in between swales in an open meadow. Wetland is formed in an open meadow between swales and drains to a larger scrub/shrub wetland located outside of survey boundaries.

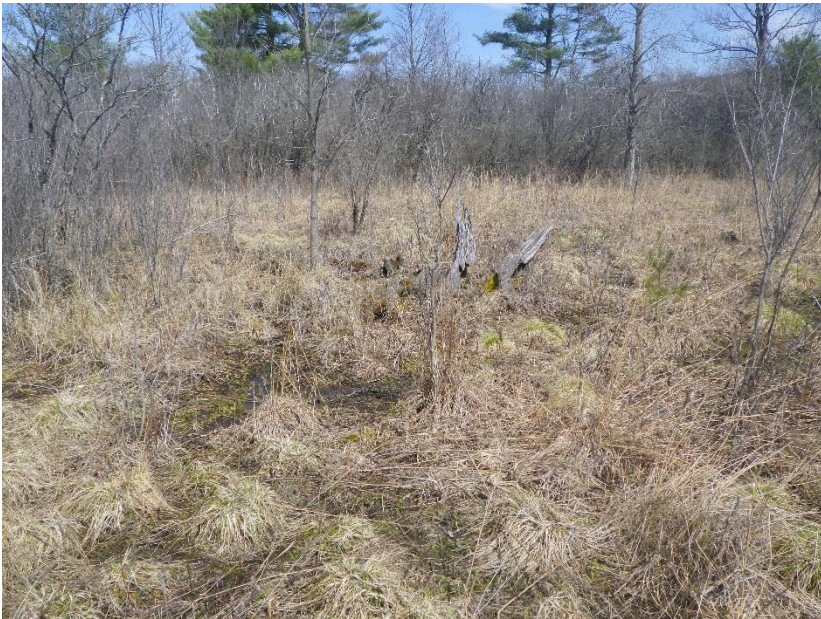
**Photographer:** M. Guinan  
**Date:** 04/10/2017  
**Photo No.:** 8  
**Direction:** N

**Comments:** Wetland W11a PEM section characterized by tussocks, standing water, drainage patterns and thick hydrophyte growth.

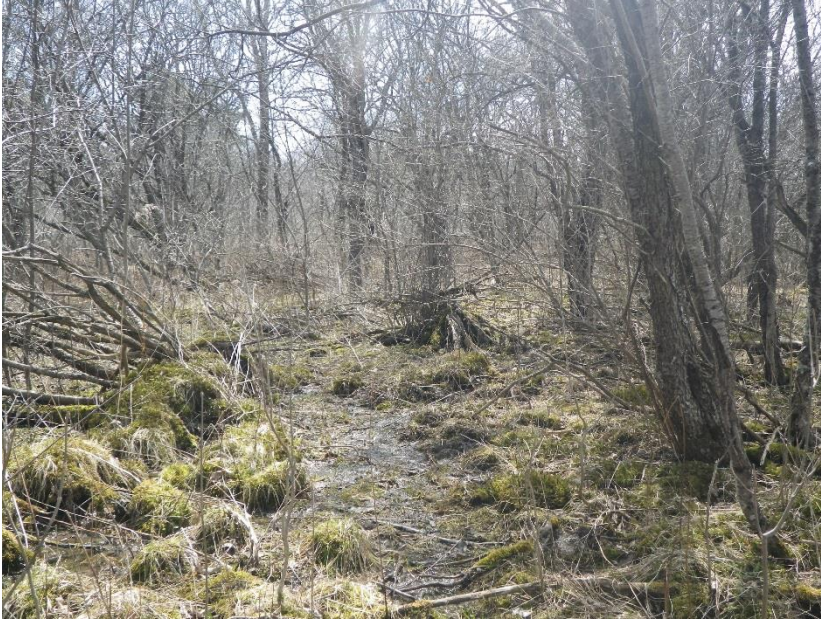
**Photographer:** M. Guinan  
**Date:** 04/10/2017  
**Photo No.:** 9  
**Direction:** E

**Comments:** Wetland W11a PSS section characterized by thick shrub vegetation, tussocks, moss trim lines, standing water, drainage patterns and redox depressions.

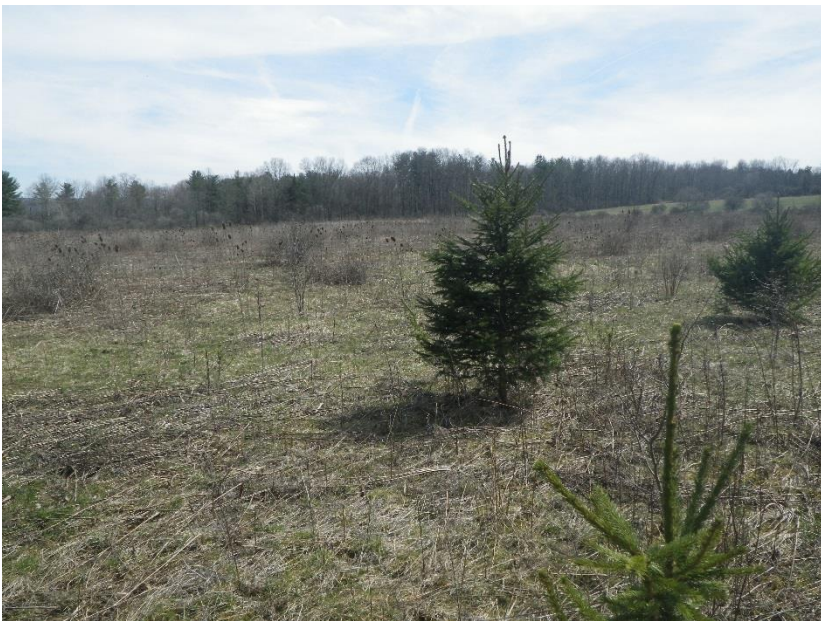
**Photographer:** M. Guinan  
**Date:** 04/10/2017  
**Photo No.:** 10  
**Direction:** NE

**Comments:** Upland area associated with Wetland W11a. No signs of hydrology are present and there is an identifiable topographic change.

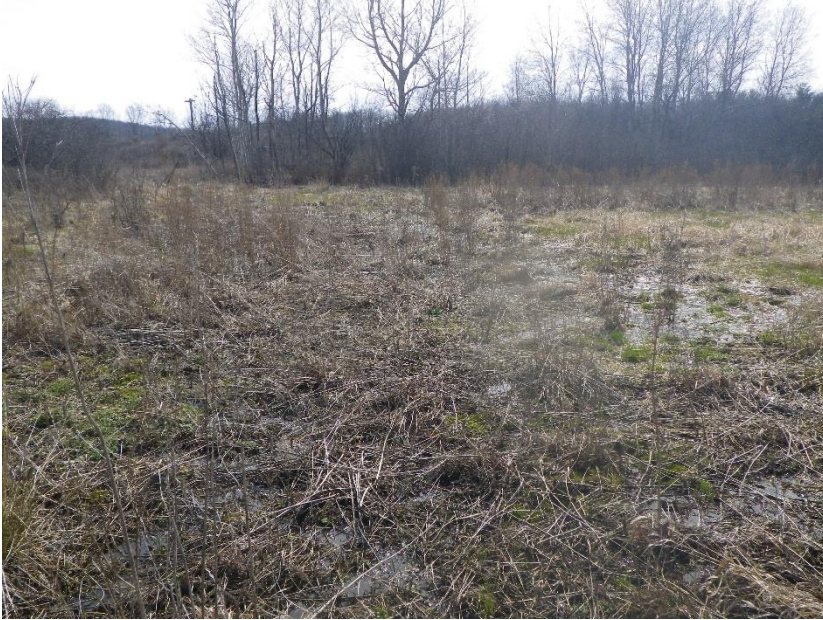
**Photographer:** M. Guinan  
**Date:** 04/10/2017  
**Photo No.:** 11  
**Direction:** W

**Comments:** Wetland W12a PEM section characterized by heavy hydrophyte growth, tussocks and standing water.

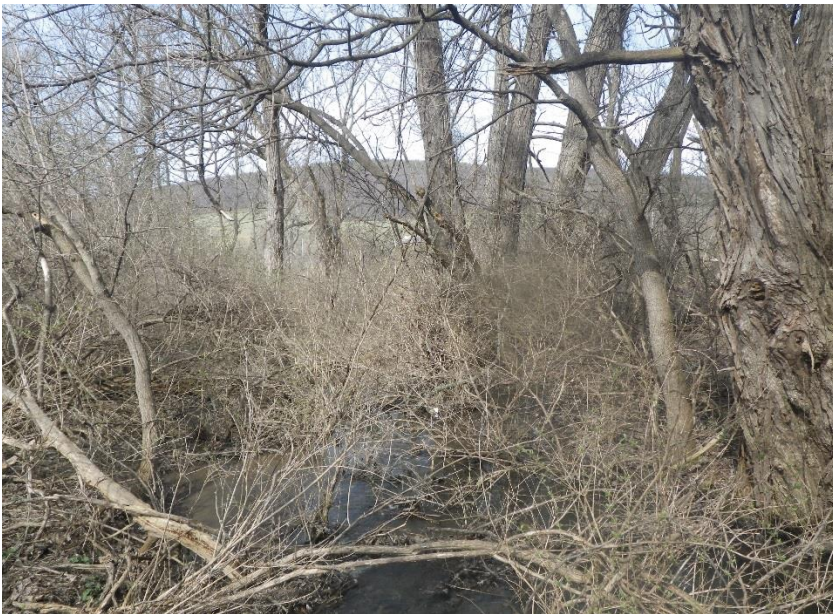
**Photographer:** M. Guinan  
**Date:** 04/10/2017  
**Photo No.:** 12  
**Direction:** SW

**Comments:** Wetland W12a PFO section characterized by living trees, drainage patterns, moss trim lines and stunted herbaceous vegetation growth. Wetland is located in the floodplain of stream S13.

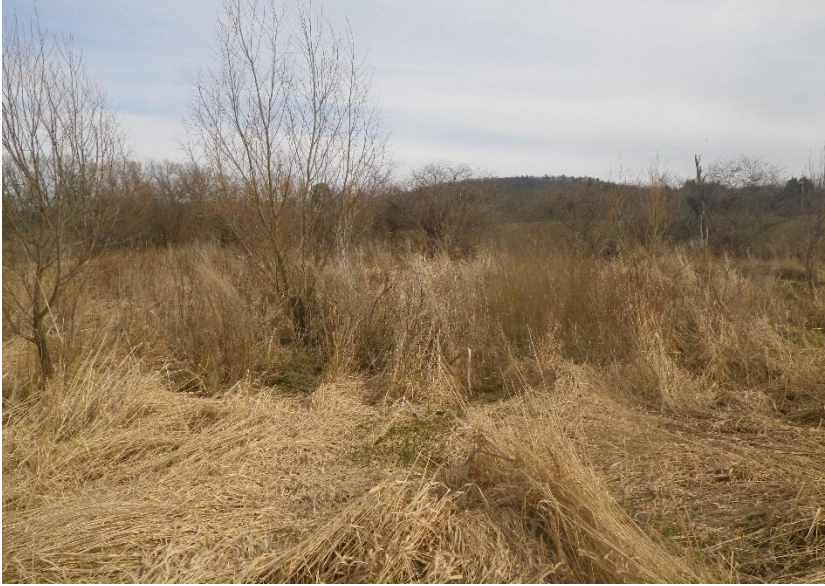
**Photographer:** M. Guinan  
**Date:** 04/10/2017  
**Photo No.:** 13  
**Direction:** E

**Comments:** Wetland W13a PEM section characterized by thick hydrophyte growth, sparse willow growth, standing water and drainage patterns.

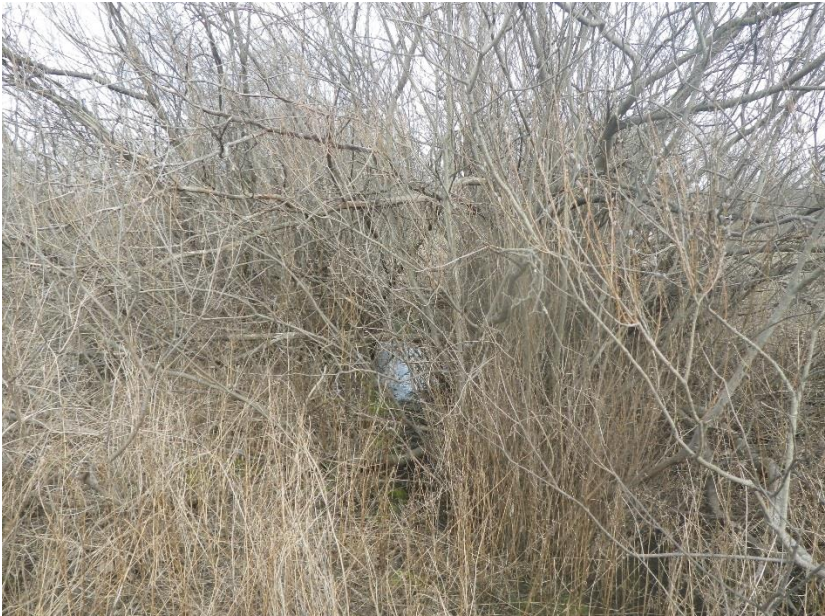
**Photographer:** M. Guinan  
**Date:** 04/10/2017  
**Photo No.:** 14  
**Direction:** SW

**Comments:** Wetland W13a PSS section characterized by thick shrub vegetation, standing/flowing water, moss rim lines and drainage patterns.

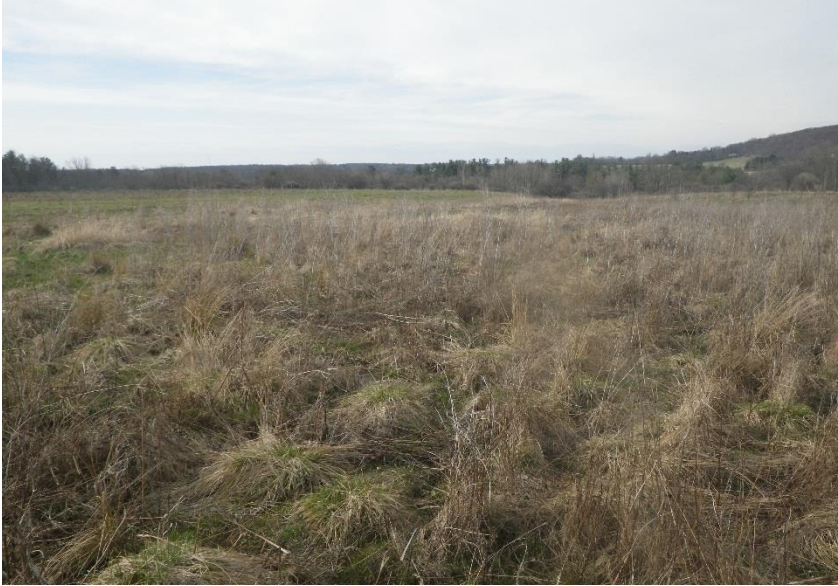
**Photographer:** M. Guinan  
**Date:** 04/10/2017  
**Photo No.:** 15  
**Direction:** N

**Comments:** Additional photograph of wetland W13a PEM portion with adjacent upland section pictured. Drainage depression that forms W13a PEM transitions to an upland swale.

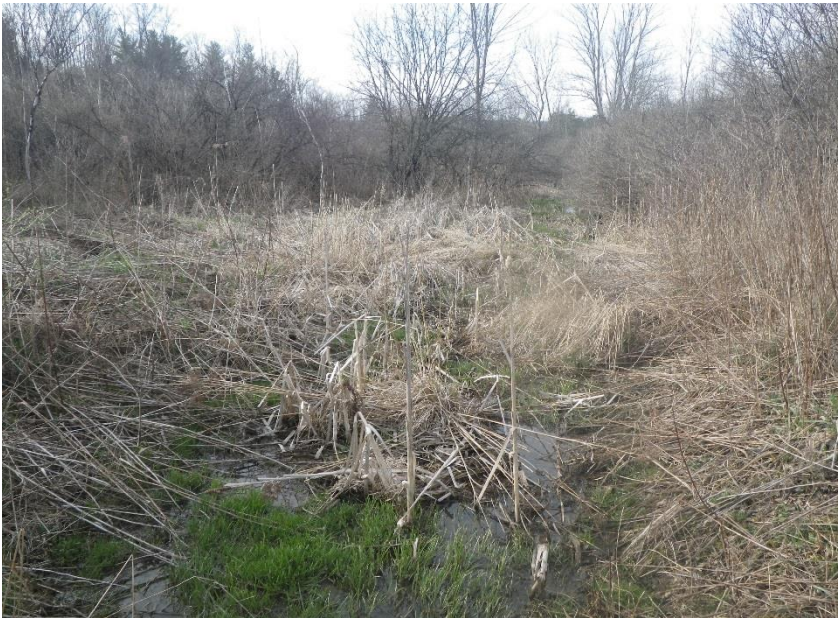
**Photographer:** M. Guinan  
**Date:** 04/05/2017  
**Photo No.:** 16  
**Direction:** N

**Comments:** Wetland W14a PEM portion characterized by hydrophyte vegetation growth surrounding the floodplain of stream S16.
