**WETLAND DELINEATION REPORT
VARNA APARTMENTS**

**TOWN OF DRYDEN
TOMPKINS COUNTY, NEW YORK**

July 2018

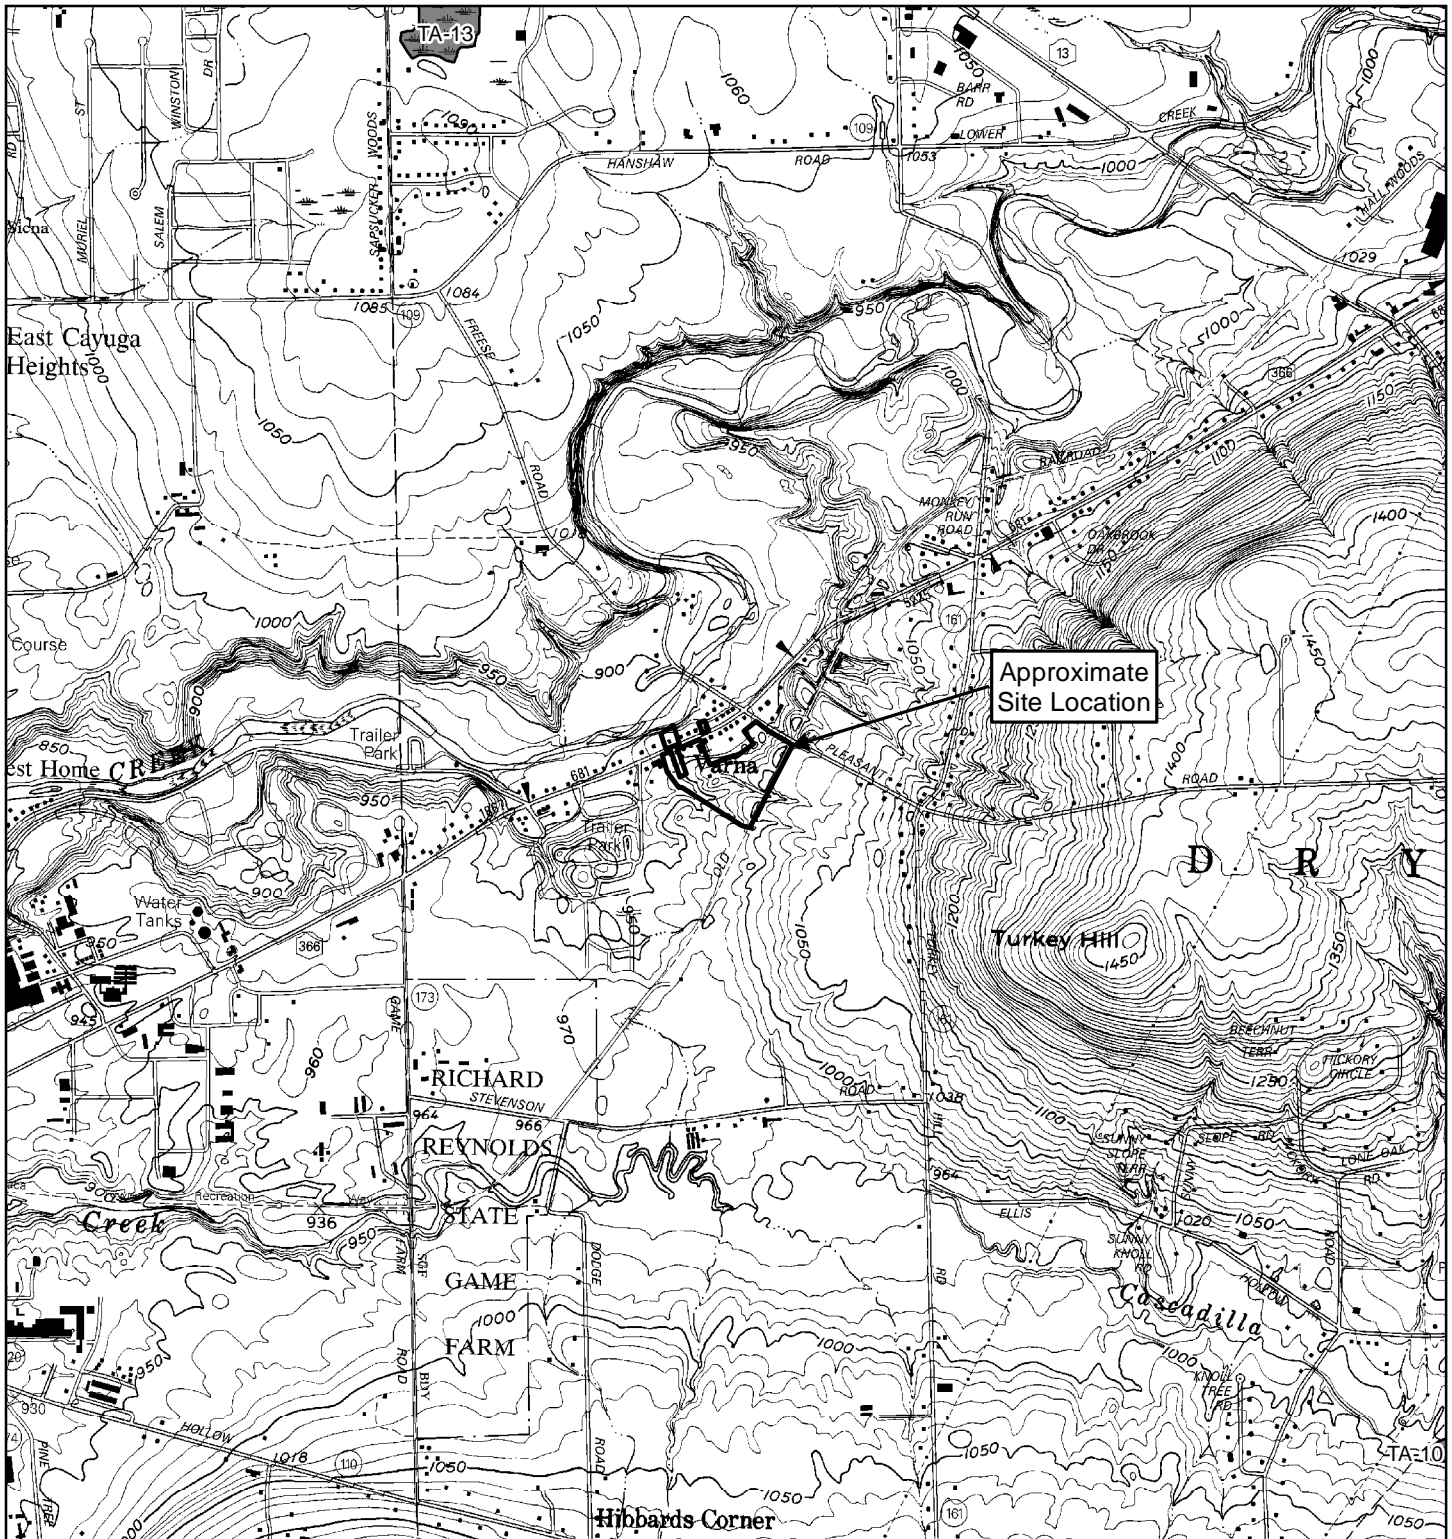
Figure 2. NYS Freshwater Wetlands Map

The NYS Freshwater Wetlands map (Figure 2) shows that there are no mapped freshwaters wetlands on site or in the vicinity.

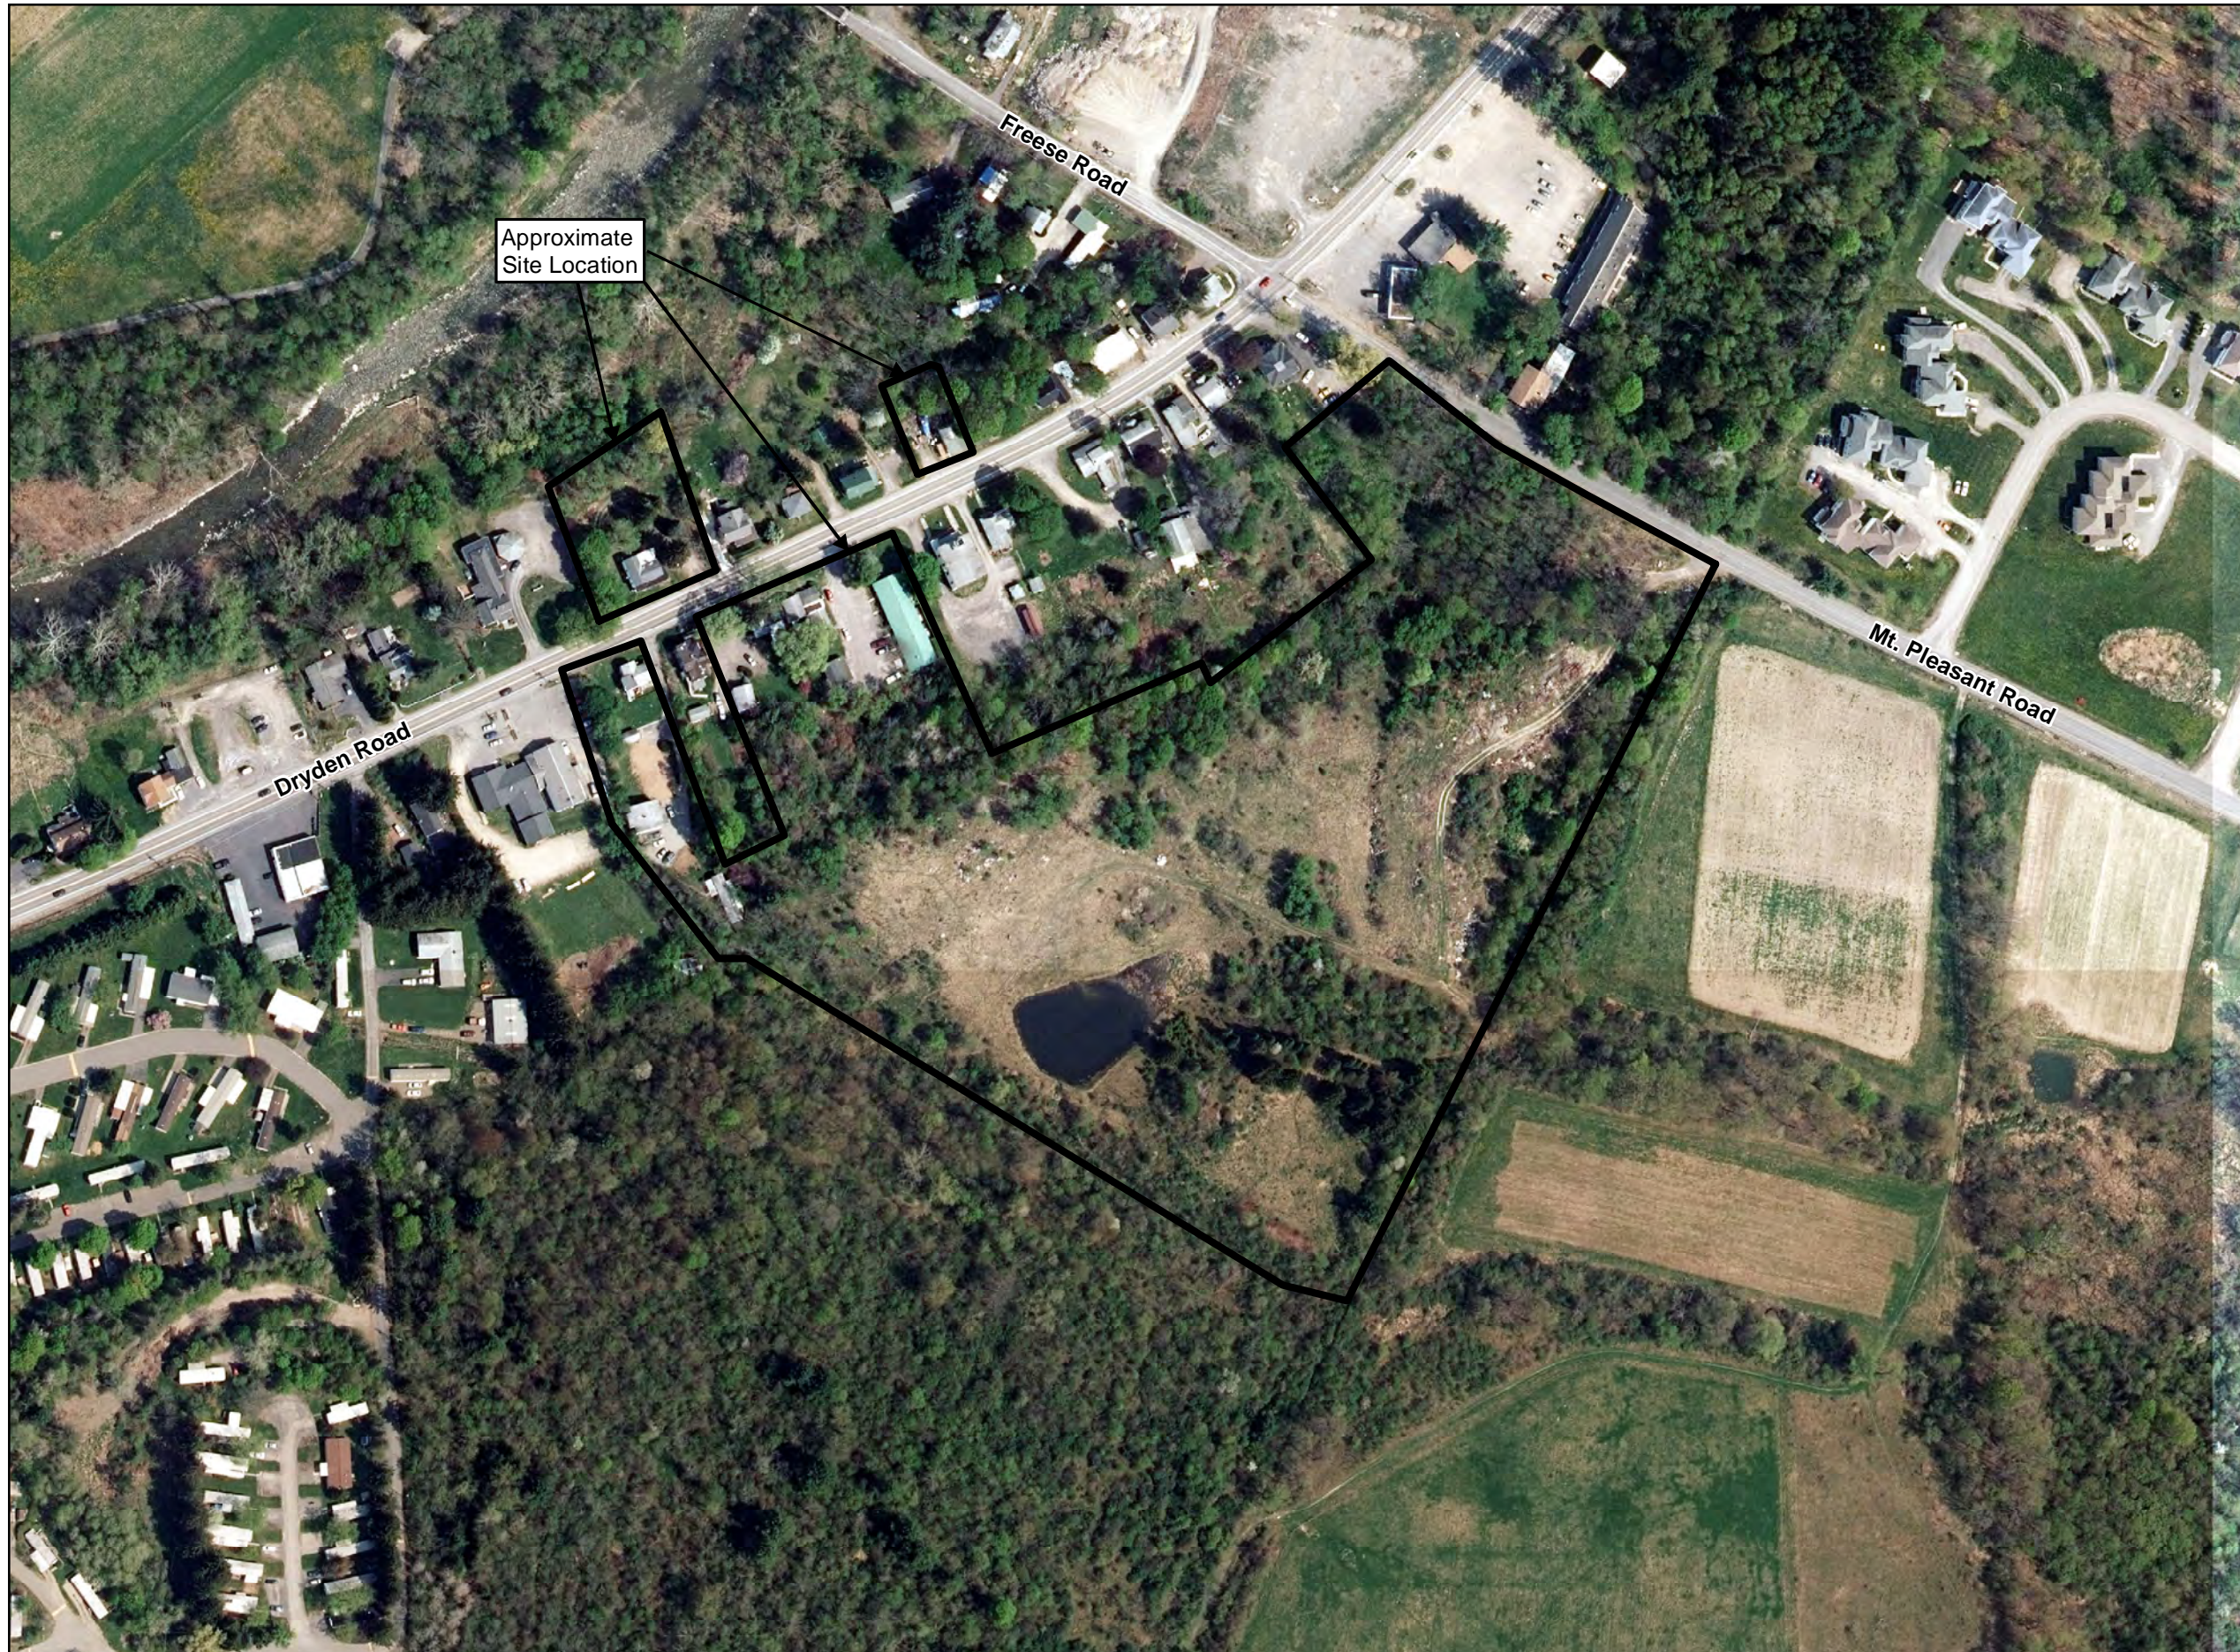
Figure 6.
**Aerial Photograph
of Site**

The aerial photograph of the project site (Figure 6) shows that the site contains open field areas, deciduous forest upland, scrub-shrub upland, a pond, emergent wetland, and several residential structures. The aerial shows piles of debris scattered throughout the largest parcel.

TES delineated Stream A in the southern portion of the site (Figure 6). Stream A is approximately 340 feet long and flows east to west originating off site to the east. Stream A has surface water connections to wetland B and Stream C.

TES delineated Wetland B in the southern portion of the project site (Figure 6). Wetland B is 0.5 acres in size and is noted as a PEM cover type. Wetland B is partially emergent wetland while the rest of it is a pond.

TES delineated Stream C in the southern portion of the site (Figure 6). Stream C is approximately 230 feet long and flows east to west extending off site to the west. Stream C has surface water connections with Wetland B and Stream A.

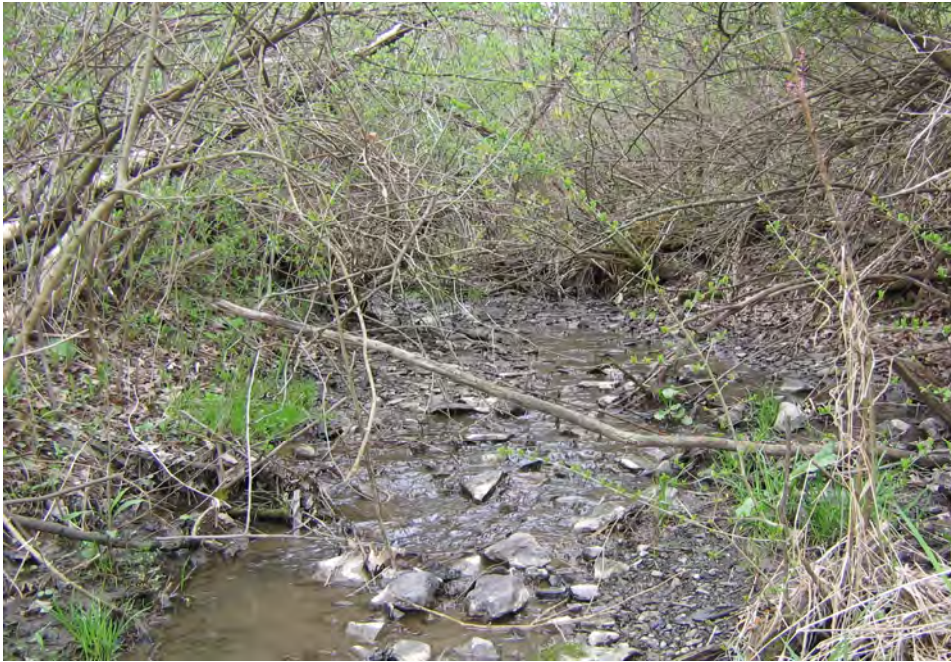
Stream A had a width that varied from 2 feet to 5 ft. The substrate was composed of silt and cobble. The water depth was on average was 5 inches deep. There was no vegetation growing in the stream. Stream A was determined to be an intermittent stream.

Photo 1. Plot Stream-A photo facing east.

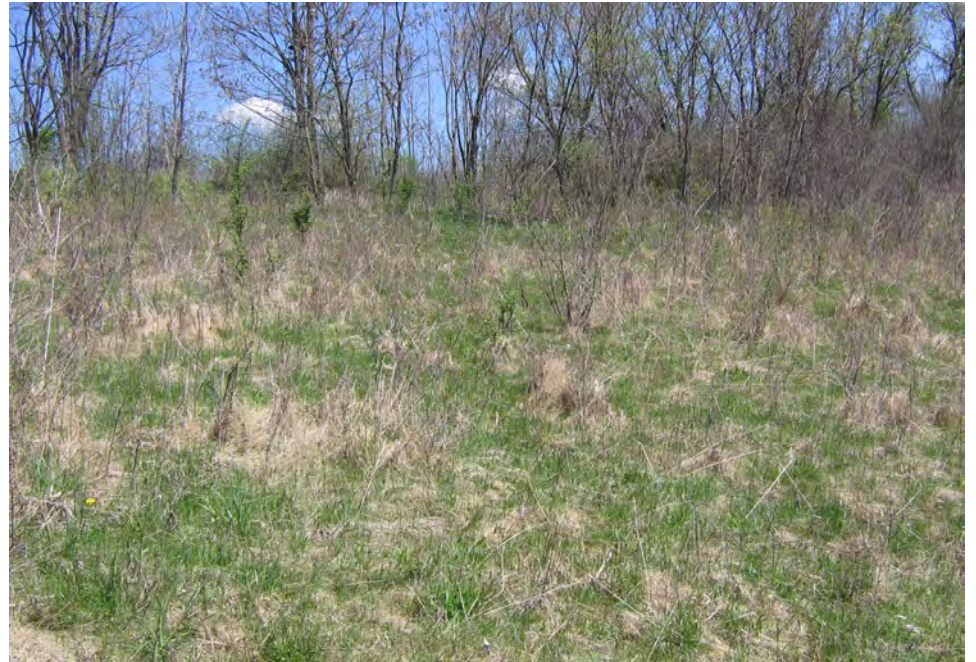
Photo 2. Plot B-1U photo facing north.

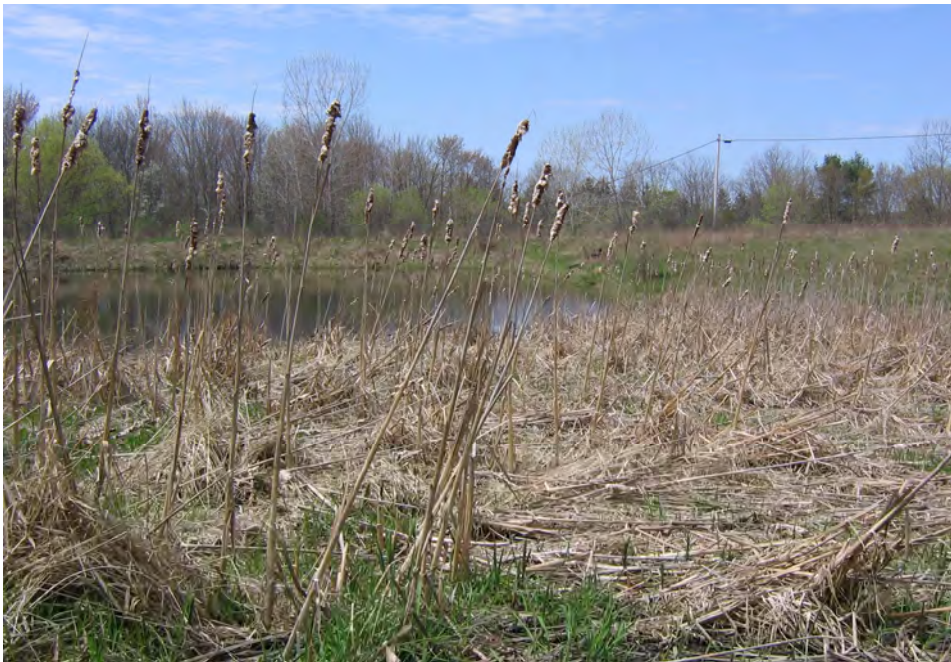
Wetland B was dominated by broadleaf cattail (*Typha latifolia*) (OBL) and common reed (*Phragmites australis*) (FACW).

Soils in Wetland B are mapped as Alluvial land. Soil samples fit the NRCS F1 indicator for Loamy Mucky Mineral. Wetland hydrology was indicated by Surface Water (A1), High Water Table (A2), Saturation (A3), Drainage Patterns (B10), and FAC-Neutral Test (D5).

Photo 3. Plot B-1W photo facing west.

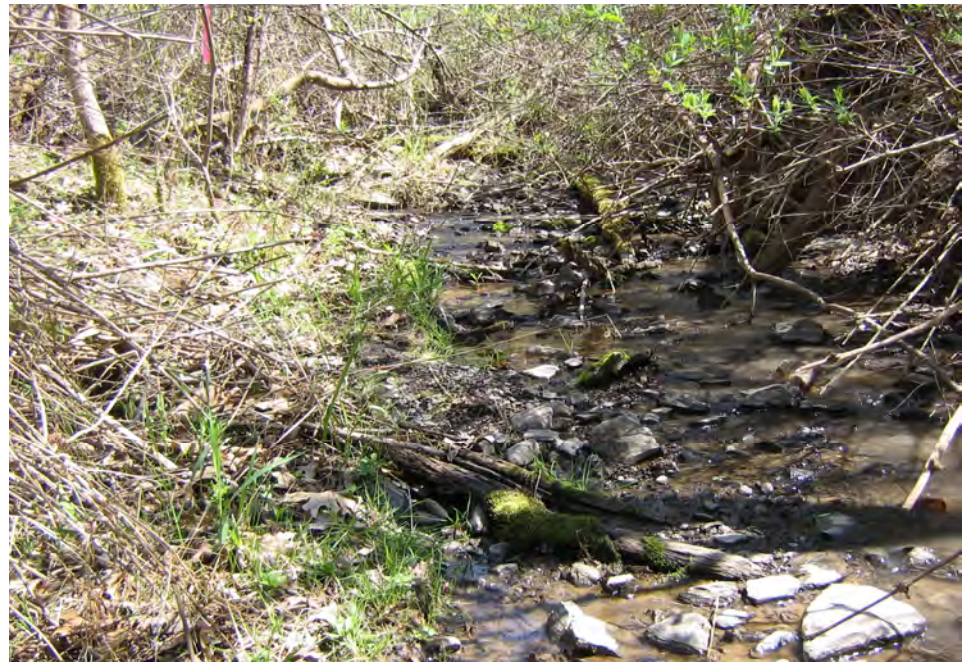
Stream C had a width that varied from 2 feet to 6 ft. The substrate was composed of silt and cobble. The water depth was on average was 4 inches deep. There was no vegetation growing in the stream. Stream C was determined to be an intermittent stream.

Photo 4. Plot Stream-C photo facing south-east.
