**RE: George Road Electrical Interconnection and Visual Impact Analysis
2150 Dryden Road PV Project**

The purpose of this memorandum is to provide an overview of the 2150 Dryden Road PV Project final interconnection requirements and a corresponding layout with a visual impact analysis.

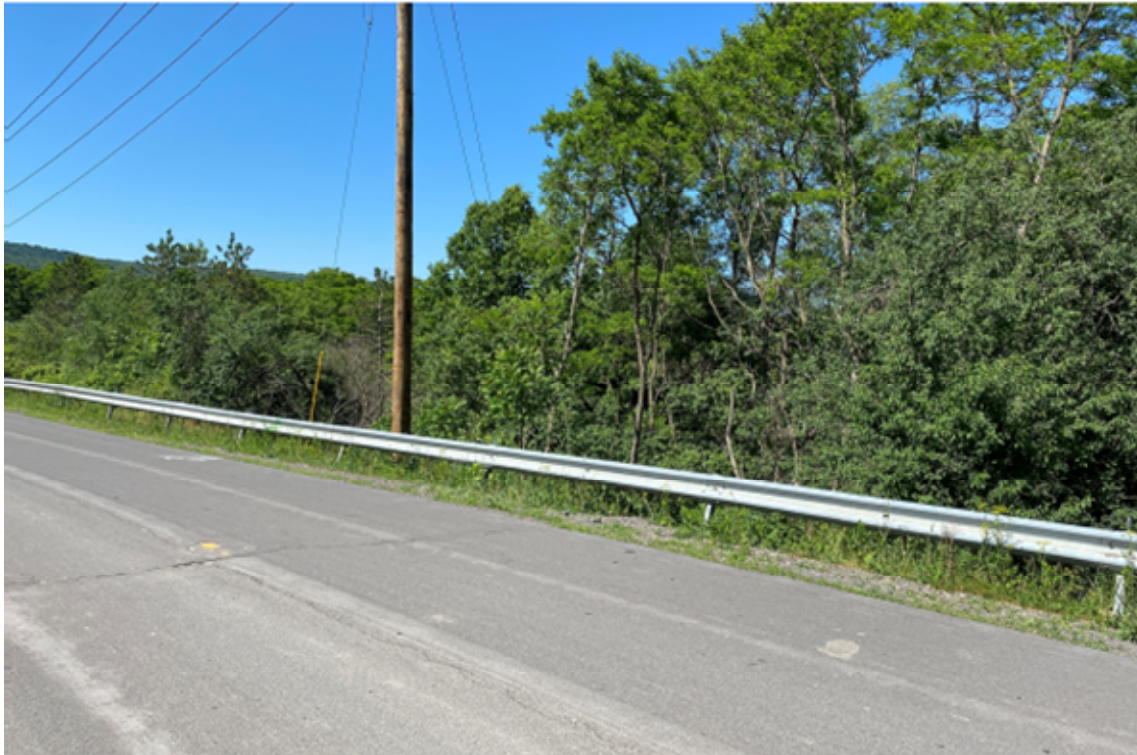
PHOTO 1 LOOKING SOUTH WEST FROM 50 ' SOUTH OF TRAIL CROSSING

ELEVATION OF ROAD 1090 , EYE ELEVATION AT 1095 FEET

This view shows that the vegetation on the west side of the road ranges from 10 to 20 feet tall (Approximate elevation of the top of vegetation 1105 feet). The maximum elevation of the NYSEG Poles at the interconnection site is 1095 feet, which is lower than the top of vegetation at this point. The vegetation at this viewpoint effectively blocks any view of the facility.

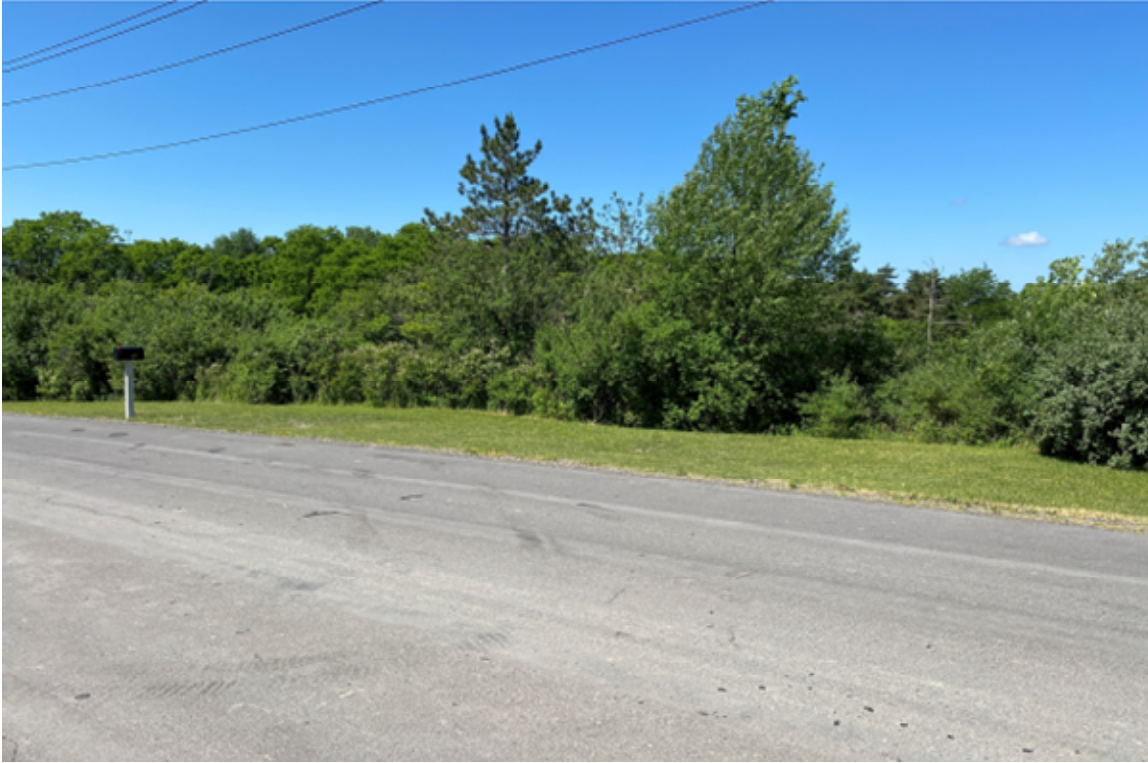
PHOTO 2 FROM ROAD AT NORTH CORNER OF 287 GEORGE ROAD

ELEVATION OF ROAD 1084, EYE ELEVATION 1089

This view shows that the vegetation on the west side of the road ranges from 10 to 20 feet tall (Approximate elevation of the top of vegetation 1095 feet). The maximum elevation of the NYSEG Poles at the interconnection site is 1095 feet, which is at the top of vegetation at this point. The vegetation at this viewpoint effectively blocks any view of the facility.

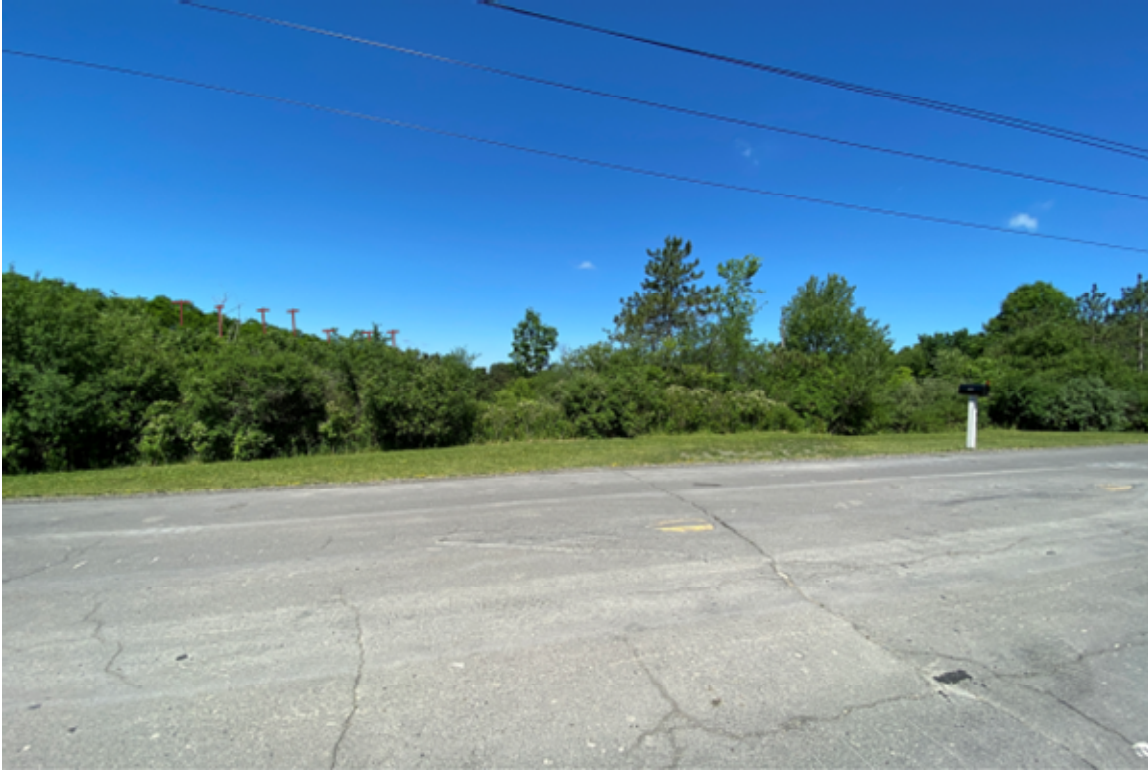
PHOTO 3 FROM DRIVEWAY OF 287 GEORGE ROAD

ELEVATION OF ROAD 1080 FEET, EYE ELEVATION 1085 FEET

This view shows that the vegetation on the west side of the road ranges from 8 to 15 feet tall (Approximate elevation of the top of vegetation 1090 feet). The maximum elevation of the NYSEG Poles at the interconnection site is 1095 feet, which is slightly above the top of vegetation at this point. The vegetation at this viewpoint effectively blocks most the view of most of the facility except for the very top of the NYSEG Poles. The customer owned poles with a top elevation of 1087 would be effectively screened.

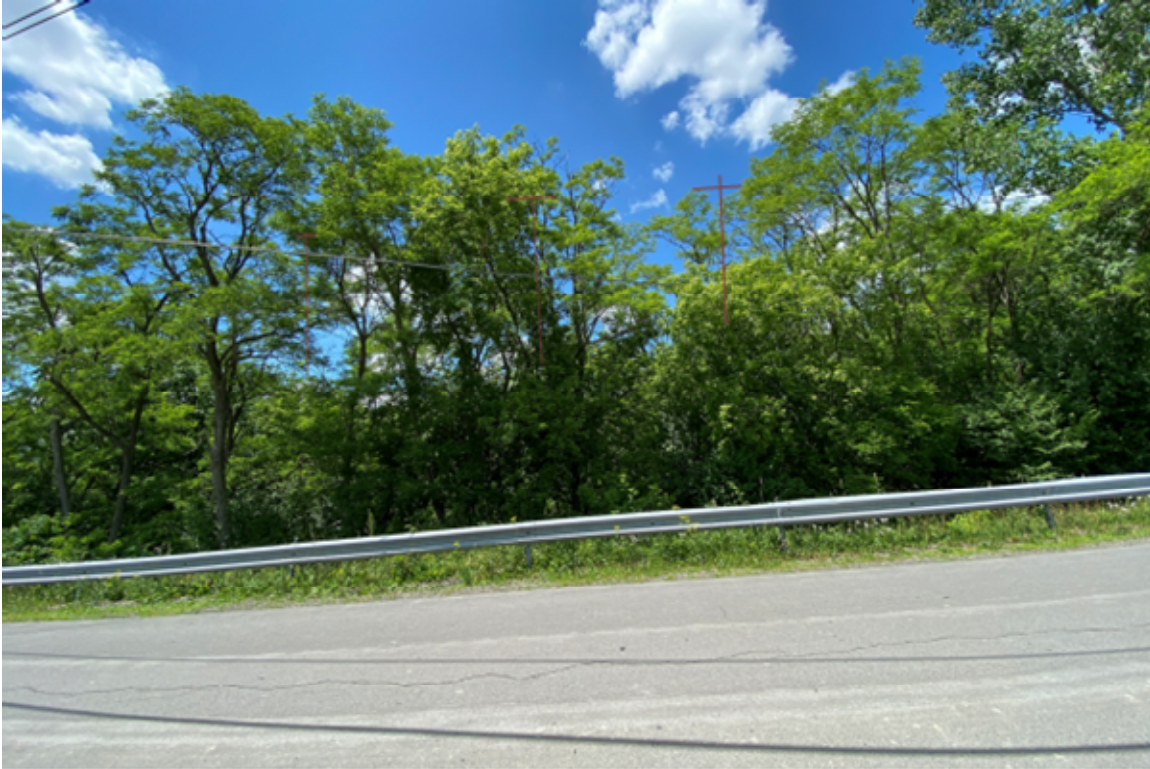
PHOTO 4 FROM IN FRONT OF AUTO BODY SHOP AT 283 GEORGE ROAD

ELEVATION OF ROAD 1078 FEET EYE ELEVATION AT 1083 FEET

This view shows that the brushy vegetation on the west side of the road ranges from 8 to 10 feet tall with some of the trees at 20 to 25 feet (Approximate elevation of the top of vegetation 1098 feet). The maximum elevation of the NYSEG Poles at the interconnection site is 1095 feet, which is slightly above the top of the denser vegetation at this point is slightly lower than the taller trees. The vegetation at this viewpoint effectively blocks most the view of most of the facility except for the very top of the NYSEG Poles during the summer months. The customer owned poles with a top elevation of 1087 would be effectively screened.

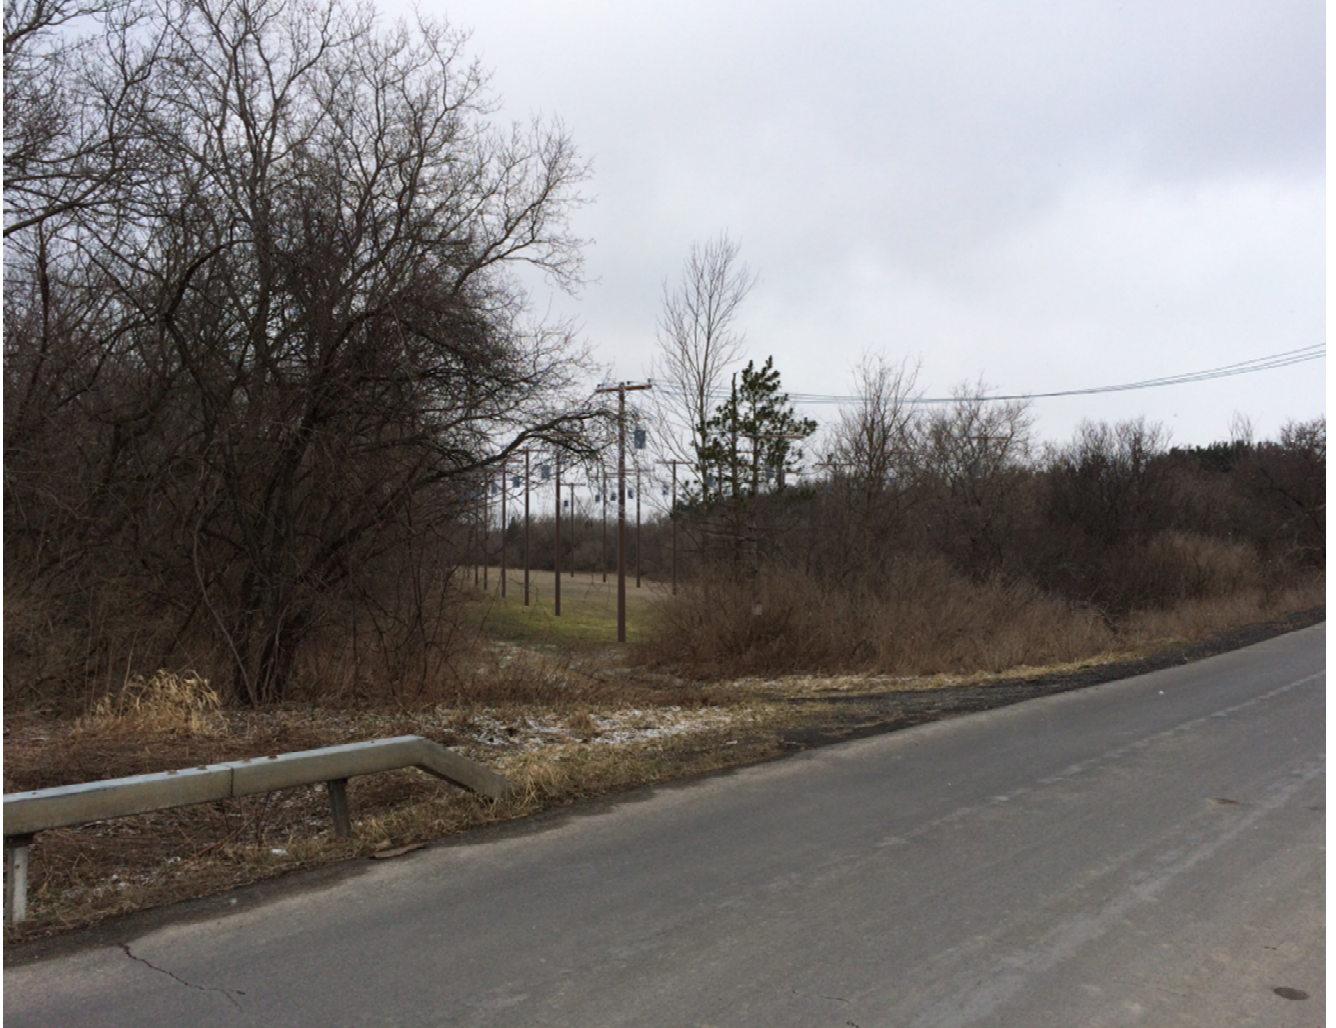
PHOTO 5. ACCESS ROAD OFF OF GEORGE ROAD LATE SPRING

ELEVATION OF THE ROAD AT 1060, EYE ELEVATION AT 1065 FEET

This view was taken in early spring prior to leaf cover and the poles nearest the road and on the south edge of the facility are visible. The roadside vegetation does provide significant screening. This area is just north of the Virgil Creek Bridge and there are no residences in this area.

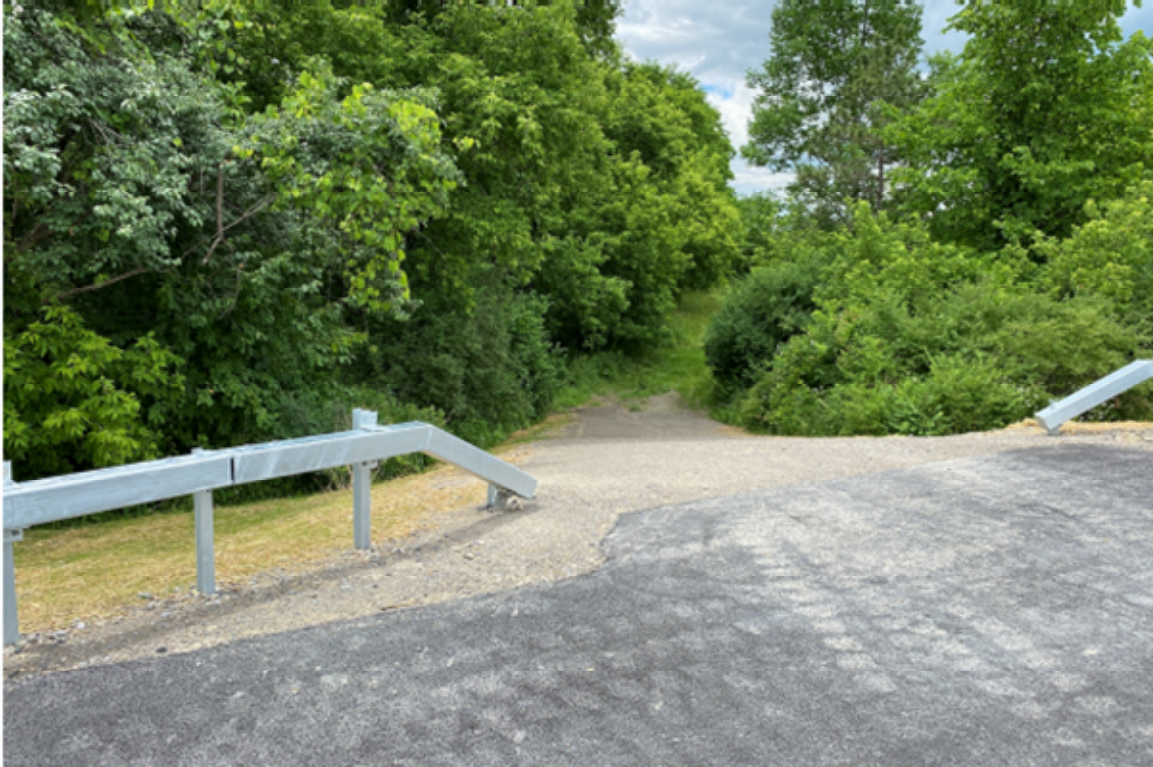
PHOTO 5a. ACCESS ROAD OFF OF GEORGE ROAD EARLY SUMMER

This photo from the same point shows the screening in the summer months.

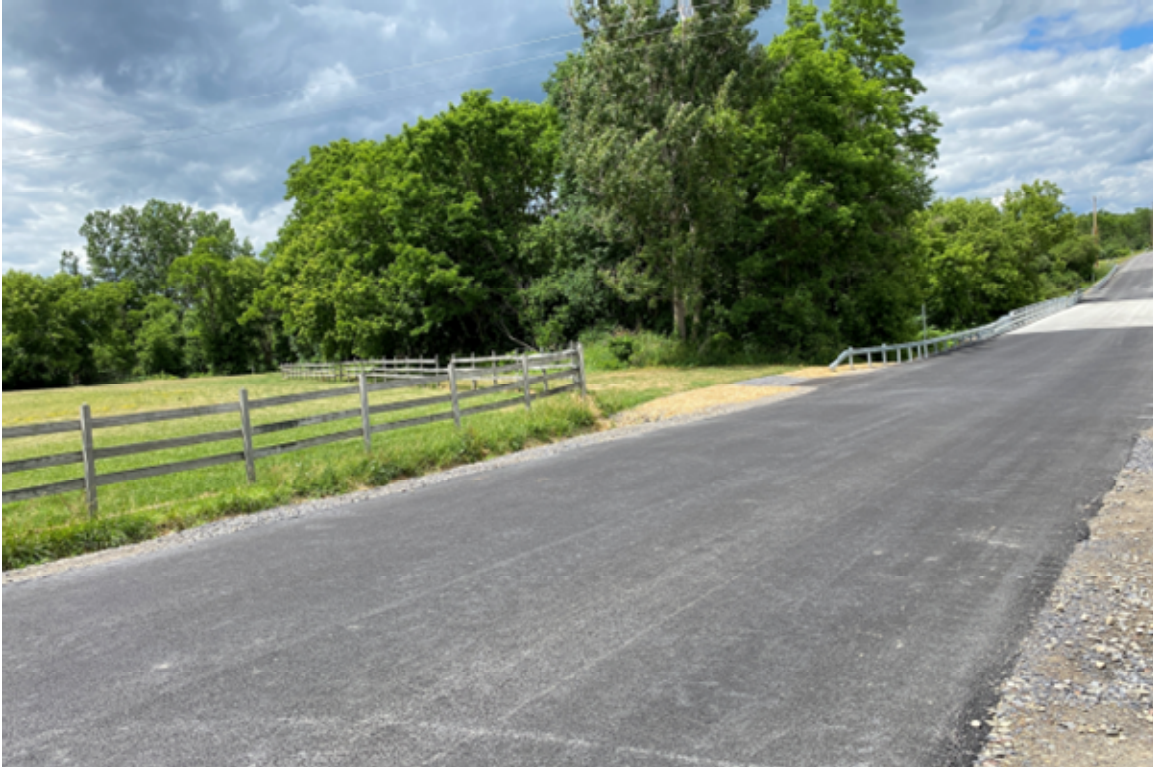
PHOTO 6 LOOKING NORTH TOWARD FROM 150 FEET SOUTH OF BRIDGE

ROAD ELEVATION 1066 FEET, EYE ELEVATION 1071 FEET

This view shows that the trees on the banks of Virgil Creek effectively block the view of the facility.
