**RE: George Road Electrical Interconnection and Visual Impact Analysis  
2150 Dryden Road PV Project**

The purpose of this memorandum is to provide an overview of the 2150 Dryden Road PV Project final interconnection requirements and a corresponding layout with a visual impact analysis.

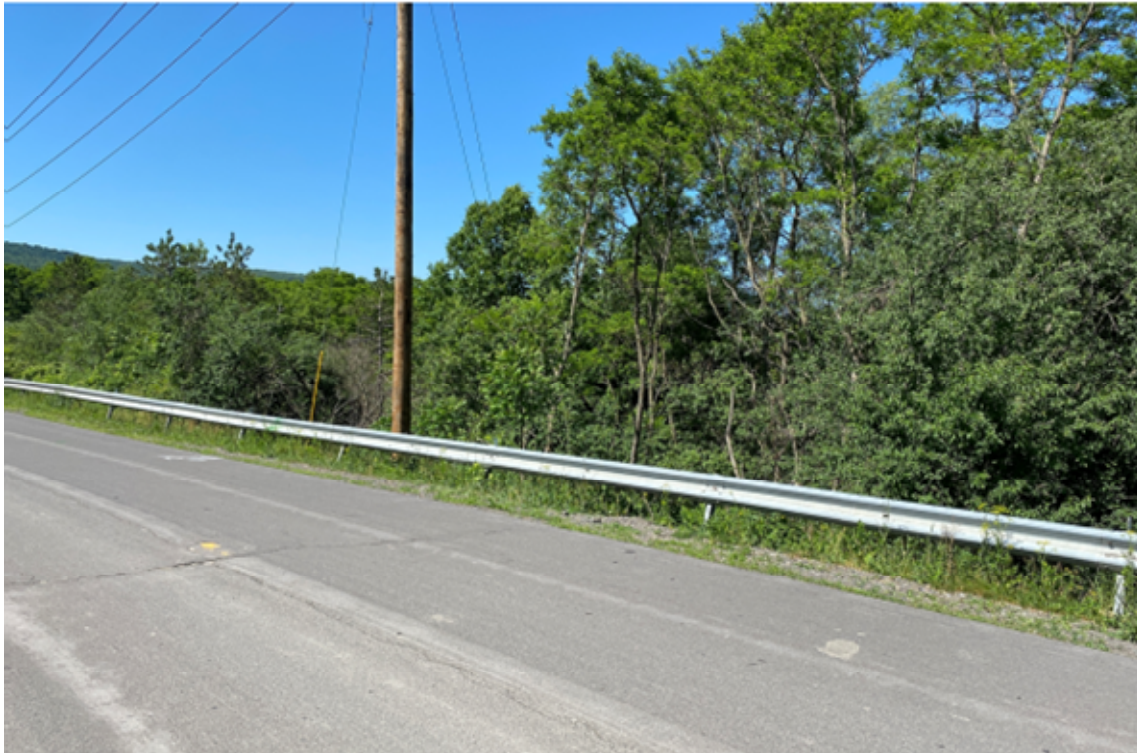
PHOTO 1 LOOKING SOUTH WEST FROM 50 ' SOUTH OF TRAIL CROSSING

ELEVATION OF ROAD 1090 , EYE ELEVATION AT 1095 FEET

This view shows that the vegetation on the west side of the road ranges from 10 to 20 feet tall (Approximate elevation of the top of vegetation 1105 feet). The maximum elevation of the NYSEG Poles at the interconnection site is 1095 feet, which is lower than the top of vegetation at this point. The vegetation at this viewpoint effectively blocks any view of the facility.

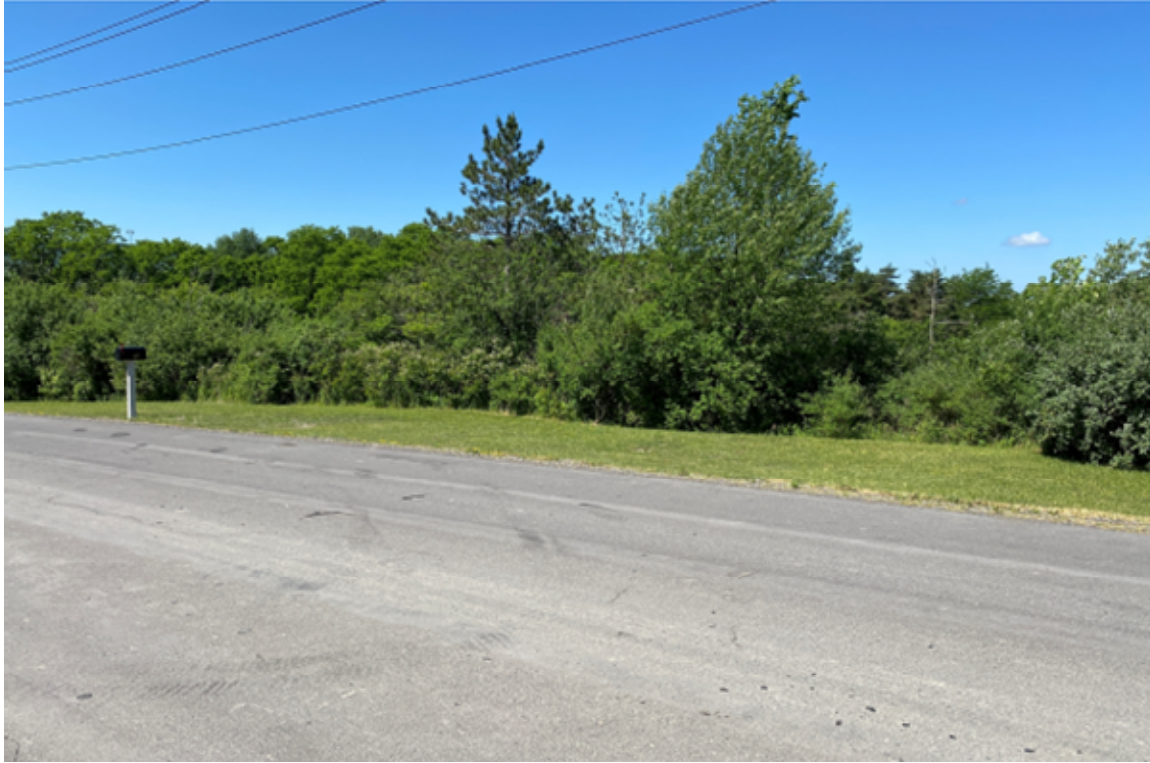
PHOTO 2 FROM ROAD AT NORTH CORNER OF 287 GEORGE ROAD

ELEVATION OF ROAD 1084, EYE ELEVATION 1089

This view shows that the vegetation on the west side of the road ranges from 10 to 20 feet tall (Approximate elevation of the top of vegetation 1095 feet). The maximum elevation of the NYSEG Poles at the interconnection site is 1095 feet, which is at the top of vegetation at this point. The vegetation at this viewpoint effectively blocks any view of the facility.
