RE: Phase I Environmental Site Assessment Report
Proposed Student Housing
959 Dryden Road
Ithaca, New York 14850
PSI Work Order Number 08212827

Phase I Environmental Site Assessment

**Proposed Student Housing
959 Dryden Road
Ithaca, New York 14850**

March 27, 2018

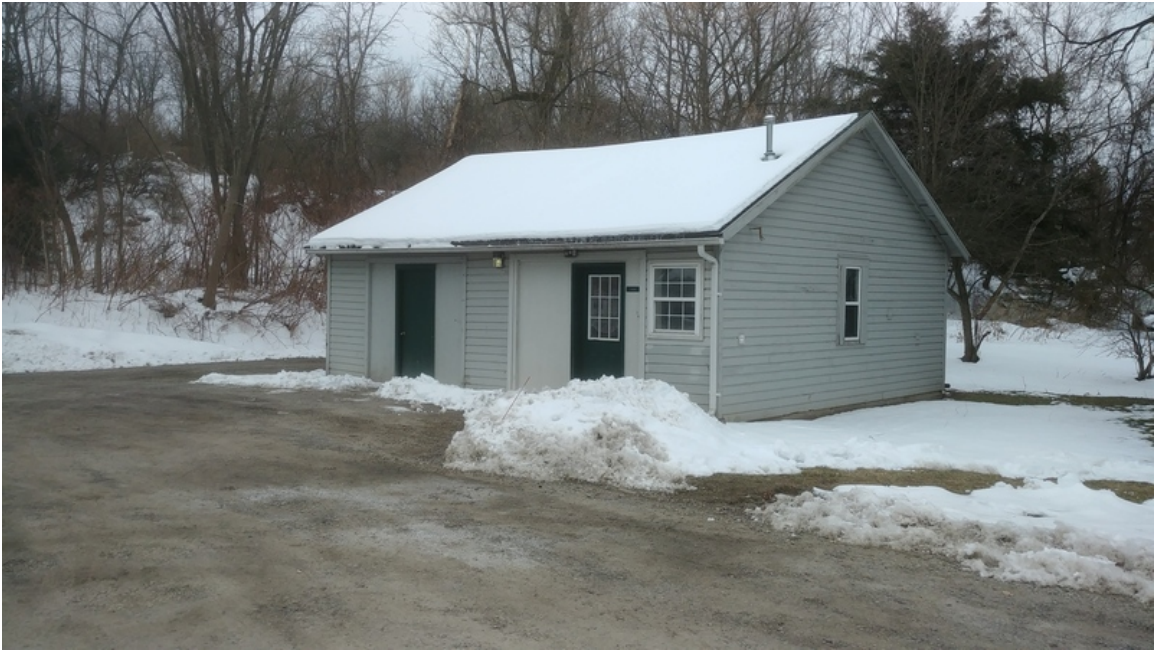
Photo 2: Laundry room and maintenance shop on 959 Dryden Road

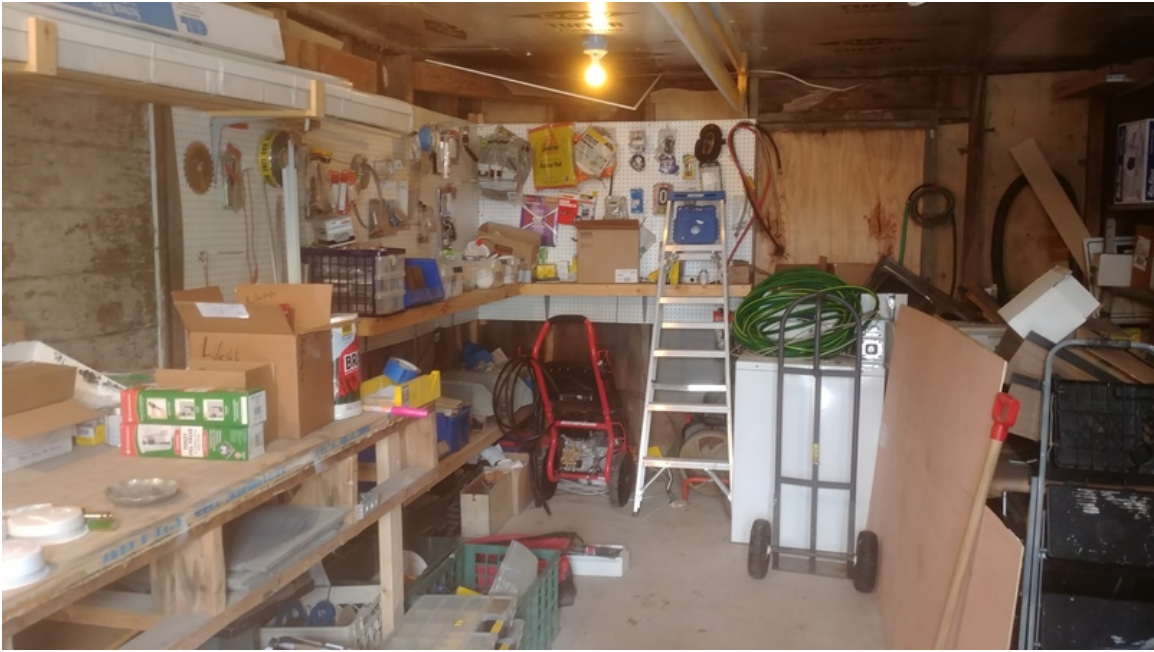
Photo 5: Interior of maintenance shop on 959 Dryden Road

PSI observed typical property maintenance chemicals, such as paints, caulks, lubricants, mastics, joint compound, cleaners, and solvents in the maintenance building on the subject property. These chemicals were generally stored in containers of 5-gallons or less. PSI did not observe evidence of significant leaking or staining in connection with the containers at the time of the site reconnaissance. Based on this information, the presence of these maintenance chemicals is not considered to be evidence of a REC in connection with the subject property.

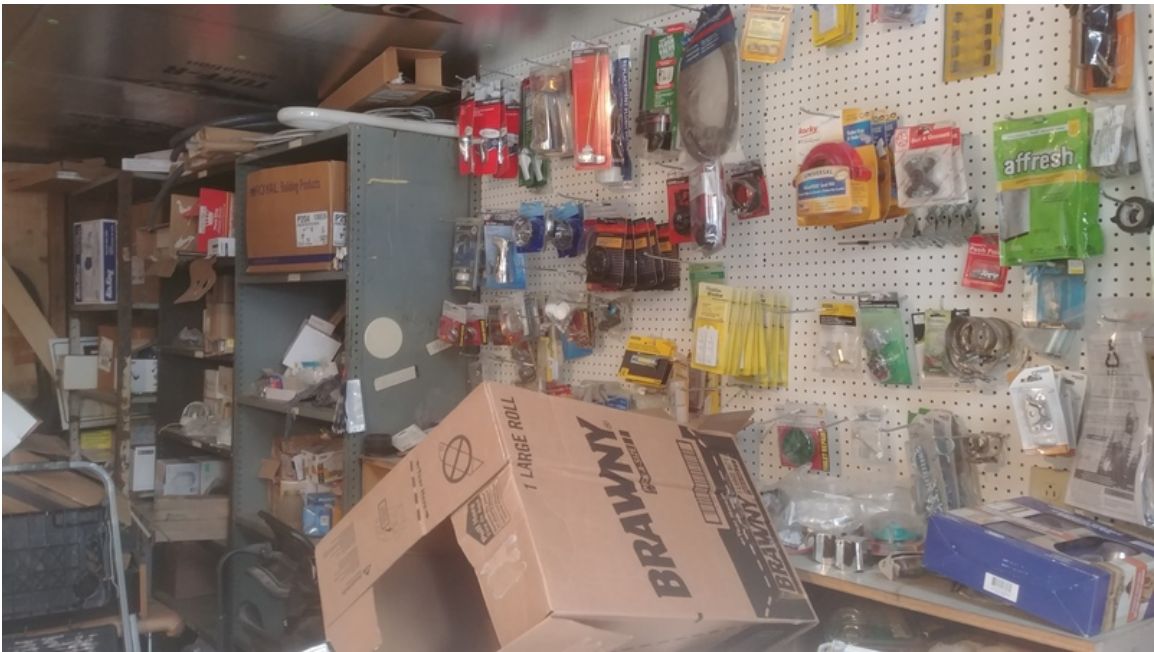
Photo 6: Interior of maintenance shop on 959 Dryden Road

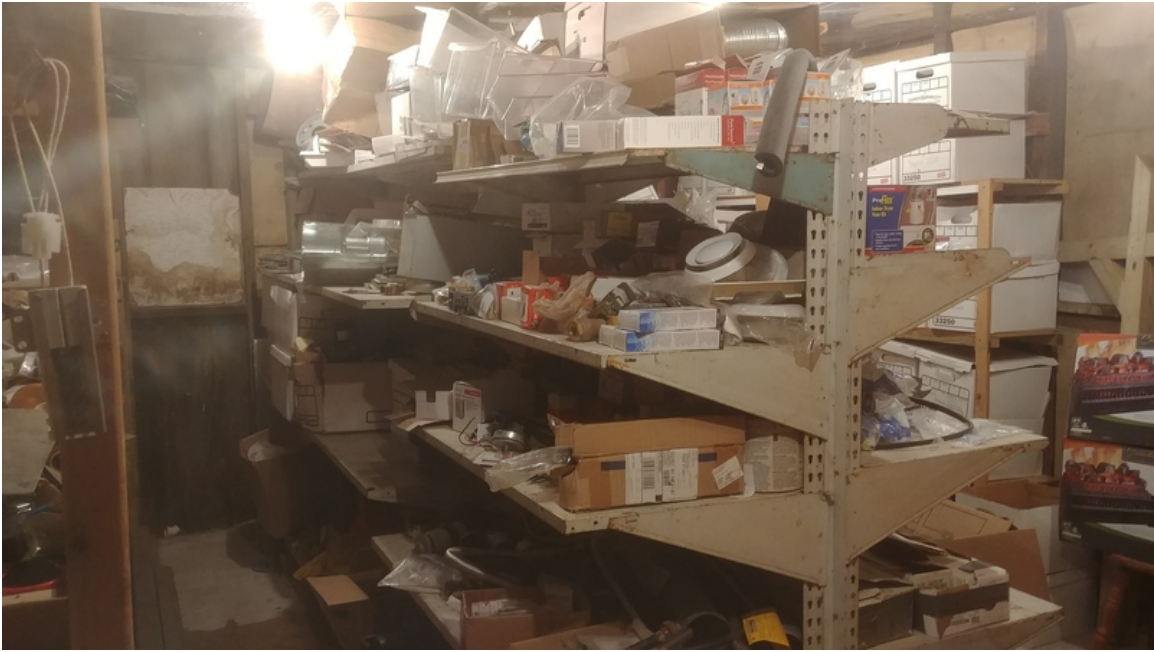
Photo 7: Interior of maintenance shop on 959 Dryden Road

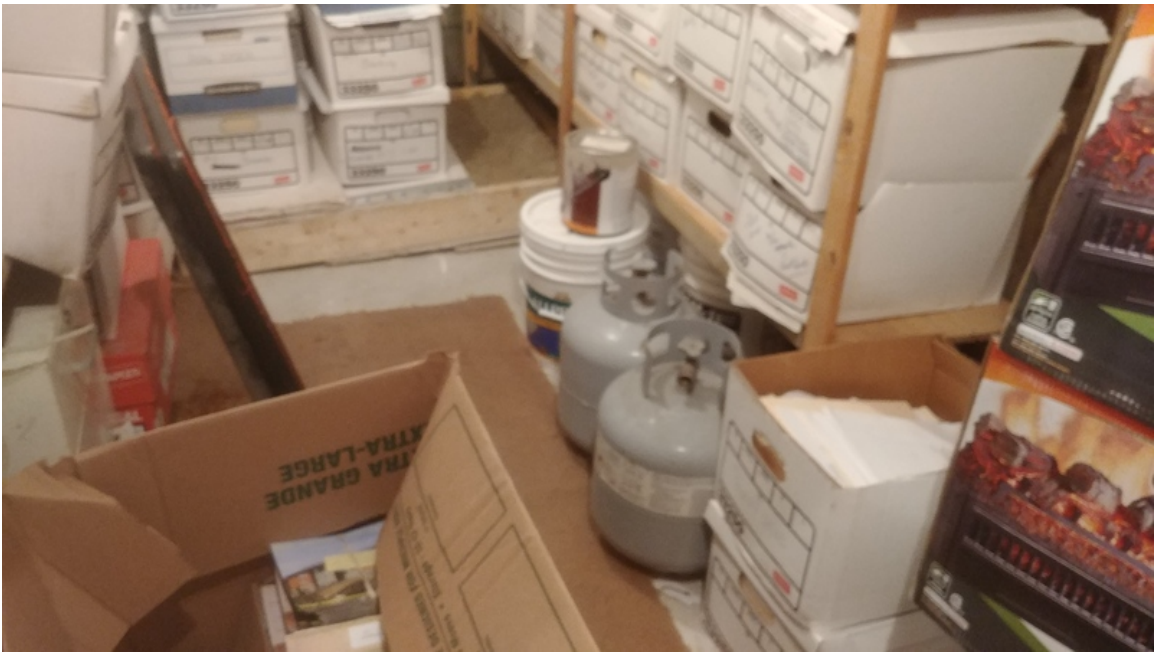
PSI observed three 20 pound propane ASTs on the subject property. The cylinders were located in the maintenance shop and appeared to be in good condition. Due to the extremely low boiling point of propane, leaks or spills from these cylinders are not expected to result in contamination of soil or groundwater. Based on the condition of the cylinders at the time of site reconnaissance, these propane ASTs are not considered to represent evidence of a REC in connection to the subject property.

Photo 8: Propane ASTs in maintenance shop

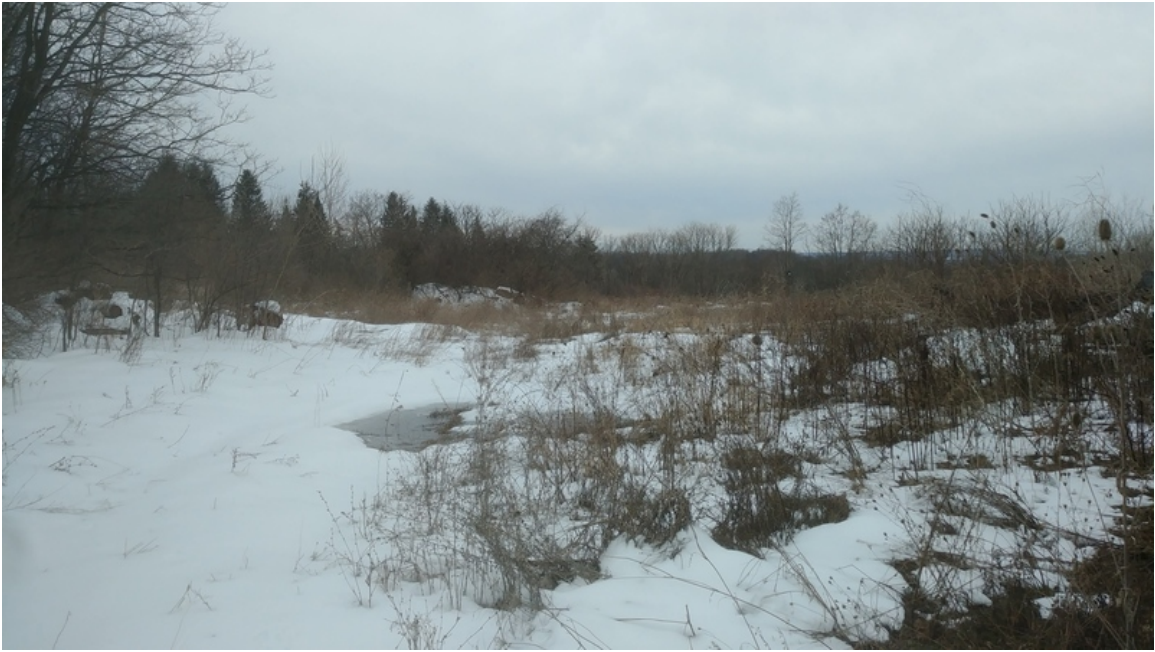
The southern property boundary was previously a railroad right-of way. PSI observed piles of old railroad spurs in the northeast corner of the undeveloped parcel of the subject property. Railroad right-of-ways are typically maintained using glyphosphate or arsenical herbicides for weed control. Routine and purposeful application of herbicides is exempt from CERCLA enforcement, provided that the herbicides are applied in accordance with manufacturer’s directions and are not spilled or released as a point source. Therefore, the use of herbicides on the subject property is not considered evidence of a REC in connection with the subject property.

Photo 17: Undeveloped subject property facing west

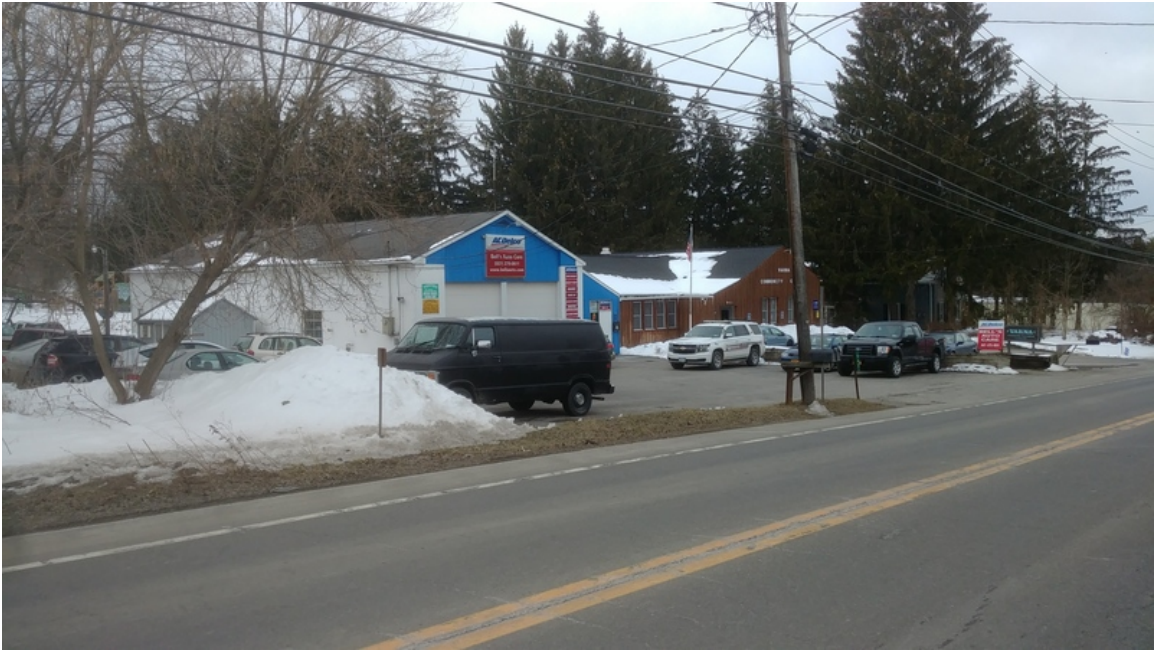
The west adjoining property is occupied by an automotive repair business. While not directly observed, these types of businesses routinely use automotive-related hazardous substances and parts washers. PSI did not observe obvious evidence of the misuse of hazardous substances from public thoroughfares at the time of the site reconnaissance. Based on the observed topographic downgradient position and no reported spills from the property, the current uses of hazardous substances at this property is not considered to be evidence of a REC in connection with the subject property.

Photo 22: Adjoining property to the west

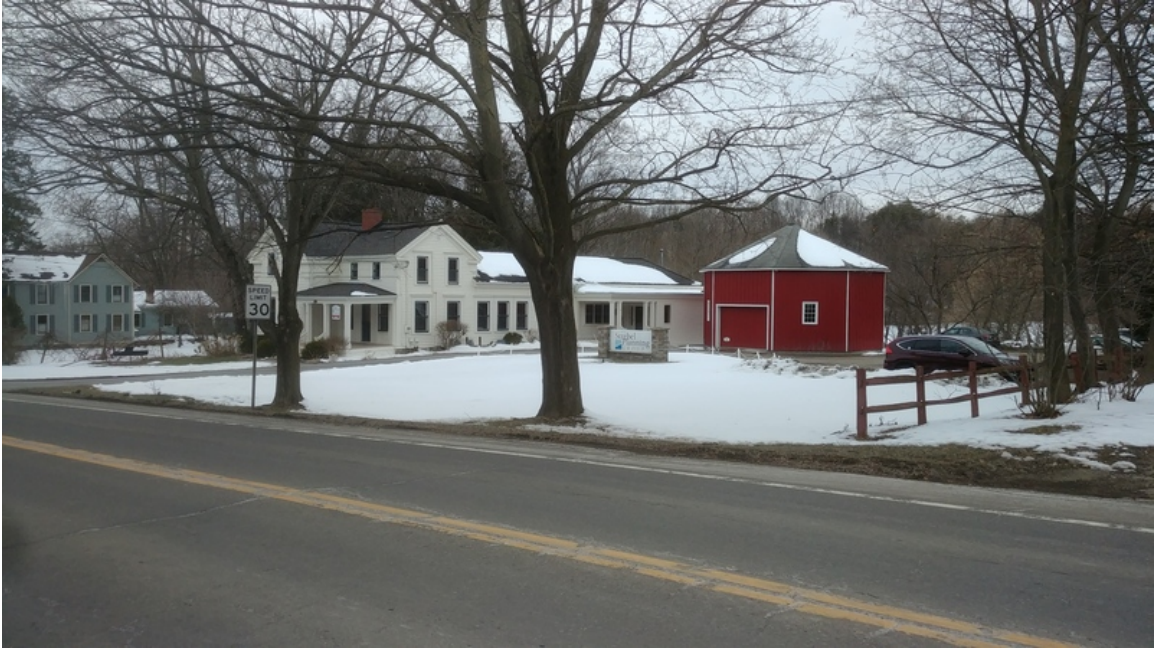
Photo 23: Adjoining property to the west
