# Transportation Project Report

## Draft Project Scoping Report/Final Design Report

Dryden Rail Trail Phase 2  
Project Identification Number (PIN): 3950.71  
Town of Dryden  
Tompkins County

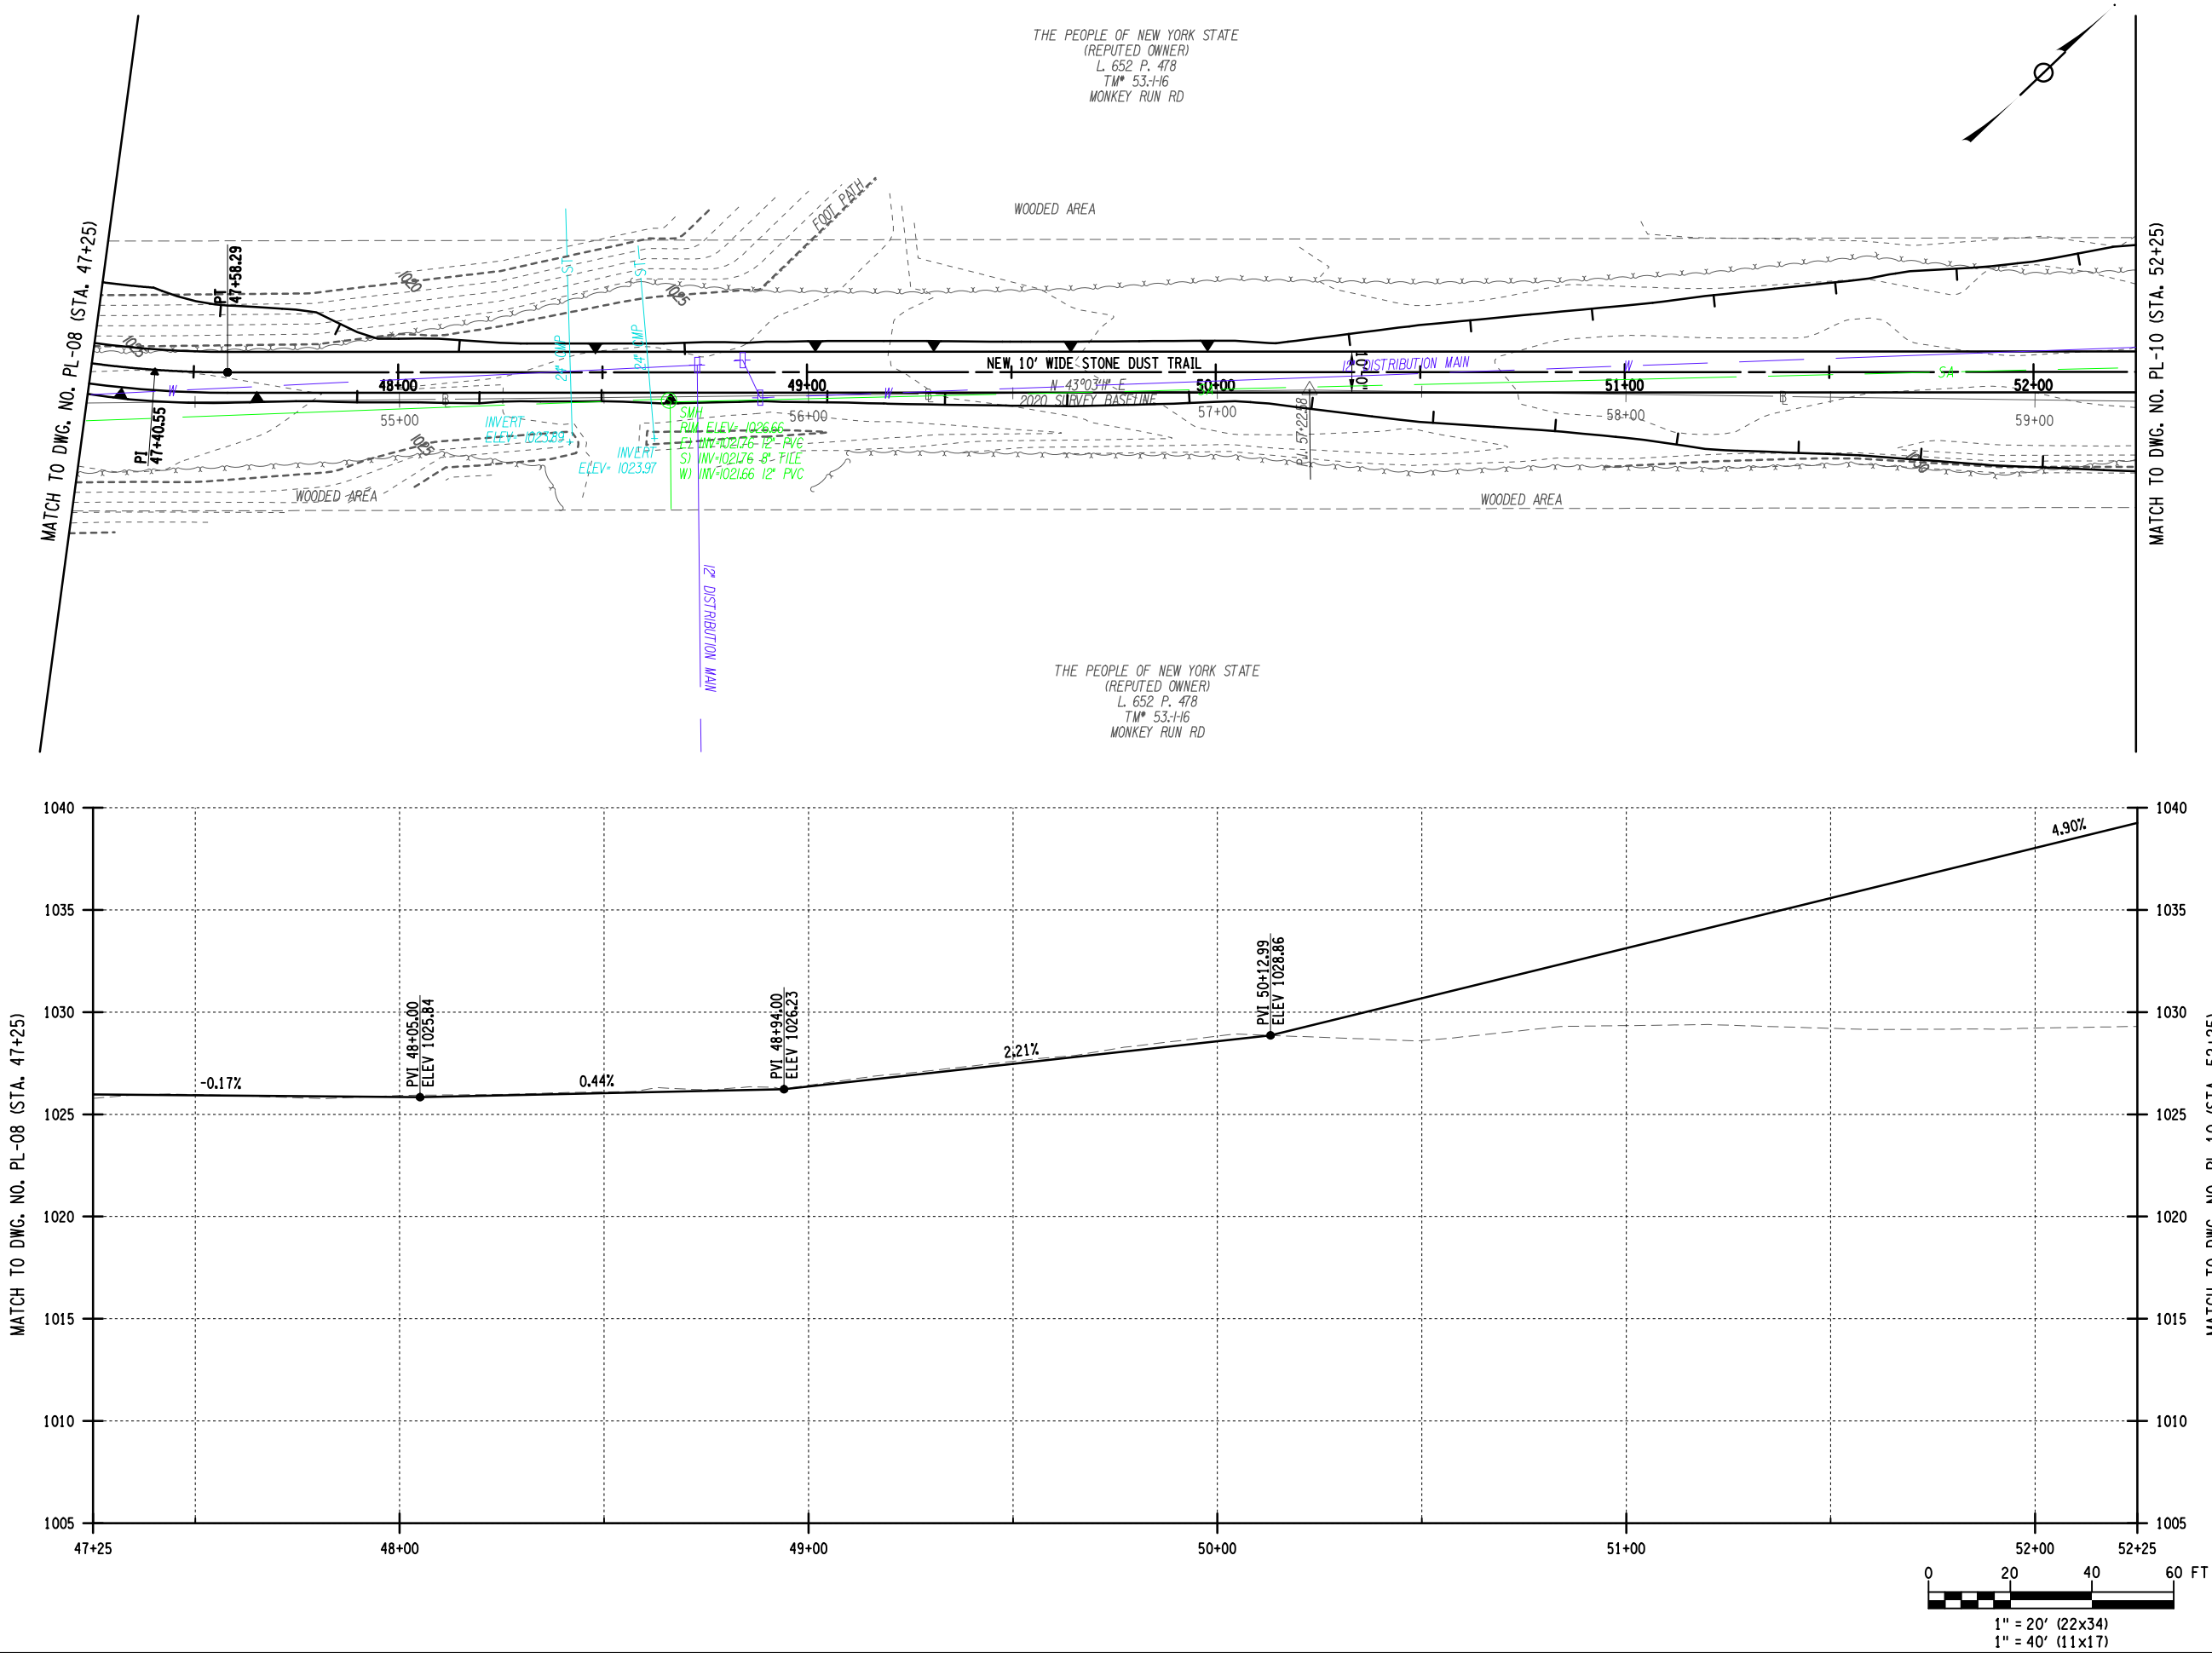
SCALE H: 1"=40' / V: 1"=5'	DATE OCTOBER 2020
P.L.N. 3950.71	FEDERAL AID PROJECT NO. XXXXXXX
SHEET NO. XX OF XX	DRAWING NO. PL-09

PLAN AND PROFILE

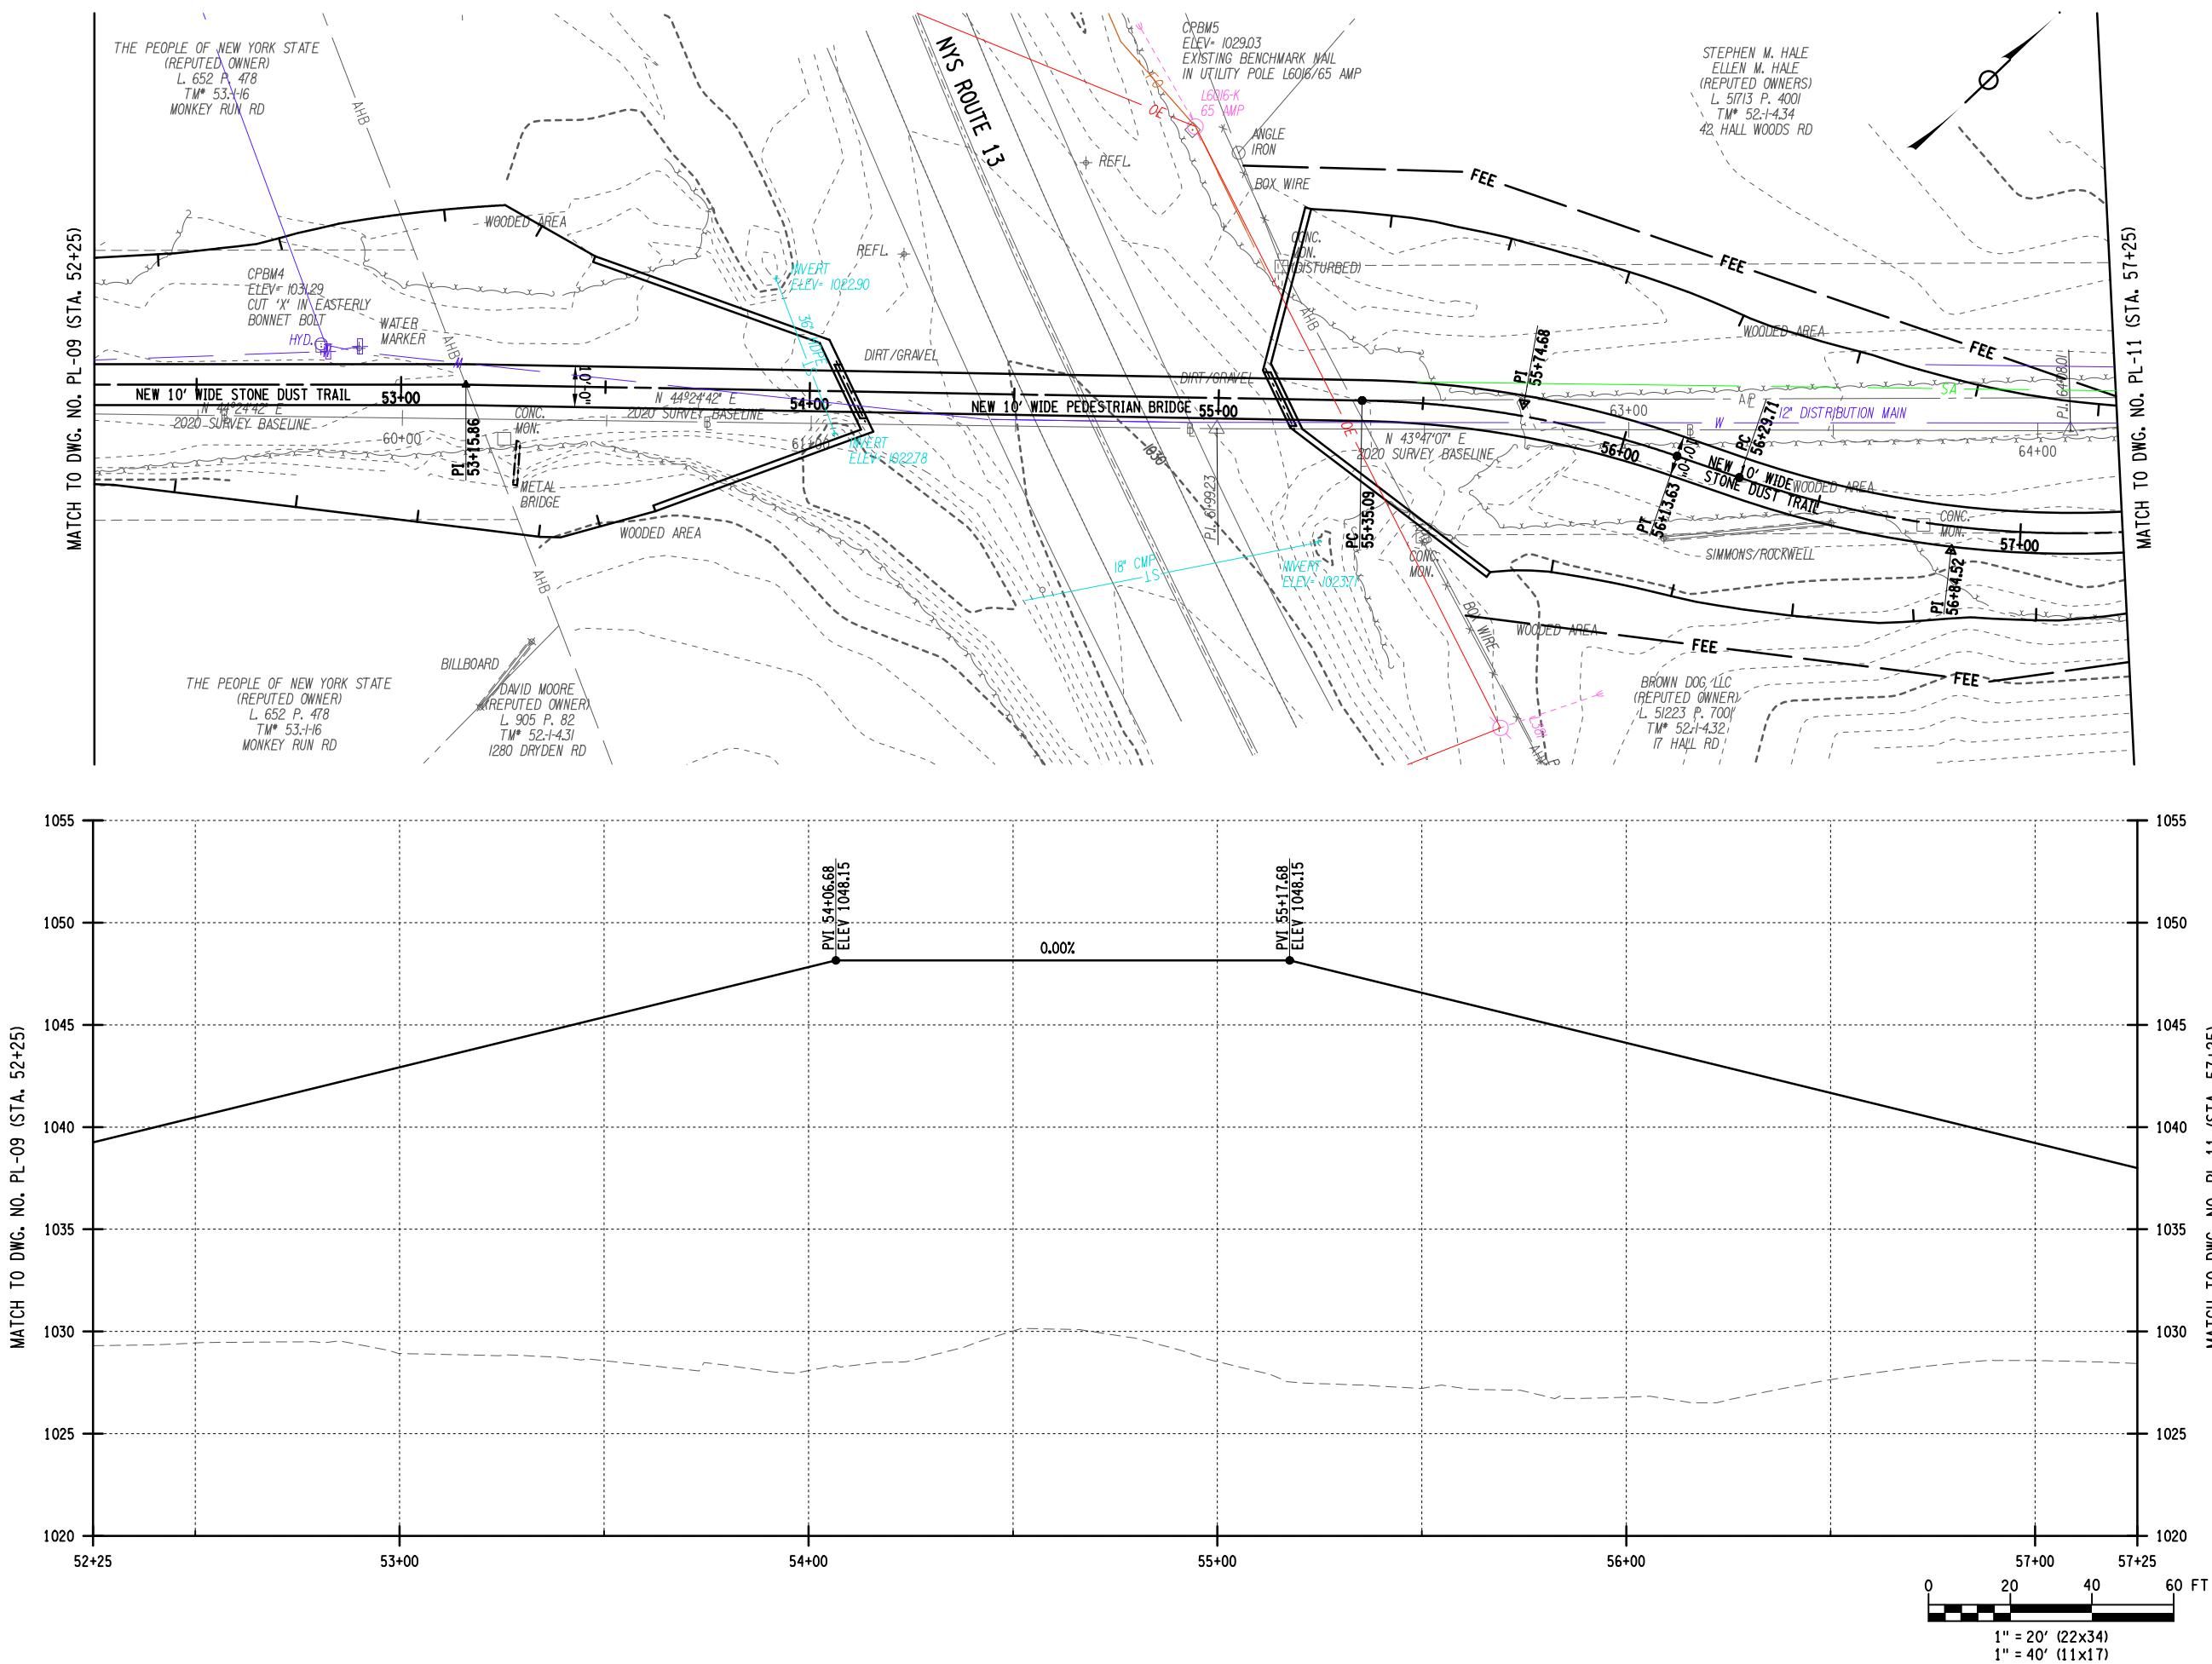
SCALE	DATE
H: 1"=40' / V: 1"=5'	OCTOBER 2020
P.L.N.	FEDERAL AID PROJECT NO.
3950.71	XXXXXXX
SHEET NO.	DRAWING NO.
XX OF XX	PL-10

PLAN AND PROFILE

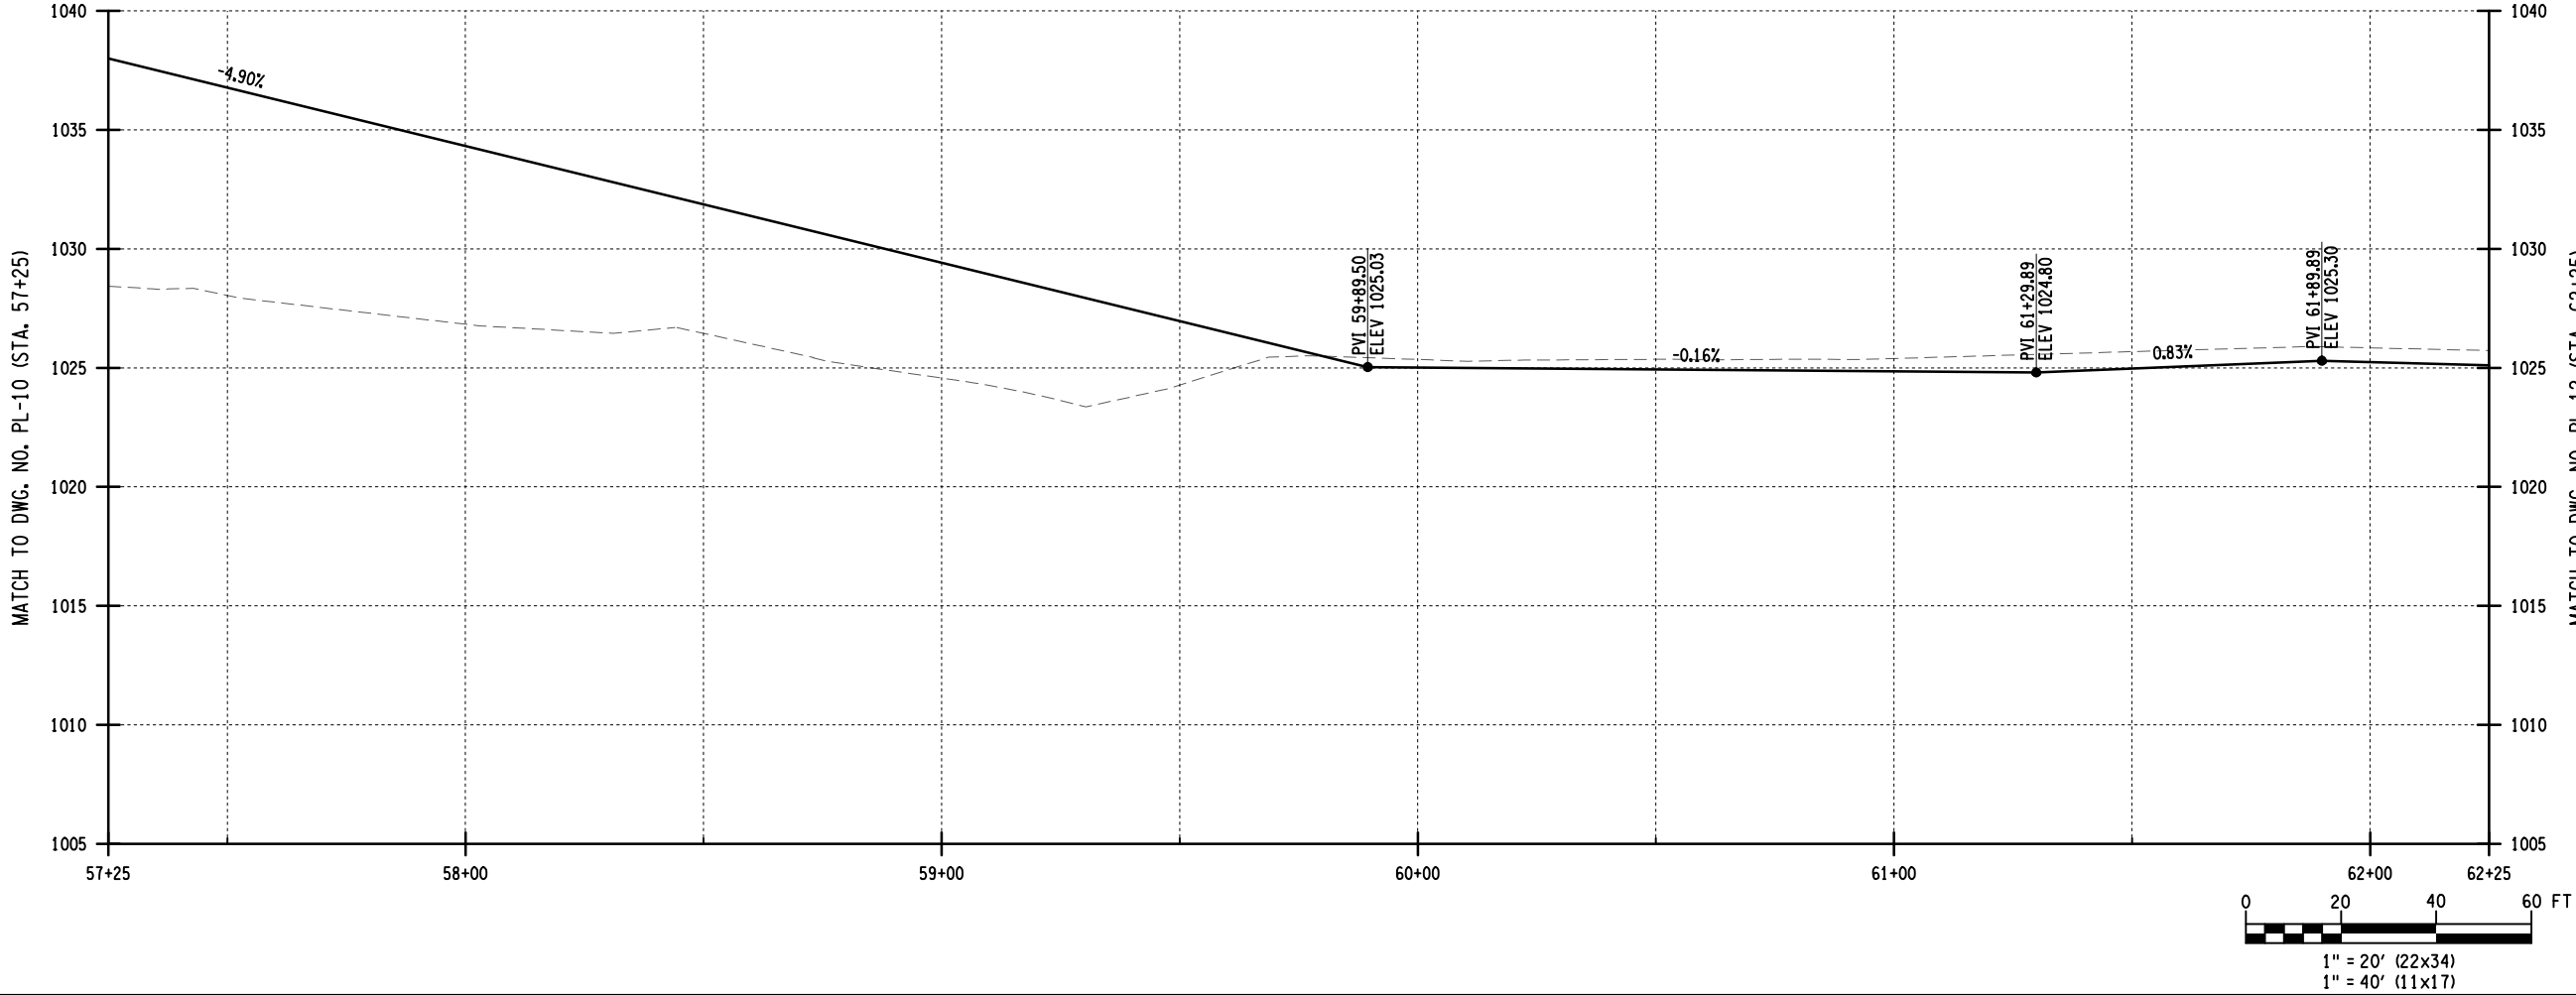
SCALE	DATE
H: 1"=40' / V: 1"=5'	OCTOBER 2020
P.L.N.	FEDERAL AID PROJECT NO.
3950.71	XXXXXXX
SHEET NO.	DRAWING NO.
XX OF XX	PL-11

**PLAN AND PROFILE**

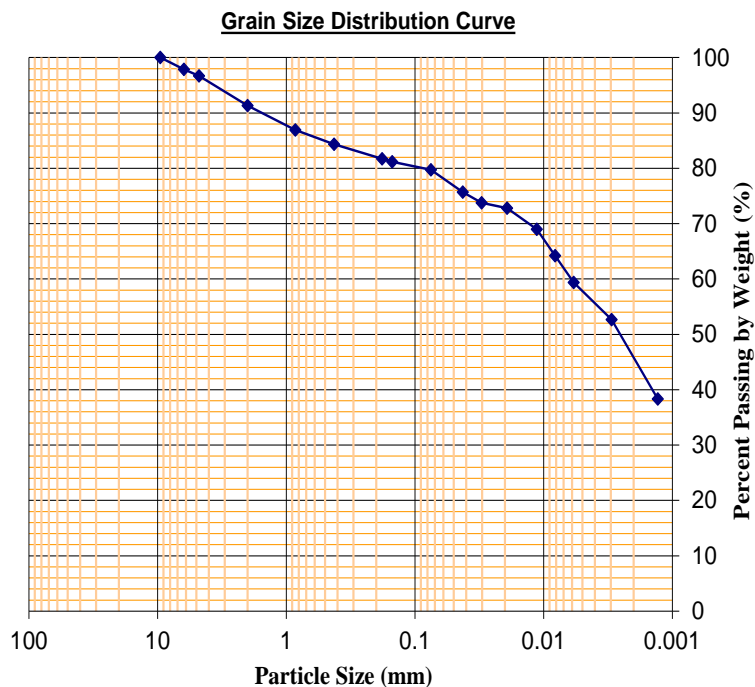
Brown CLAY, some SILT, little cmf SAND, trace fine GRAVEL

<u>Sieve Designation</u>	<u>Size (mm)</u>	<u>Percent Passing by Weight (%)</u>
3/8"	9.5	100
1/4"	6.25	98
No.4	4.75	97
No.10	2.00	91
No.20	0.850	87
No.40	0.425	84
No.80	0.180	82
No.100	0.150	81
No.200	0.075	80
Hydrometer	0.042	76
	0.030	74
	0.019	73
	0.011	69
	0.008	64
	0.006	59
	0.003	53
	0.001	38

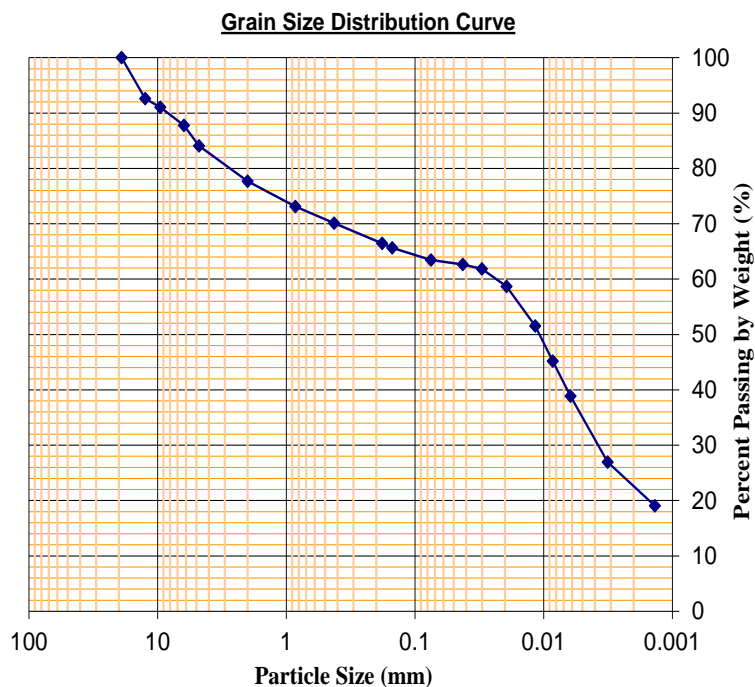
B-1; S-4

Grey CLAY, some SILT, some cmf SAND, little mf GRAVEL

<u>Sieve Designation</u>	<u>Size (mm)</u>	<u>Percent Passing by Weight (%)</u>
3/4"	19.0	100
1/2"	12.5	93
3/8"	9.5	91
1/4"	6.25	88
No.4	4.75	84
No.10	2.00	78
No.20	0.850	73
No.40	0.425	70
No.80	0.180	66
No.100	0.150	66
No.200	0.075	63
Hydrometer	0.042	63
	0.030	62
	0.019	59
	0.012	52
	0.008	45
	0.006	39
	0.003	27
	0.001	19

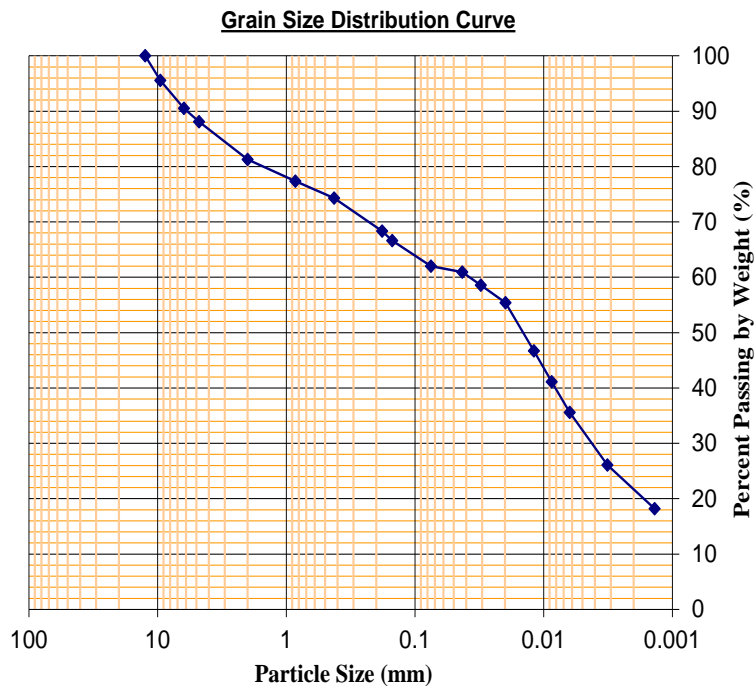
B-2; S-2

Grey/Brown CLAY, some SILT, some cmf SAND, little fine GRAVEL

Sieve Designation	Size (mm)	Percent Passing by Weight (%)
1/2"	12.5	100
3/8"	9.5	96
1/4"	6.25	91
No.4	4.75	88
No.10	2.00	81
No.20	0.850	77
No.40	0.425	74
No.80	0.180	68
No.100	0.150	67
No.200	0.075	62
Hydrometer	0.043	61
	0.031	59
	0.020	55
	0.012	47
	0.009	41
	0.006	36
	0.003	26
	0.001	18

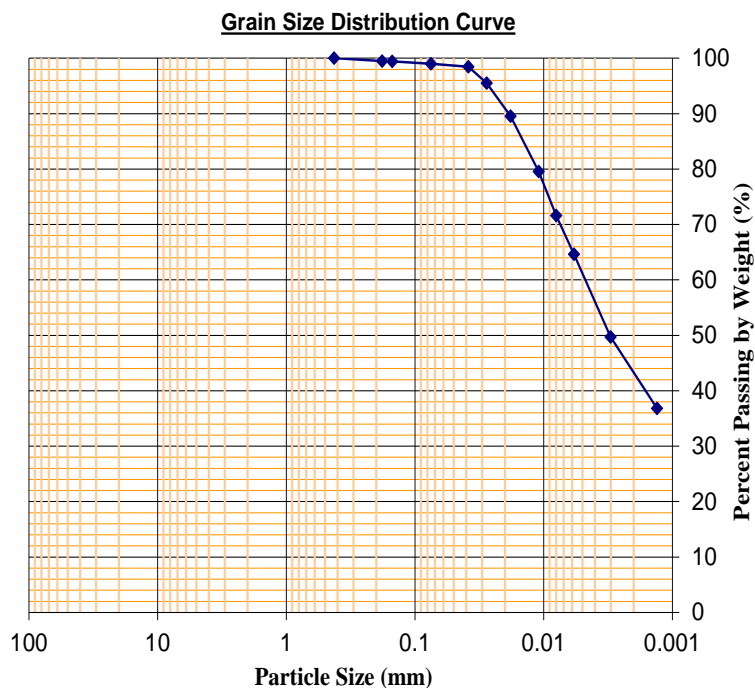
B-2; S-4A

Grey CLAY and SILT, trace fine SAND

Sieve Designation	Size (mm)	Percent Passing by Weight (%)
No.40	0.425	100
No.80	0.180	99
No.100	0.150	99
No.200	0.075	99
Hydrometer	0.038	98
	0.028	95
	0.018	90
	0.011	80
	0.008	72
	0.006	65
	0.003	50
	0.001	37
